# 64 Winchester Drive Atherton, CA Arborist Report 2024

Site: 64 Winchester Drive  
Atherton, CA 94027

Date: August 19, 2024

Subject Re: Letter for planning commission of trees #5 and #43

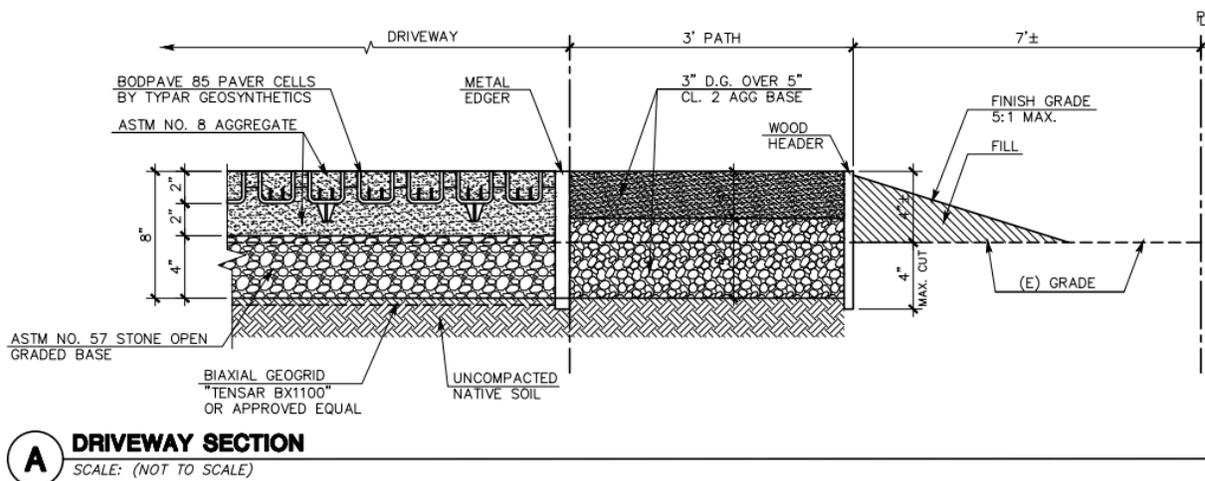
**Showing provided detail of the driveway work and decomposed granite pathway work.**

Coast live oak tree #5 is in fair condition. 24% of the tree's root zone will be impacted by the proposed work. Coast live oak trees have a good tolerance to construction impacts, as seen in the Matheny and Clark relative tree tolerance chart. The tree is expected to continue to thrive in the landscape. Impacts will be mitigated through deep water fertilizing the tree with Nutriroot. This

**COAST LIVE OAK TREE #5-** A new driveway is shown within the tree protection zone of the neighboring coast live oak tree #5. The driveway is shown at 3.33x the tree's diameter or at 10' from the tree. In order to construct the driveway with minimal impacts to the tree, It is recommended to construct the driveway using Biaxial Geogrid (Tensar BX-1100 or equivalent). Biaxial Geogrid can be used as a subgrade layer below aggregate for reinforcing the driveway. The Geogrid allows for pinning down of the surrounding soil and can be constructed over tree root zones. Using the Geogrid material will improve filtration, reduce the base thickness needed allow for compaction of underlying parent soil to be no greater than 85-90%, reduce incidents of tire ruts and soil migration, and relieve the roots from strain/compaction caused by vehicles. No more than 4" of excavation (mostly for rough grading and scarifying the soil) shall be allowed for the driveway

construction when working within 30 feet (10x diameter) from tree #5. The existing grade and proposed driveway grade will need to be nearly identical to allow for this work to take place with minimal impacts to the tree. The civil engineer has placed the driveway slightly above the existing grade by 4" so that the driveway allows for a slightly thicker base section. After minor grading and scarifying of the soil has been completed (4"), the Geogrid material shall be laid directly on top of the soil, and the driveway shall be constructed entirely on top of the root zone. Edging for the driveway construction is recommended to be supported by individual pins, as excavating for a continuous edge would nullify the use of Geogrid. By building the driveway using the techniques described above, the impact to tree #5 would be minor. Because the driveway work is to take place within the tree's tree protection zone, the work will require the direct supervision of the Project Arborist. Grading and scarifying the soil will need to be done by hand under the Project Arborist's supervision when working within 30 feet of tree #5. Any exposed roots during the driveway work will need to be kept moist by covering roots in layers of wetted-down burlap to help avoid root desiccation. Exposed roots will be required to be documented by the Project Arborist. Before the driveway work is to start, the tree protection zone is recommended to be deep water fertilized with 300 gallons of water mixed with Nutriroot. The top foot of the soil within the tree protection zone is recommended to be saturated.

A decomposed granite pathway is proposed to follow the edge of the driveway near oak tree #5. The pathway is recommended to be built with a minimal 4" cut into grade. This work will need to be done by hand under the project arborist supervision when working within 30' from the tree. No roots shall be cut for the pathway work. Any root encountered must be retained within the granite itself or base rock layer.

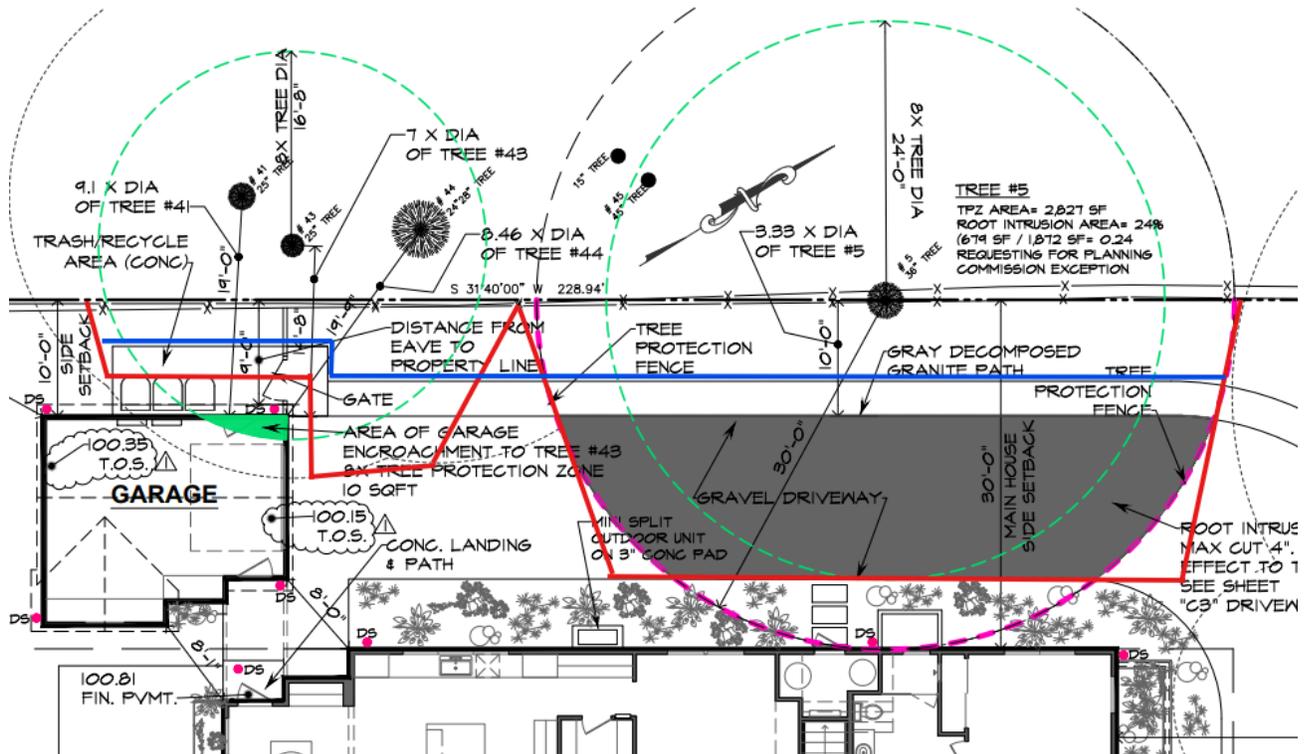
**Red line shows the recommended placement of tree protection fencing, and the blue line indicates the placement of tree protection fencing during the driveway work**
