# Kielty Arborist Services LLC

November 5<sup>th</sup>, 2021, Revised March 24<sup>th</sup>, 2022

Site: 183 Patricia Drive, Atherton CA

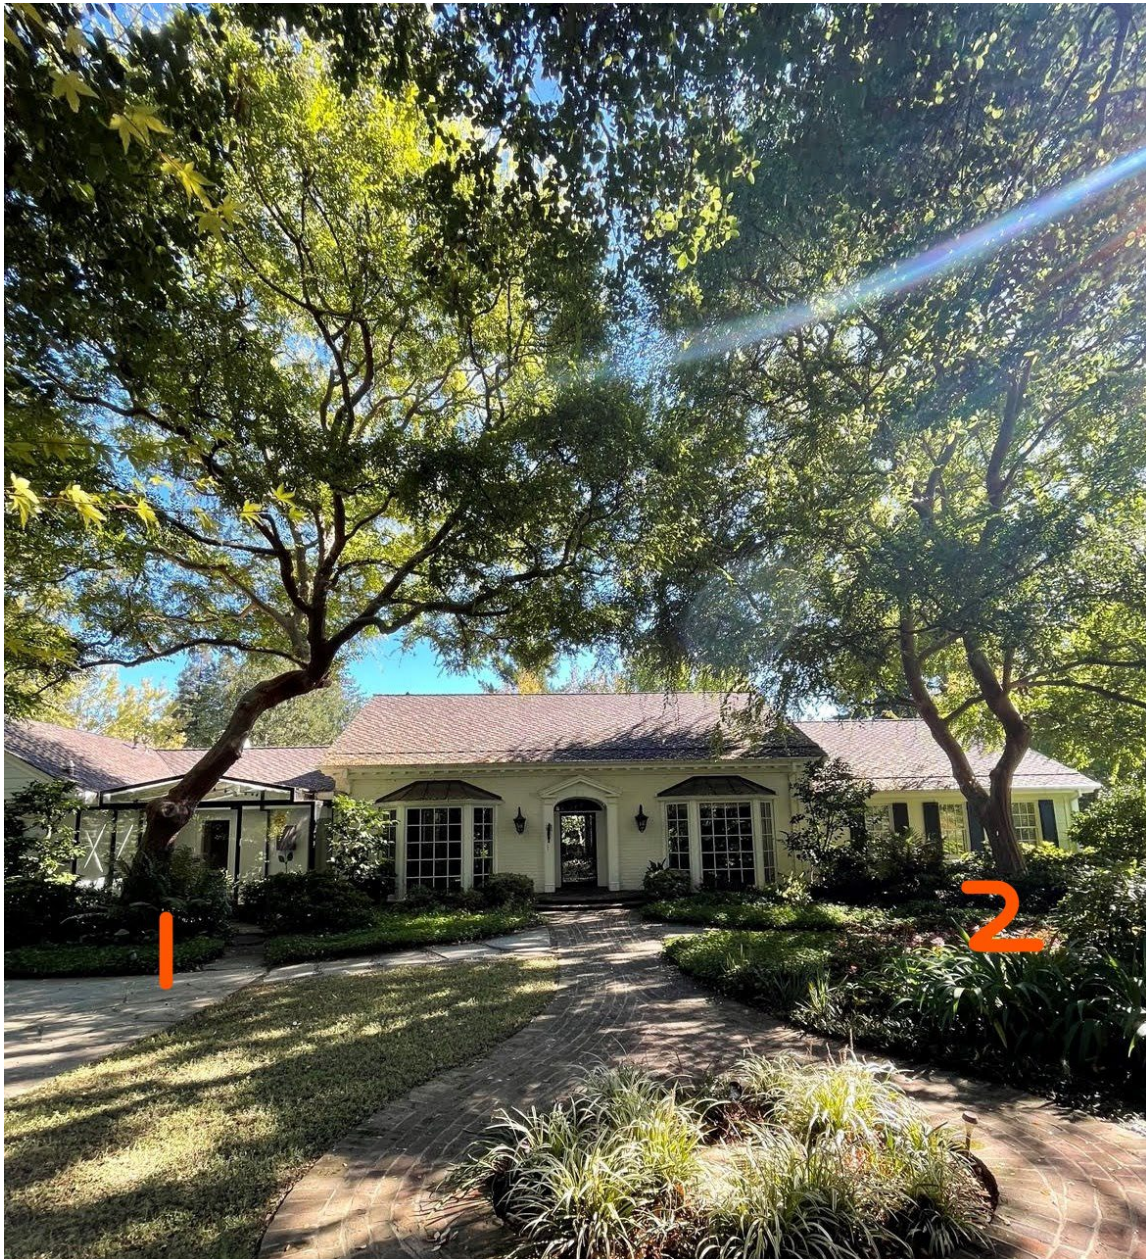
**Showing Chinese Elm trees #1 and #2**

<b>Tree#</b>	<b>Species</b>	<b>DBH</b>	<b>CON</b>	<b>HT/SP</b>	<b>Comments</b>
<b>1R</b>	Chinese Elm ( <i>Ulmus parvifolia</i> )	21.7	70	40/40	Good vigor, good form, slight lean, close to home, <b>IN BUILDABLE SPACE</b>
<b>2P/R</b>	Chinese Elm ( <i>Ulmus parvifolia</i> )	19.5	70	40/40	Good vigor, good form, close to home. <b>Appraised value=\$5,400</b> <b>10x diameter= 16.2'</b> <b>8x diameter= 13'</b>

Chinese Elm tree #2 is in good condition. The tree is located too close to the existing home and proposed home. Any limb failure or trunk failure would likely have high chance of impacting the home (target). Consequences of failure would be high for the high value home. The proposed home foundation is at risk of being damaged by the tree's roots, as the tree is very close to the proposed home. Cutting roots at the proposed foundation would have a high impact on the stability and health of the tree. Tree removal is recommended as the tree is hazardous to the home. (See picture on page 2)

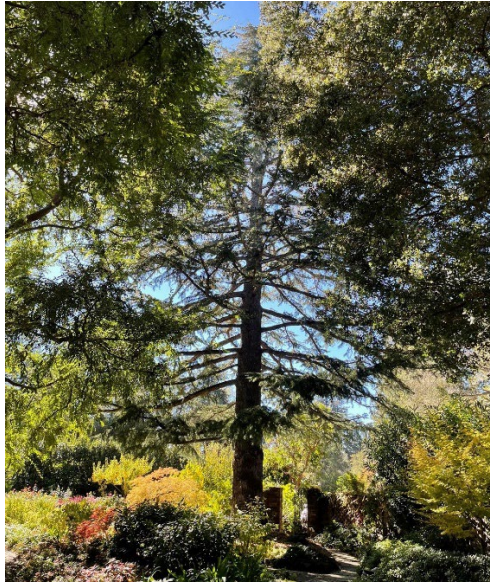
<b>Tree#</b>	<b>Species</b>	<b>DBH</b>	<b>CON</b>	<b>HT/SP</b>	<b>Comments</b>
3P	Deodar Cedar ( <i>Cedrus deodara</i> )	45.8	70	65/45	Good vigor, good form.
Appraised value=\$27,200					
10x diameter= 38.1'					
8x diameter= 30.5'

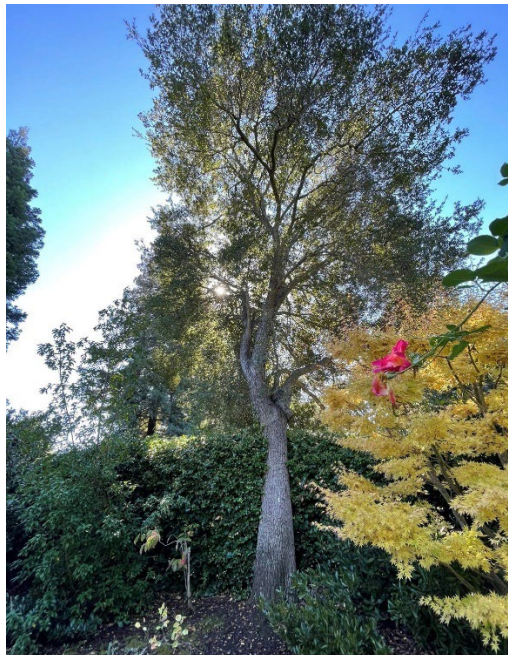
4P	Coast Live Oak ( <i>Quercus agrifolia</i> )	24.0	70	40/30	Good vigor, fair form, too close to irrigation, heavy towards neighbor's property.
Appraised value=\$9,100					
10x diameter= 20'					
8x diameter= 16'

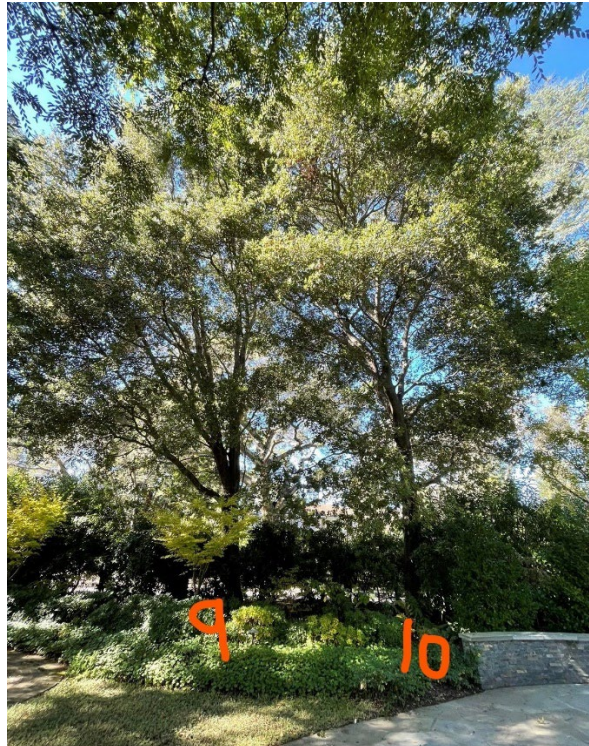
<b>Tree#</b>	<b>Species</b>	<b>DBH</b>	<b>CON</b>	<b>HT/SP</b>	<b>Comments</b>
5	Sweet Bay ( <i>Laurus nobilis</i> )	10.0	50	12/8	Good vigor, fair form, hedge pruned, screening material.
6	Sweet Bay ( <i>Laurus nobilis</i> )	10.0	50	12/8	Good vigor, fair form, hedge pruned, screening material.
7	Sweet Bay ( <i>Laurus nobilis</i> )	12.0	50	12/8	Good vigor, fair form, hedge pruned, screening material.
8	Strawberry Madrone ( <i>Arbutus marina</i> )	9.8	50	15/12	Fair vigor, fair form, decay on trunk.
9P	Coast Live Oak ( <i>Quercus agrifolia</i> ) <b>Appraised value=\$7,800</b> <b>10x diameter= 19.8'</b> <b>8x diameter= 15.8'</b>	23.8	60	45/35	Good vigor, fair form, codominant at 12 feet with included bark.
10P	Coast Live Oak ( <i>Quercus agrifolia</i> ) <b>Appraised value=\$9,900</b> <b>10x diameter= 21'</b> <b>8x diameter= 16.8'</b>	25.2	70	45/40	Good vigor, good form.

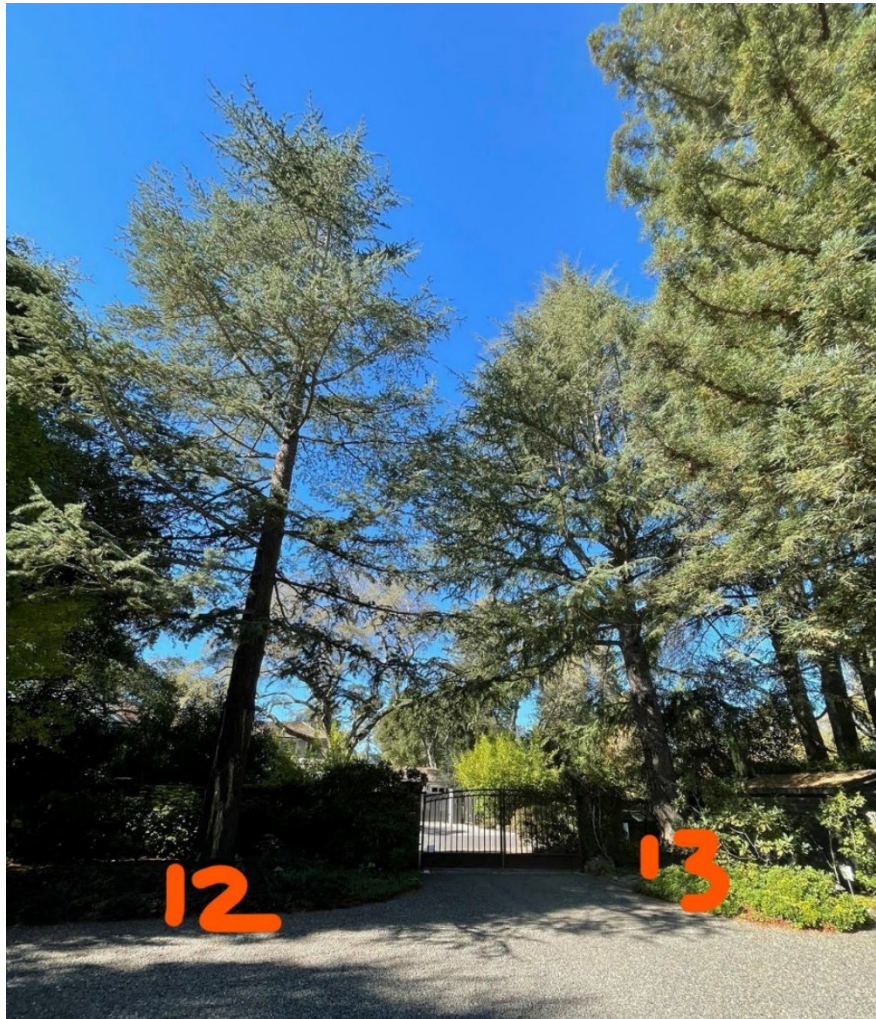
<b>Tree#</b>	<b>Species</b>	<b>DBH</b>	<b>CON</b>	<b>HT/SP</b>	<b>Comments</b>
11	Ginkgo ( <i>Ginkgo biloba</i> )	11.3	65	30/20	Good vigor, good form, suppressed.
12P	Deodar Cedar ( <i>Cedrus deodara</i> ) <b>Appraised value=\$14,300</b> <b>10x diameter= 25'</b> <b>8x diameter= 20'</b>	30.0	70	65/30	Good vigor, good form.
13P	Deodar Cedar ( <i>Cedrus deodara</i> ) <b>Appraised value=\$20,500</b> <b>10x diameter= 34.1</b> <b>8x diameter= 27.3'</b>	41.0	60	85/35	Good vigor, poor form, codominant at 40'

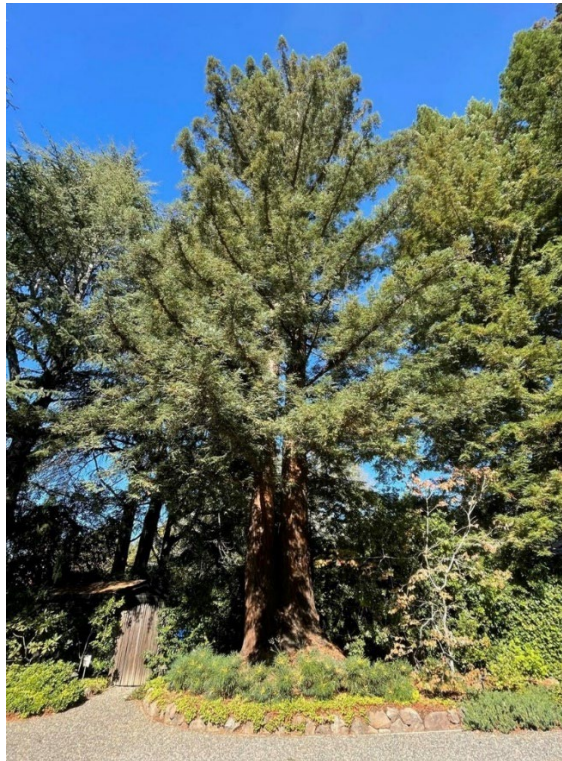
<b>Tree#</b>	<b>Species</b>	<b>DBH</b>	<b>CON</b>	<b>HT/SP</b>	<b>Comments</b>
14aP	Redwood ( <i>Sequoia sempervirens</i> ) <b>Appraised value=\$11,000</b> <b>10x diameter= 45.8'</b> <b>8x diameter= 36.6'</b>	35.2	60	80/35	Fair vigor, poor form, codominant at grade with 14b.

14bP	Redwood ( <i>Sequoia sempervirens</i> ) <b>Appraised value=\$16,900</b> <b>10x diameter= 45.8'</b> <b>8x diameter= 36.6'</b>	47.3	60	80/35	Fair vigor, poor form, codominant at grade with 14a.
------	--	------	----	-------	--

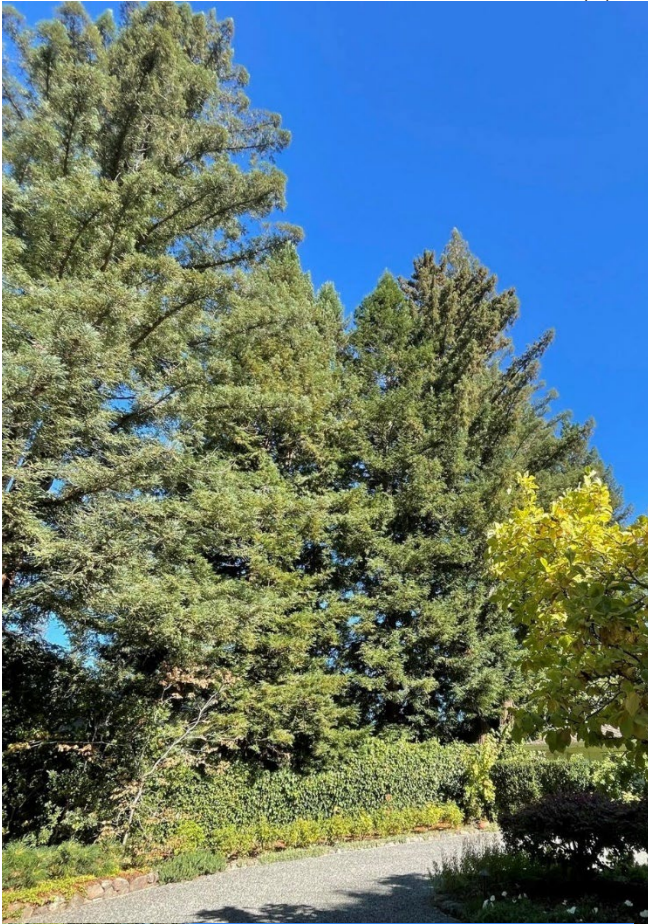
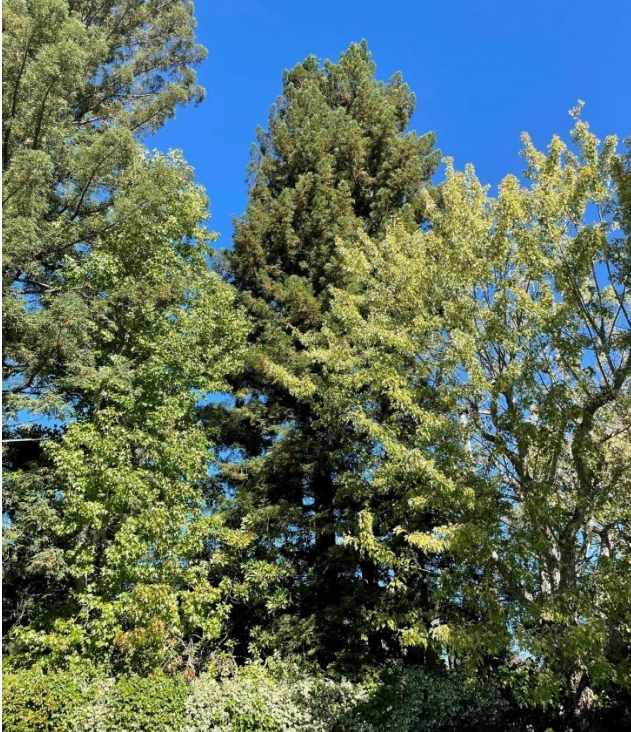
**Pictures showing neighboring Redwood trees #16-22 & #24 and 25**

16*P	Redwood ( <i>Sequoia sempervirens</i> ) <b>Appraised value=\$ 5,100</b> <b>10x diameter= 16.6'</b> <b>8x diameter= 13.3'</b>	20est	70	85/25	Fair vigor, fair form, minor drought stress.
------	--	-------	----	-------	--

17*	Redwood ( <i>Sequoia sempervirens</i> )	14est	70	85/25	Fair vigor, fair form, minor drought stress.
-----	--	-------	----	-------	--

<b>Tree#</b>	<b>Species</b>	<b>DBH</b>	<b>CON</b>	<b>HT/SP</b>	<b>Comments</b>
18*P	Redwood ( <i>Sequoia sempervirens</i> ) <b>Appraised value=\$3,720</b> <b>10x diameter= 14.1'</b> <b>8x diameter= 11.3'</b>	17est	70	85/25	Fair vigor, fair form, minor drought stress.
19*P	Redwood ( <i>Sequoia sempervirens</i> ) <b>Appraised value=\$5,100</b> <b>10x diameter= 16.6'</b> <b>8x diameter= 13.3'</b>	20est	70	85/25	Fair vigor, fair form, minor drought stress.
20*	Redwood ( <i>Sequoia sempervirens</i> )	14est	70	85/25	Fair vigor, fair form, minor drought stress.
21*P	Redwood ( <i>Sequoia sempervirens</i> ) <b>Appraised value=\$ 14,700</b> <b>10x diameter= 31.6'</b> <b>8x diameter= 25.3'</b>	38est	60	95/25	Fair vigor, fair from, bot canker infected.
22*P	Redwood ( <i>Sequoia sempervirens</i> ) <b>Appraised value=\$17,600</b> <b>10x diameter= 36.6'</b> <b>8x diameter= 29.3'</b>	44est	60	110/30	Fair vigor, fair form, drought stressed, die back.

23*	Liquidambar ( <i>Liquidambar styraciflua</i> )	14est	55	50/25	Fair vigor, fair form, suppressed.
24*P	Redwood ( <i>Sequoia sempervirens</i> ) <b>Appraised value=\$9,900</b> <b>10x diameter= 23.3'</b> <b>8x diameter= 18.6'</b>	28est	70	90/25	Fair vigor, fair form.
25*P	Redwood ( <i>Sequoia sempervirens</i> ) <b>Appraised value=\$9,900</b> <b>10x diameter= 23.3'</b> <b>8x diameter= 18.6'</b>	28est	70	90/25	Fair vigor, fair form.

The proposed detached garage on site will need a town arborist exception for Redwood trees #14a, 14b, 16, 19, 21, and 22. This is discussed in a separate letter as an addendum to this report and will be used for the planning commission meeting. None of the other retained Heritage trees will have work proposed within the 10x diameter distance and therefore no other impacts are expected. The following tree protection plan will help to reduce impacts to the trees on site.

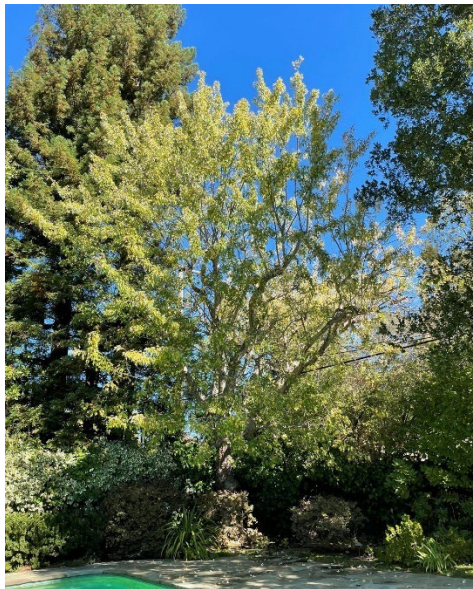
<b>Tree#</b>	<b>Species</b>	<b>DBH</b>	<b>CON</b>	<b>HT/SP</b>	<b>Comments</b>
26P	Silver maple ( <i>Acer saccharinum</i> )	32.1	50	35/35	Fair vigor, poor form, topped for utilities, off balanced, heavy into property.
<b>Appraised value=\$5,900</b>					
<b>10x diameter= 26.7'</b>					
<b>8x diameter= 21.4'</b>

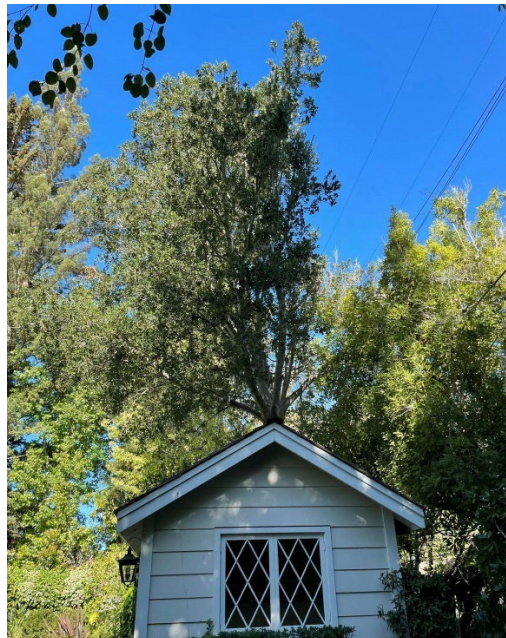
27P	Coast Live Oak ( <i>Quercus agrifolia</i> )	23.5	60	35/25	Fair vigor, fair form, pruned for utilities on one side, close to irrigation.
<b>Appraised value=\$6,700</b>					
<b>10x diameter= 19.5'</b>					
<b>8x diameter= 15.6'</b>

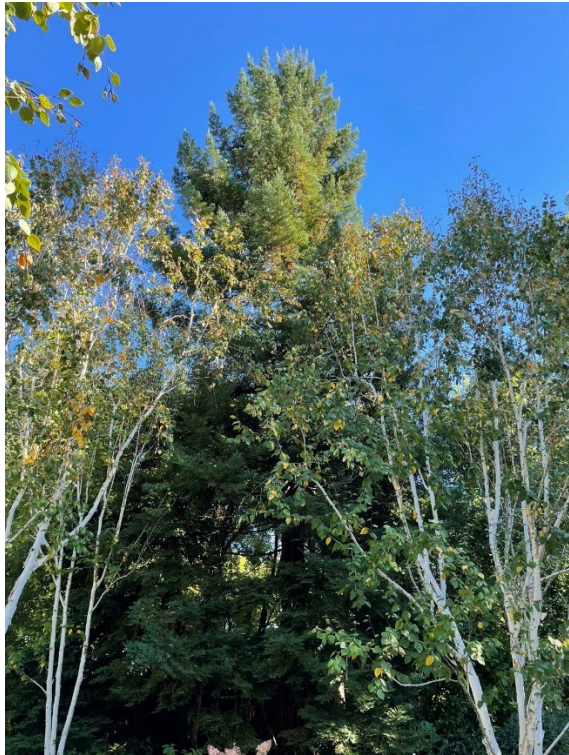
<b>Tree#</b>	<b>Species</b>	<b>DBH</b>	<b>CON</b>	<b>HT/SP</b>	<b>Comments</b>
28	Birch ( <i>Betula pendula</i> )	10.9	70	25/15	Good vigor, good form.
29	Birch ( <i>Betula pendula</i> )	11.8	70	25/15	Good vigor, good form.
30	Birch ( <i>Betula pendula</i> )	11.2	70	25/15	Good vigor, good form.
31	Birch ( <i>Betula pendula</i> )	10.1	70	25/15	Good vigor, good form.
32	Pittosporum ( <i>Pittosporum eugenioides</i> )	9.5	50	30/15	Fair vigor, poor form, topped for utilities.
33P	Redwood ( <i>Sequoia sempervirens</i> ) <b>Appraised value=\$7,300</b> <b>10x diameter= 20.2'</b> <b>8x diameter= 16.2'</b>	24.3	70	55/20	Good vigor, good form.

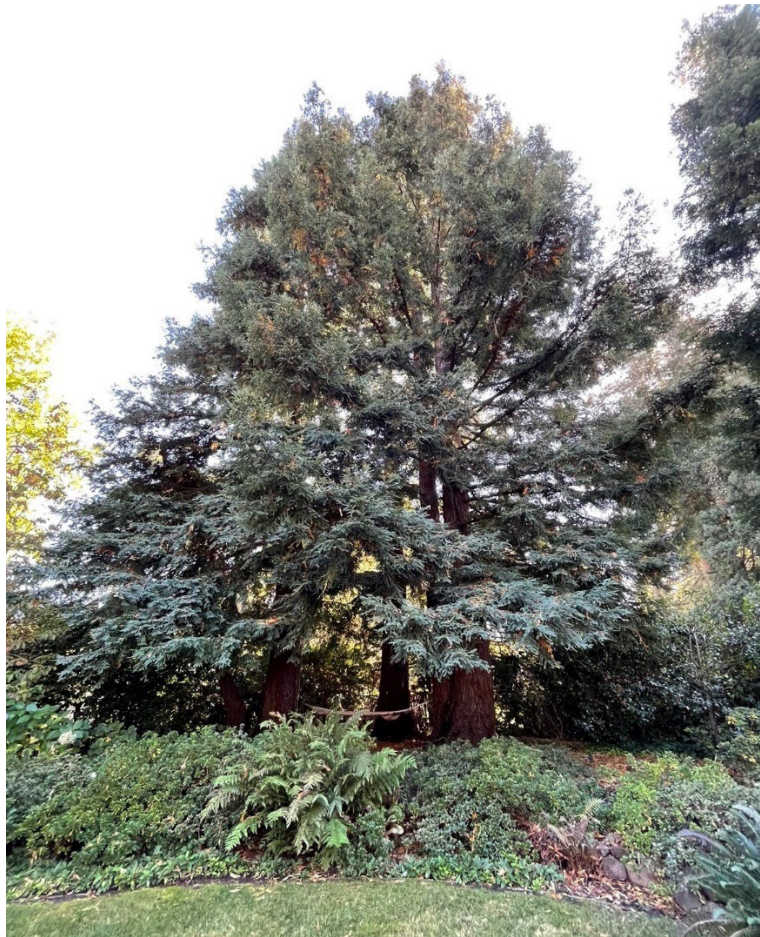
**Showing Redwood trees #35-37**

<b>Tree#</b>	<b>Species</b>	<b>DBH</b>	<b>CON</b>	<b>HT/SP</b>	<b>Comments</b>
35P	Redwood	34-38-15	55	75/25	Good vigor, poor form, codominant. ( <i>Sequoia sempervirens</i> ) fixed diameter= 62.5 <b>Appraised value=\$ 26,800</b> <b>10x diameter= 52'</b> <b>8x diameter= 41.6'</b>
36P	Redwood	41.5	70	75/25	Good vigor, good form. ( <i>Sequoia sempervirens</i> ) <b>Appraised value=\$ 19,800</b> <b>10x diameter= 34.5'</b> <b>8x diameter= 27.6'</b>
37P	Redwood	25-38	60	75/25	Good vigor, fair form, codominant. ( <i>Sequoia sempervirens</i> ) fixed diameter=50.5 <b>Appraised value=\$ 21,400</b> <b>10x diameter= 42'</b> <b>8x diameter= 33.6'</b>

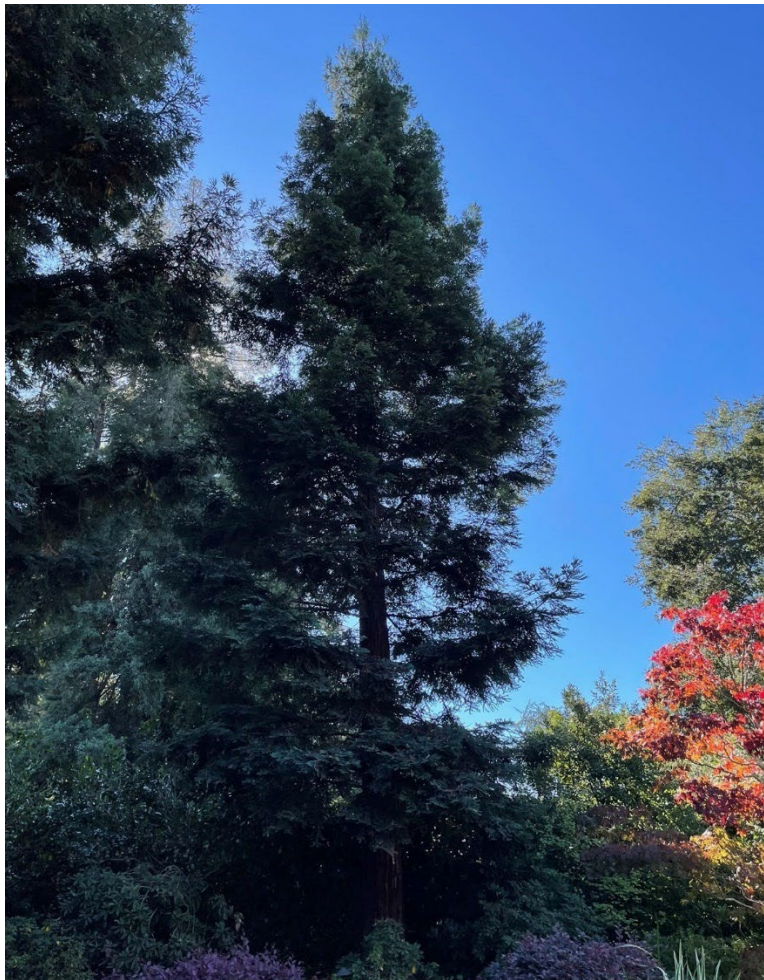
<b>Tree#</b>	<b>Species</b>	<b>DBH</b>	<b>CON</b>	<b>HT/SP</b>	<b>Comments</b>
38P	Redwood ( <i>Sequoia sempervirens</i> )	22.2	70	55/20	Good vigor, good form.
<b>Appraised value=\$ 6,200</b>					
<b>10x diameter= 18.5'</b>					
<b>8x diameter= 14.8'</b>
