Kielty Arborist Services LLC

May 1st, 2023

Site: 29 Stockbridge, Atherton CA

As requested on Wednesday, January 18th, 2023, and again on April 12th 2023, Kielty Arborist Services LLC visited the above site for the purpose of providing a Tree Inventory Report/Tree Protection Plan for the proposed construction. A new home, pool house, pool, detached garage and sports court are proposed on site, and as required a tree protection plan is needed when submitting plans to the town of Atherton. Site plan A1.0 dated 4/28/23 was reviewed for writing this report. This Tree Inventory Report is not a Tree Risk Assessment. As such, no trees were assessed for risk in accordance with industry standards, nor are there any tree risk ratings or risk mitigation recommendations provided within this preservation plan unless stated otherwise.

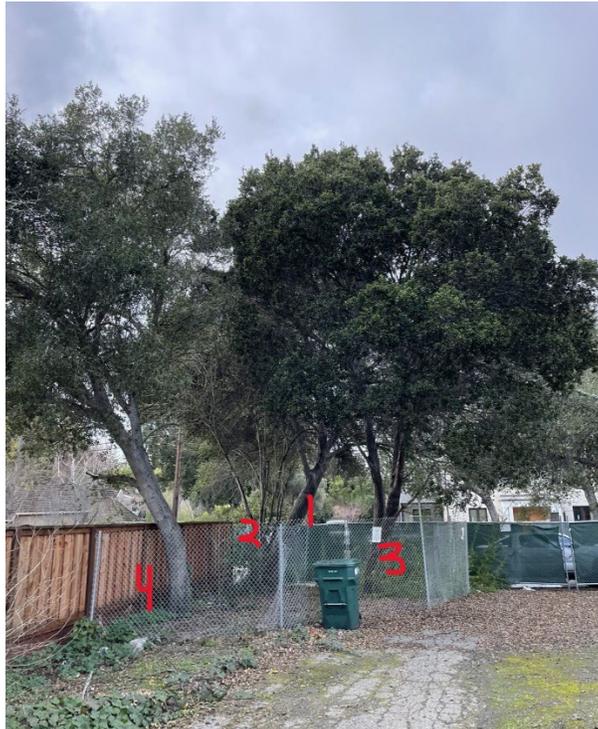
Showing trees 1-4

Tree#	Species	DBH	CON	HT/SP	Comments
1P	Coast live oak (<i>Quercus agrifolia</i>) 10 times diameter=19.1' 8 times diameter= 15.3' 6 times diameter= 11.5' Appraised value=\$6,700	23.0	60	30/30	Fair vigor, fair structure, leans towards street.
2R	English hawthorn (<i>Crataegus laevigata</i>)	9.0	30	15/10	Poor vigor, poor structure, suppressed, no room for vertical growth.
3P	Coast live oak (<i>Quercus agrifolia</i>) 10 times diameter= 14.5' 8 times diameter= 11.6' 6 times diameter= 8.7' Appraised value=\$3,770	17.5	55	20/15	Fair vigor, poor structure, codominant at 5' with poor union.
4P	Coast live oak (<i>Quercus agrifolia</i>) 10 times diameter= 14.2' 8 times diameter= 11.4' 6 times diameter= 8.5' Appraised value=\$3,680	17.1	60	25/20	Fair vigor, fair structure, grows into neighboring property, suppressed, codominant at 10'

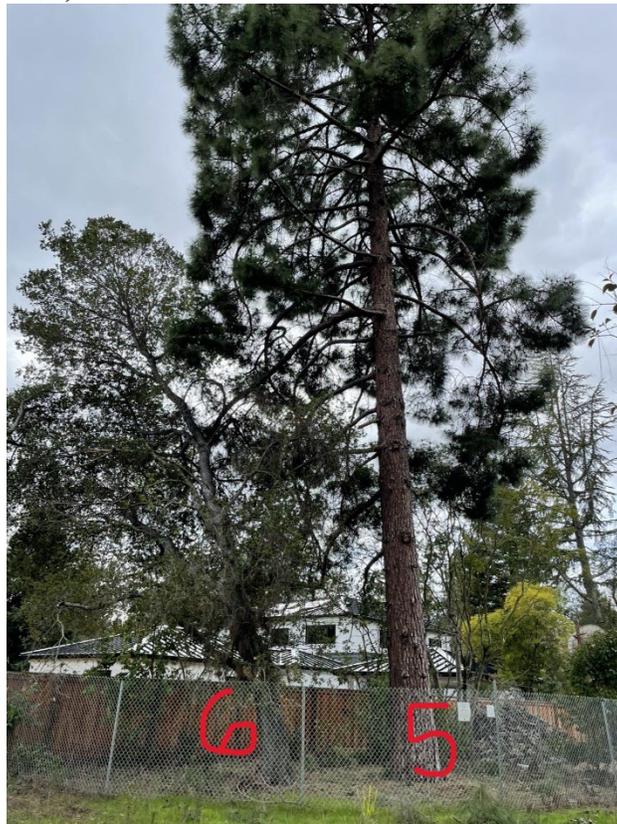
Showing trees #5 and #6

<u>Tree#</u>	<u>Species</u>	<u>DBH</u>	<u>CON</u>	<u>HT/SP</u>	<u>Comments</u>
5P	Canary Island pine (<i>Pinus canariensis</i>)	34.8	70	70/35	Fair vigor, fair structure.
	10 times diameter= 29'				
	8 times diameter= 23.2'				
	6 times diameter= 17.4'				
	Appraised value=\$16,000				
6P	Coast live oak (<i>Quercus agrifolia</i>)	20.2	60	30/20	Fair vigor, fair structure, suppressed by #5.
	10 times diameter= 16.8'				
	8 times diameter= 13.4'				
	6 times diameter= 10.1'				
	Appraised value=\$5,100

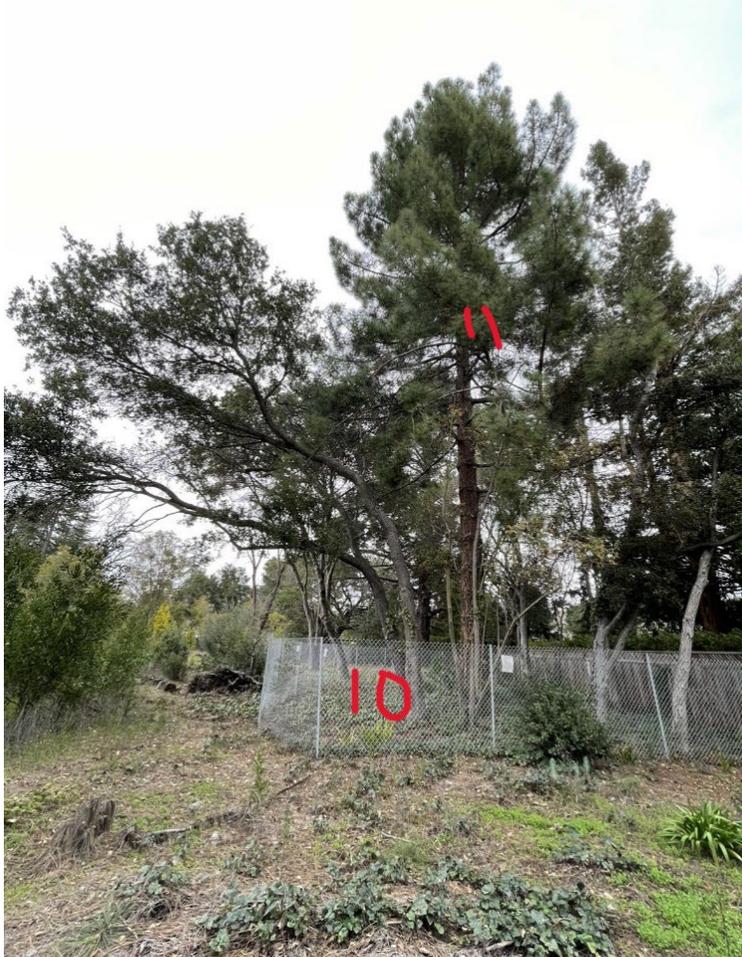
Showing trees #10 and #11

Tree#	Species	DBH	CON	HT/SP	Comments
9R	Coast live oak (<i>Quercus agrifolia</i>)	14.8	45	30/20	Fair vigor, poor structure, topped, under utilities.
10P/R	Coast live oak (<i>Quercus agrifolia</i>)	21.3	40	30/25	Fair vigor, poor structure, suppressed, grows at lean into site, codominant at 3', hazard
11P	Canary Island pine (<i>Pinus canariensis</i>)	36.9	70	75/35	Good vigor, good structure.

10 times diameter= 30.7'
8 times diameter= 24.6'
6 times diameter= 18.4'
Appraised value=\$17,600

Coast live oak tree #10 is growing at a heavy lean due to suppressed growing conditions. The tree is a hazard to the property as risk of tree failure is high. No mitigation measures within ANSI A300 pruning standards are expected to mitigate the risk of failure; therefore, the tree is recommended for removal.

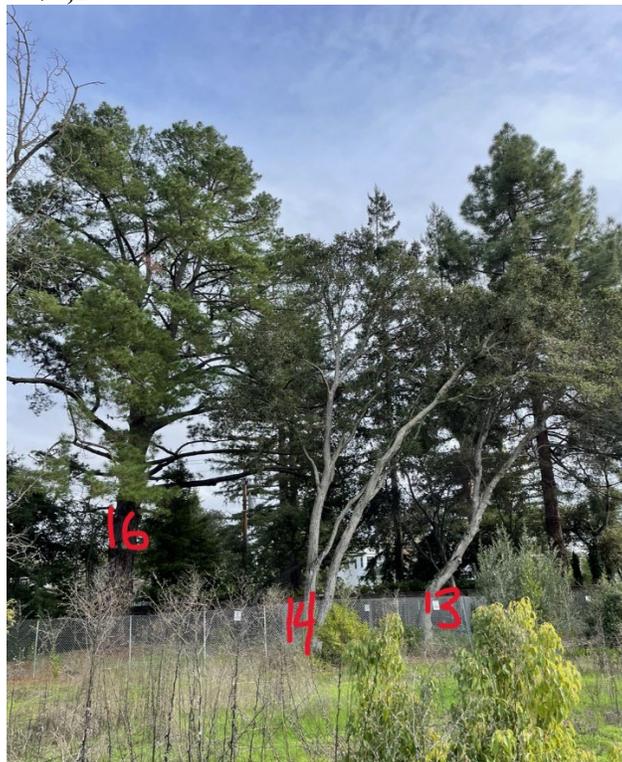
Showing trees #13, 14, and 16

<u>Tree#</u>	<u>Species</u>	<u>DBH</u>	<u>CON</u>	<u>HT/SP</u>	<u>Comments</u>
13P	Coast live oak (<i>Quercus agrifolia</i>) 10 times diameter= 16.2' 8 times diameter= 13' 6 times diameter= 9.7' Appraised value=\$3,900	19.5	60	35/30	Fair vigor, fair structure, suppressed, leans into site.
14P	Coast live oak (<i>Quercus agrifolia</i>) 10 times diameter= 23.2' 8 times diameter= 18.6' 6 times diameter= 13.9' Appraised value=\$7,600	27.9	60	35/35	Fair vigor, poor structure, codominant at 3' with included bark, cabled in past, suppressed, grows into site.
15	Coast live oak (<i>Quercus agrifolia</i>)	14.5	50	25/35	Fair vigor, poor form, grows horizontally, suppressed, pruned for utilities.
16P	Monterey pine (<i>Pinus radiata</i>) 10 times diameter= 45.4' 8 times diameter= 36.3' 6 times diameter= 27.2' Appraised value=\$6,100	54.5	50	70/60	Fair vigor, fair structure, codominant at 30'. DISFAVORED SPECIES

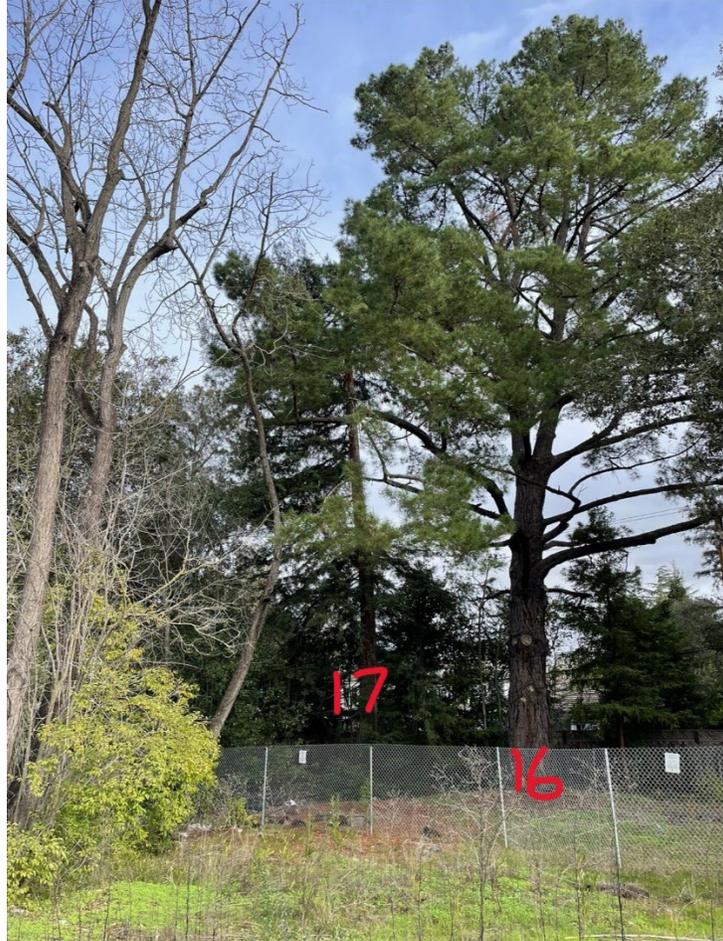
Showing trees #16 and #17

<u>Tree#</u>	<u>Species</u>	<u>DBH</u>	<u>CON</u>	<u>HT/SP</u>	<u>Comments</u>
17P	Redwood <i>(Sequoia sempervirens)</i>	24.0	50	45/18	Good vigor, poor structure, topped.
	10 times diameter= 20'				
	8 times diameter= 16'				
	6 times diameter= 12'				
	Appraised value=\$4,860

Monterey pine tree #16 is likely at the end of its natural lifespan within the landscape. This species is short lived when grown outside its native range. Bark beetles, prolonged drought, and pine pitch canker disease have shortened the lifespan of the tree. The species is a “disfavored species” in the town of Atherton. This tree is to be retained as it is in fair condition. The tree is recommended to be

treated for bark beetles as a preventative measure. The tree is also recommended to be irrigated every other week during the dry season until the top foot of soil within 20 feet from the tree is saturated.

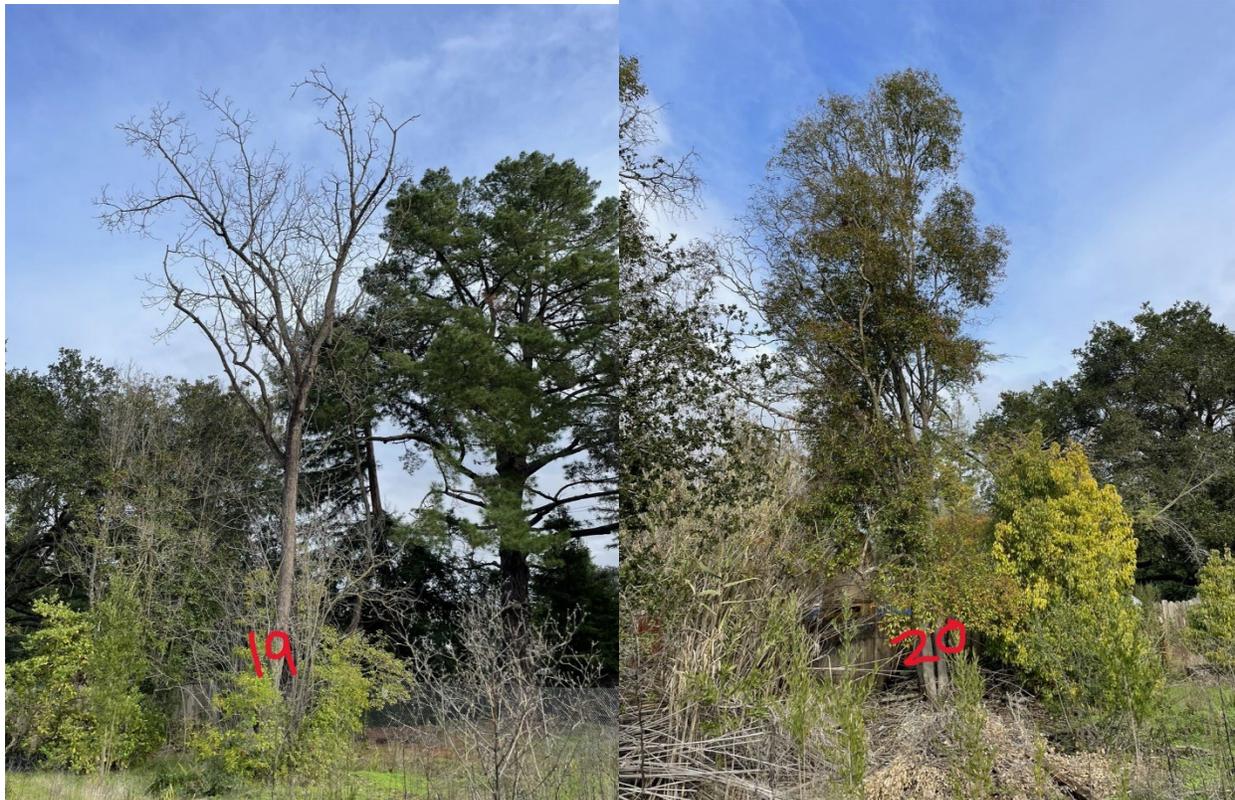
Showing trees #19 and #20

<u>Tree#</u>	<u>Species</u>	<u>DBH</u>	<u>CON</u>	<u>HT/SP</u>	<u>Comments</u>
20P/R	Privet (<i>Ligustrum japonicum</i>)	10-8-6-10	30	35/20	Poor vigor, poor structure, codominant at grade, in decline.
					10 times diameter= 18.3'
					8 times diameter= 14.6'
					6 times diameter= 11'
					Appraised value=\$1,020

Black walnut tree #19 is dead and hazardous to the property. This tree is recommended for removal as soon as possible. The walnut tree is also in the location of the sports court and needs to be removed to facilitate the proposed construction (see page 7 for photo of tree).

Privet tree #20 is recommended to be removed as the tree is in decline and hazardous to the property. The tree is codominant at grade with multiple trunks at high risk of failure due to included bark. The tree is also in the location of the proposed garage. This species is a poor invasive species (see page 7 for photo of tree).

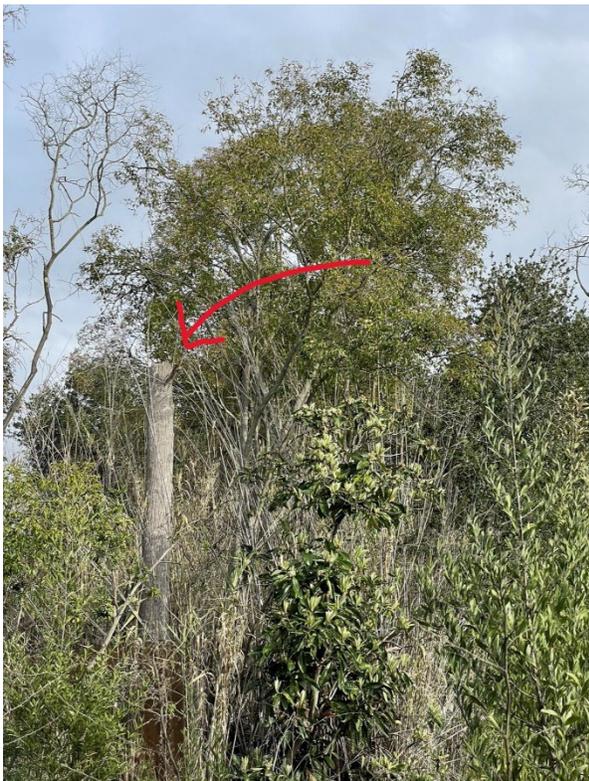
Showing stump #22

Tree #22 is a large dead stump standing at 15' tall. The stump is hazardous and recommended for removal as soon as possible. The tree is in the proposed driveway (see page 8 for photo of stump).

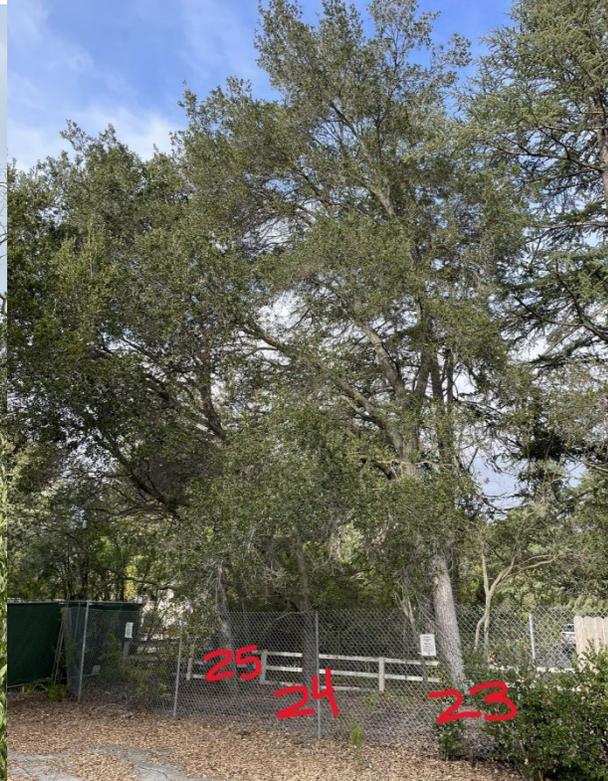
Showing oaks #23-25

Tree#	Species	DBH	CON	HT/SP	Comments
24R	Coast live oak (<i>Quercus agrifolia</i>)	11.9	45	30/30	Fair vigor, poor form, leans west.
25P	Coast live oak (<i>Quercus agrifolia</i>) 10 times diameter= 14.7' 8 times diameter= 11.8' 6 times diameter= 8.8' Appraised value=\$4,120	17.7	60	40/35	fair vigor, poor form, leans west. dominate tree.

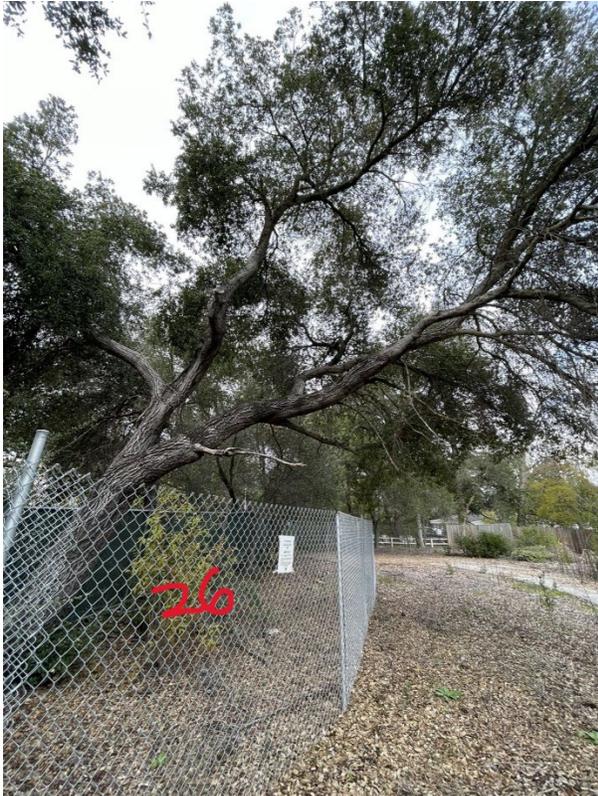
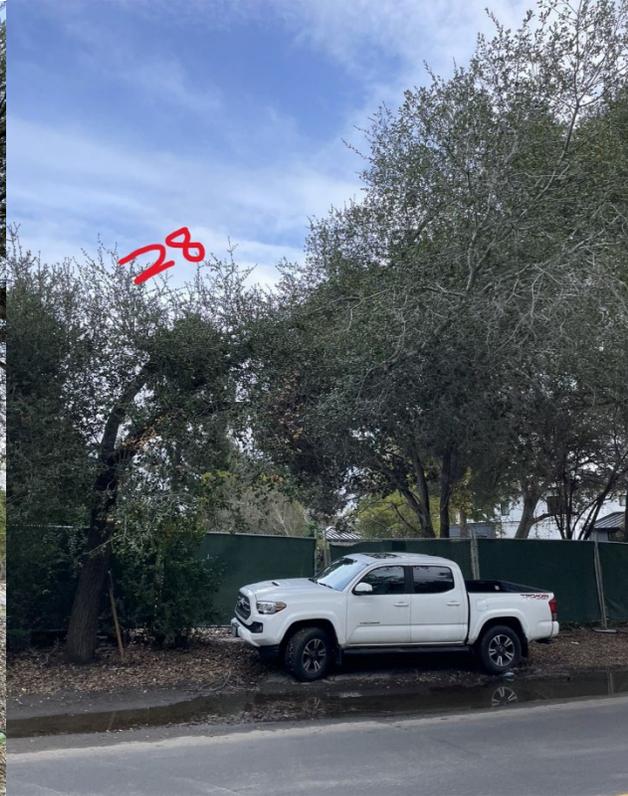
Showing trees #26 and #28

Tree#	Species	DBH	CON	HT/SP	Comments
28P/R	Coast live oak (<i>Quercus agrifolia</i>)	15.2	45	25/30	Fair vigor, poor structure, heavy lean.
	10 times diameter=	12.6'			
	8 times diameter=	10.1'			
	6 times diameter=	7.6'			
	Appraised value=	\$1,670

Coast live oak tree #26 is in poor condition due to a heavy lean. The tree leans heavily into the property. A tree failure has taken place near this tree and has left the tree exposed to prevailing winds. Due to the lean of the tree, the tree is considered hazardous to the property and recommended for removal as pruning the tree is not expected to lower the risk of failure.

Coast live oak tree #28 is recommended for removal as it is a hazard to the property. The tree is very off balanced and grows heavy over the street at a nearly horizontal. Risk of tree failure is high with no mitigations within ANSI A300 pruning standards expected to mitigate the poor form of the tree (see page 9 with photo of tree).

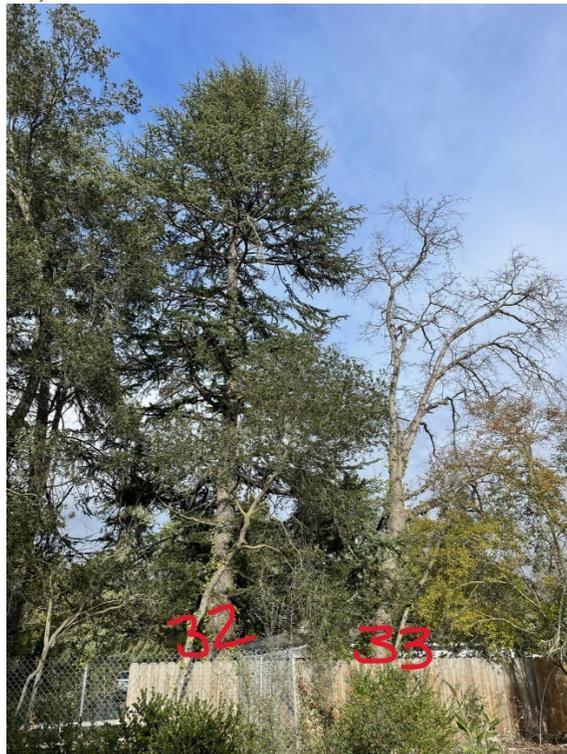
Showing neighboring trees #32 and #33

<u>Tree#</u>	<u>Species</u>	<u>DBH</u>	<u>CON</u>	<u>HT/SP</u>	<u>Comments</u>
32*P	Deodar cedar (<i>Cedrus deodara</i>)	24est	70	65/30	Good vigor, good structure, limited visual inspection, 5' from property line.
	10 times diameter= 20'				
	8 times diameter= 16'				
	6 times diameter= 12'				
	Appraised value=\$7,800				
33*P	Valley oak (<i>Quercus lobata</i>)	18est	50	50/30	Fair vigor, poor form, suppressed, leans away from #32, limited visual inspection.
	10 times diameter= 15'				
	8 times diameter= 12'				
	6 times diameter= 9'				
	Appraised value=\$3,000

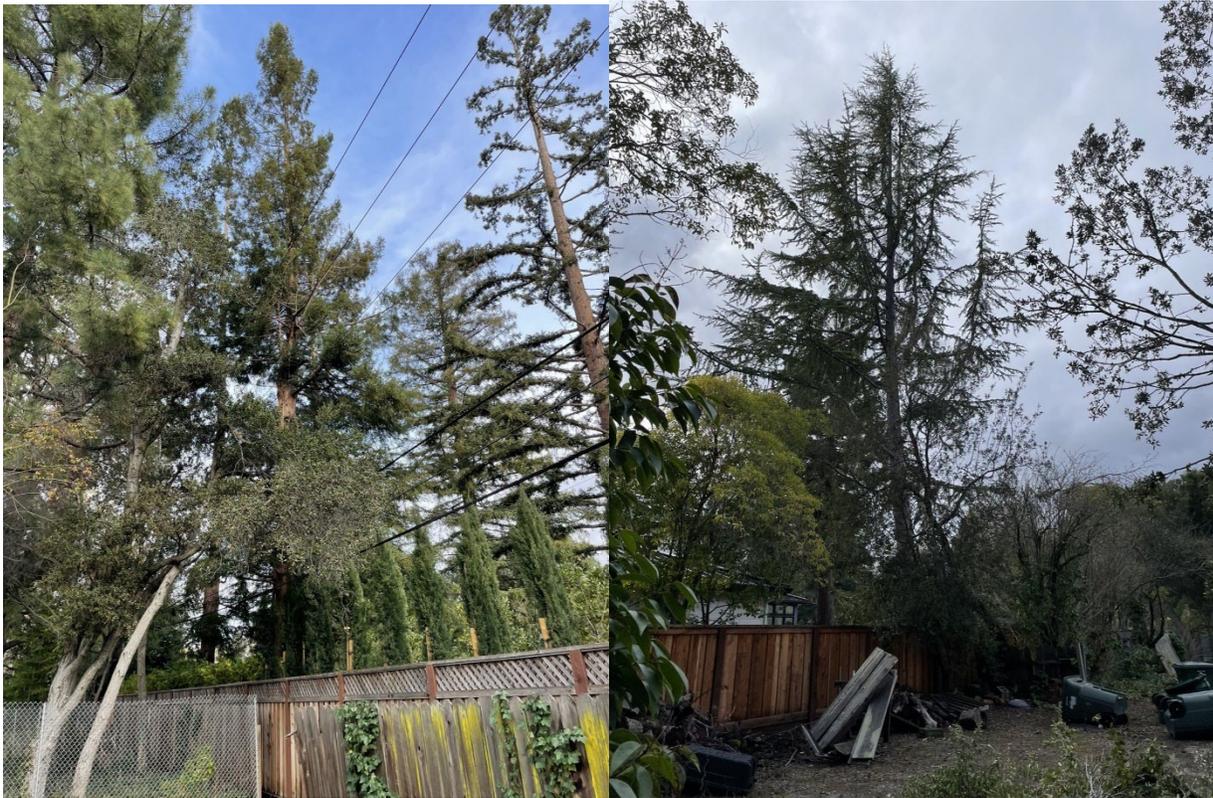
Showing redwood trees #34 and #35 (left) Showing deodar cedar tree #36 (right)

<u>Tree#</u>	<u>Species</u>	<u>DBH</u>	<u>CON</u>	<u>HT/SP</u>	<u>Comments</u>
35*P/R	Redwood (<i>Sequoia sempervirens</i>) 10 times diameter=20' 8 times diameter= 16' 6 times diameter= 12' Appraised value=\$1,870	24est	20	70/25	Fair vigor, poor structure, cut on trunk at 40' looks like a hinge cut, recommended to remove tree, hazard.
36*P	Deodar cedar (<i>Cedrus deodara</i>) 10 times diameter= 13.3' 8 times diameter= 10.6' 6 times diameter= 8' Appraised value=\$3,990	16est	65	55/30	Fair vigor, fair structure, codominant at top of canopy, limited visual inspection.

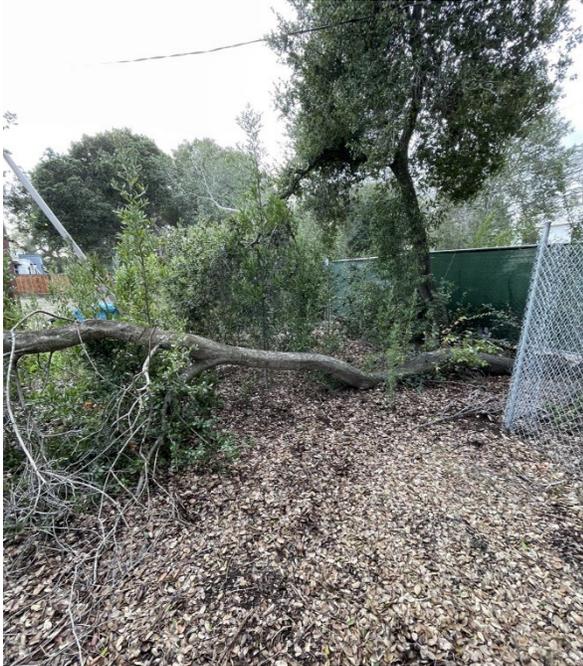
A mix of imported and native trees were surveyed on this property. The property looks to have been poorly maintained for some time. No signs of recent tree maintenance were observed. A failed oak tree was observed at the front of the property with 2 large dead black walnut trees also observed (#18 and #19). A large unidentifiable stump (#22) was also found on site. The dead trees are recommended to be removed as they are a hazard to the property.

Showing failed oak tree at front of property

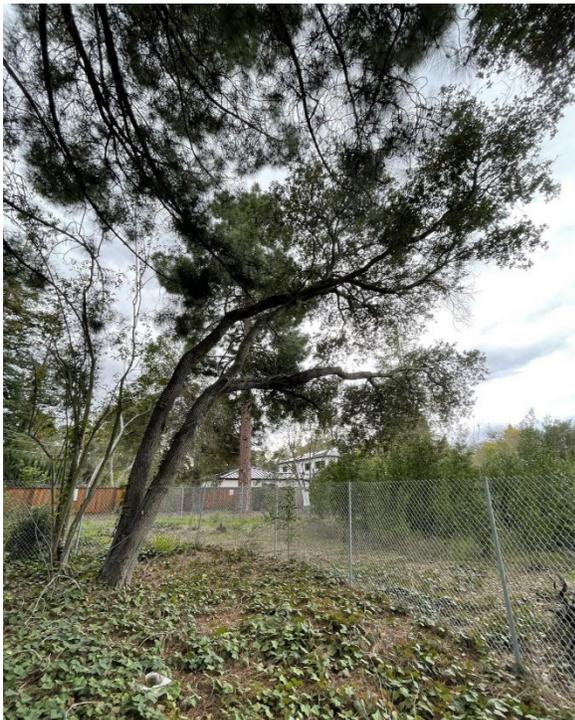
Many of the oak trees on site are growing in suppressed conditions resulting in heavy leans. Oak trees #6, 10,13, 14, 26, and 28 in particular are leaning heavily. Crown reduction pruning where heavy over extended limbs are observed is recommended to reduce risk of a limb failure where possible. In the past oak tree #14 was cabled due to a poor codominant union. The cable is recommended to be inspected biannually by an arborist.

Showing leaning oak tree

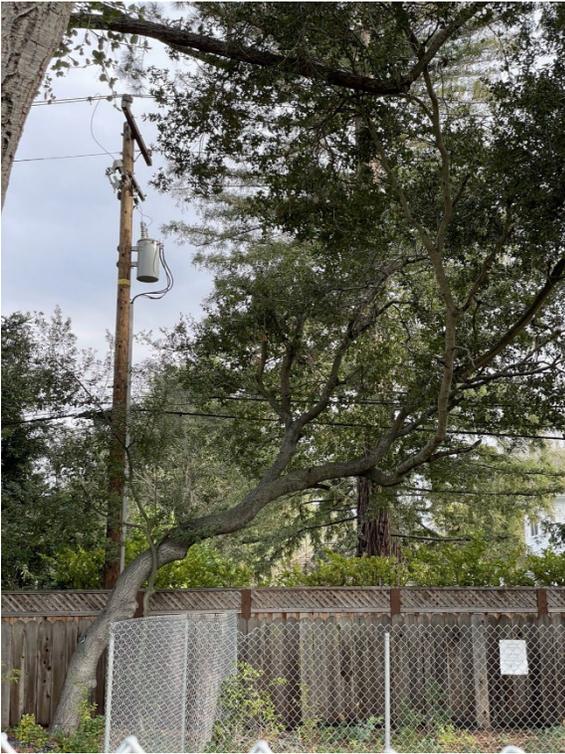
Some of the smaller non-protected oak trees at the back of the property (such as #8 and #9) have been topped for utility line clearance pruning and are growing in suppressed conditions. These trees do offer a fair amount of screening for the property. Annual pruning maintenance is recommended for these trees to reduce risk of limb failures.

Showing leaning oak tree under power lines

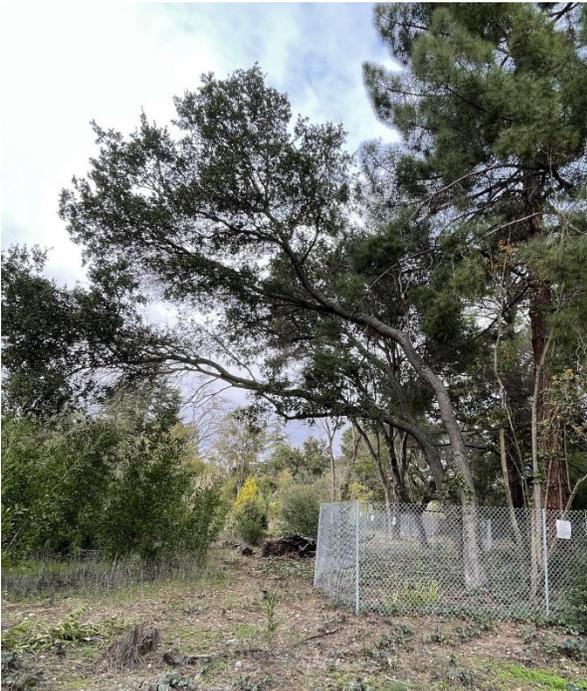
Showing lean on oak tree #10

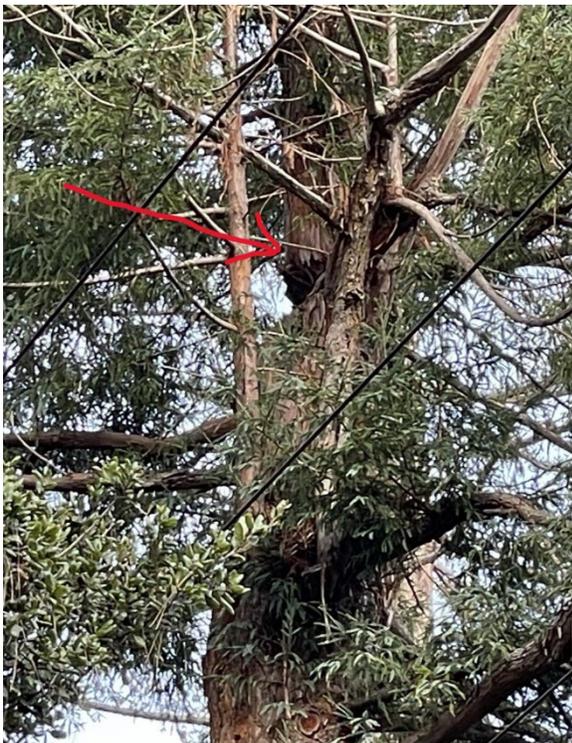
Redwood tree #35 is located on the neighboring property to the east at a few feet from the property line. The tree has fair vigor and looks to be healthy. When inspecting the canopy, an irregularity in the trunk was observed at 40'. The trunk in this area looks to have been cut in the past and looks like a hinge cut. This tree is hazardous and recommended for removal as the rest of the tree from 40' to 70' is at high risk of failure.

Showing cut into trunk

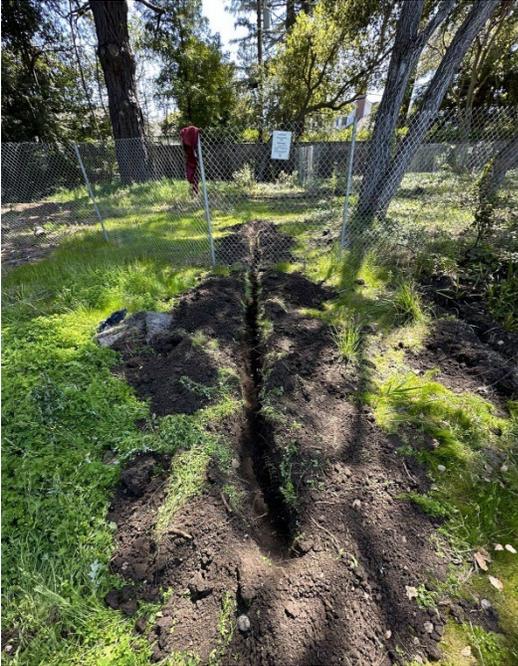
Coast live oak tree #14 is located at 10' from the proposed decomposed granite pathway or at 4.3x the tree's diameter. The decomposed granite pathway is recommended to be built up on top of grade using only rough surface grading where needed so that little to no excavation is needed. Excavation for the decomposed granite area is recommended to not exceed more than 6" when working within 10x the tree's diameter. Impacts are expected to be minor to non-existent if built in this manner. No mitigation measures would be required. An exploratory trench along the edge of the proposed decomposed granite area was done at the depth of 6". No roots were encountered measuring larger than 1" in diameter.

Showing exploratory trench near oak tree #14 for the decomposed granite area

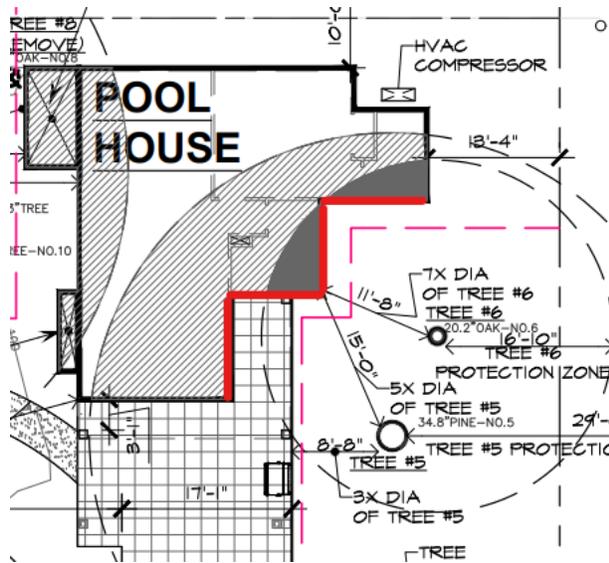
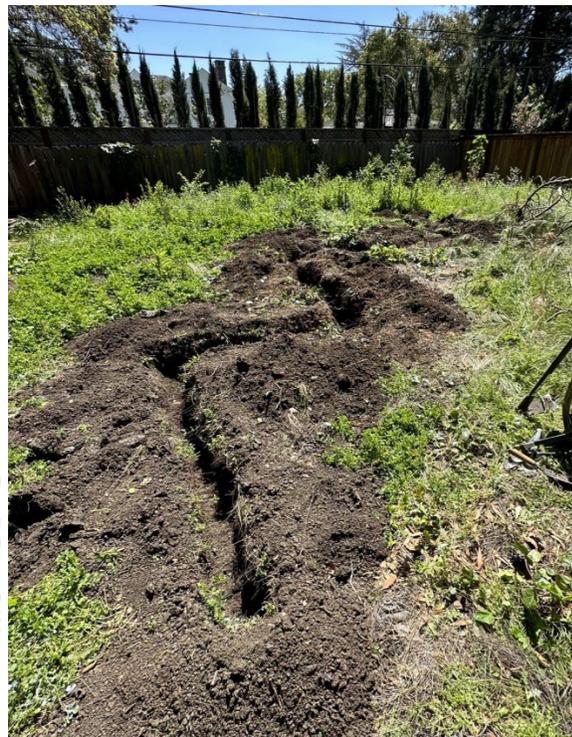
Canary Island pine tree #5 is located at 15' from the pool house or at 5.1x the tree's diameter. The proposed hardscape around the pool house is located at 8.7' from the tree or at 3x the tree's diameter. The pine tree is in good condition and the species has a moderate to good relative tolerance to construction impacts as seen in the Matheny and Clark tolerance chart. The percentage of the tree's root zone to be impacted at 10x the trees diameter is 13.8% (including hardscape work). An exploratory trench was conducted at the pool house foundation using an air knife in combination with hand tools. The depth of the trench was done to 2' as the majority of roots are in the top 2' of soil. Four roots were encountered measuring 1" in diameter or larger. The size of the roots are as followed: 1.8", 2", 1", and 2.2". Impacts are expected to be minor for the pine tree. Hand excavation under the Project Arborist supervision is required for excavating the foundation of the pool house when working within 10x the tree's diameter. All roots encountered measuring 1" in diameter or larger will need to be documented in the required monthly inspections. Encountered roots are recommended to be cleanly cut with cut root ends on the tree side covered in layers of wetted down burlap. This will help to avoid desiccation. Between the pool house and tree, it is recommended to irrigate the soil when within 10x the tree's diameter using 200 gallons of water before the start of excavation for the pool house foundation and again 2 weeks later. This will act as mitigation for the minor impacts. Irrigation will be prescribed during the monthly inspections as needed.

Red line showing location of exploratory trench

Showing exploratory trench.

The hardscape within 10x the diameter of pine tree #5 is recommended to be built up on top of grade while utilizing Biaxial Geogrid (Tensar BX-1100 or equivalent) as an underlayment. The hardscape has been revised to show a minimal offset distance of 8.7' (3x diameter) away from the pine tree. Biaxial Geogrid can be used as a subgrade layer below aggregate for reinforcing the hardscape. The Geogrid allows for pinning down of the surrounding soil and can be constructed over tree root zones. Using the Geogrid material will improve filtration, reduces the base thickness needed and allow for compaction of underlying parent soil to be no greater than 85-90%, reduce incidents of tire ruts and soil migration, and relieve the roots from strain/compaction caused by foot traffic. No more than 6" of excavation (mostly for rough grading and scarifying the soil) shall be allowed for the hardscape construction when working within 29 feet from Canary Island pine tree #5. The existing grade and hardscape grade will need to be nearly identical to allow for this work to take place with minimal impacts to the tree.

The finished grade of the hardscape is recommended to be slightly above the existing grade. After minor grading and scarifying the soil has been completed, the Geogrid material shall be laid directly on top of the soil with the hardscape being constructed entirely on top of the root zone. Edging for the hardscape construction is recommended to be supported by individual pins as excavating for a continuous edge would nullify the use of Geogrid. By building the hardscape using the techniques described above, impact to the protected Canary Island pine tree would be minor. Because the hardscape work is to take place within the tree's tree protection zone of 29', the work will require the direct supervision of the Project Arborist. Grading and scarifying the soil will need to be done by hand under the Project Arborist supervision when working within 29 feet from the Canary Island pine tree #5. Any exposed roots during the hardscape work will need to be kept moist by covering roots in layers of wetted down burlap to help avoid root desiccation. Exposed roots will be required to be documented by the Project Arborist. Before the hardscape work is to start, the tree protection zone is recommended to be heavily irrigated using 200 gallons of water and again 2 weeks later. The top foot of the soil within the tree protection zone is recommended to be saturated. The irrigation will act as mitigation for the pine tree.

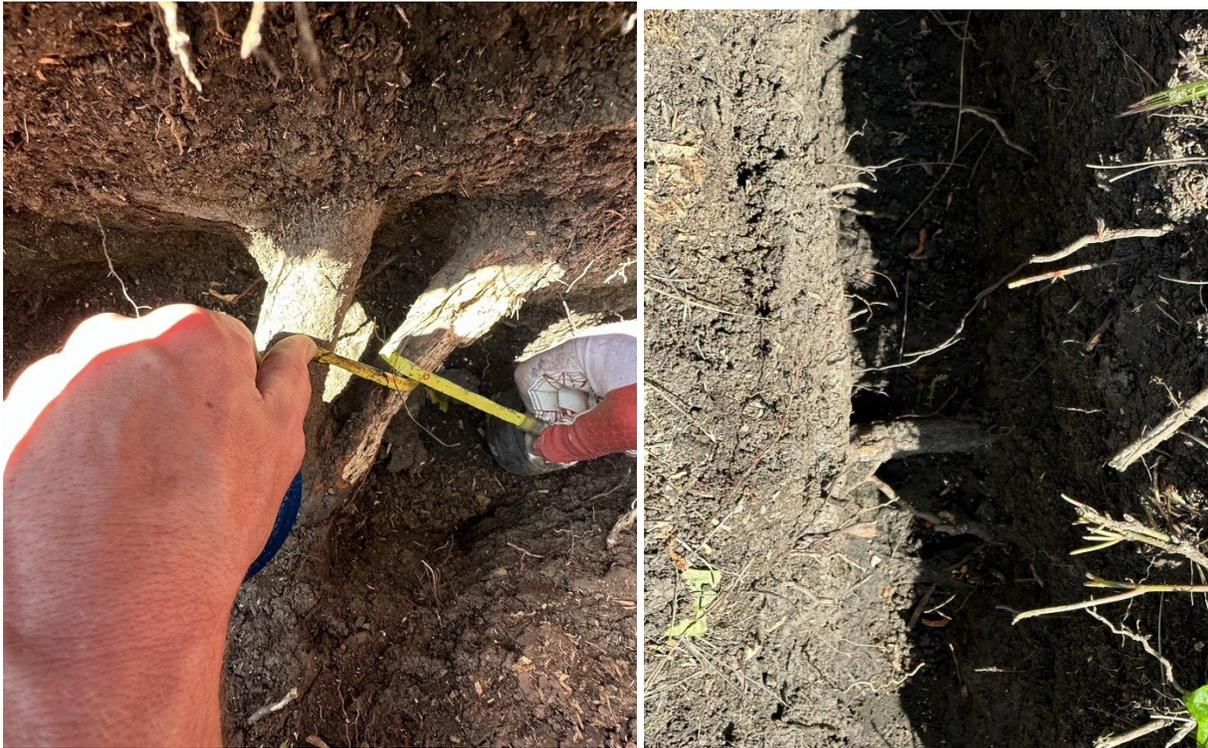
Showing the two 2" diameter roots encountered at the pool house foundation

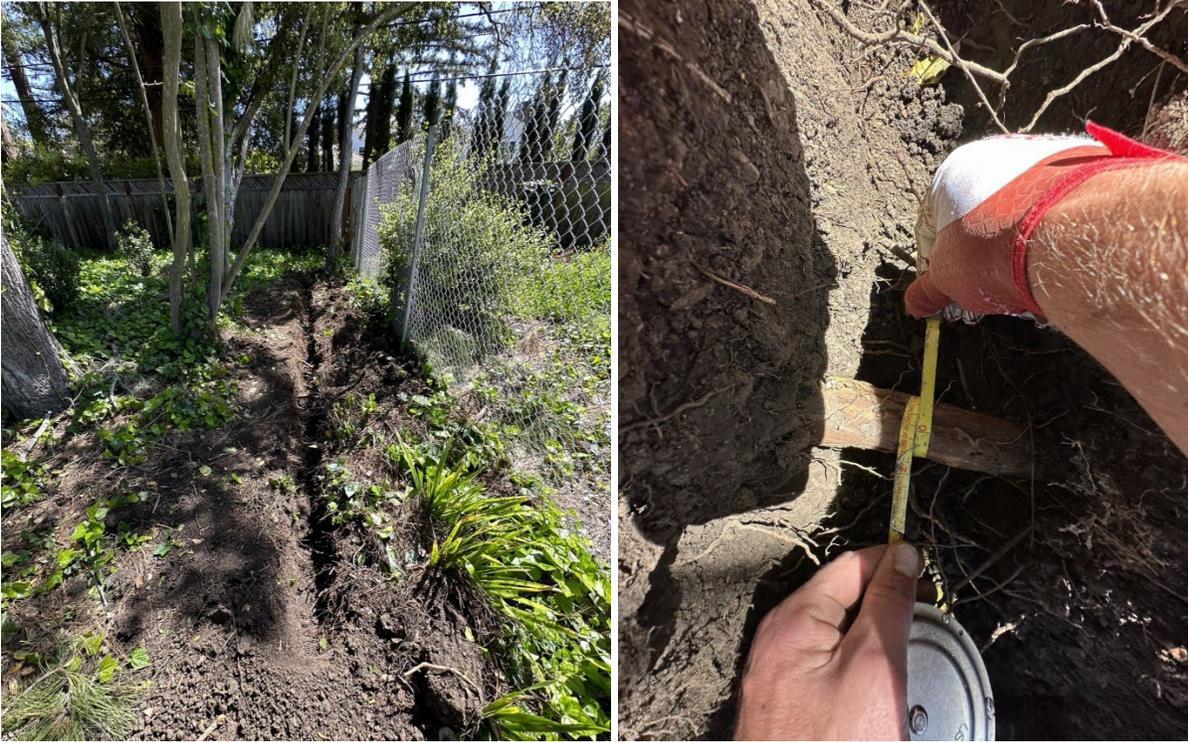
Canary Island pine tree #11 is located at 26' from the pool house or 8.4x the tree's diameter. The pool equipment shed is located at 21' from the tree or at 6.8x the diameter of the tree and will require an exception by planning commission. The pine tree is in good condition and the species has a moderate to good relative tolerance to construction impacts as seen in the Matheny and Clark tolerance chart. The percentage of the tree's root zone to be impacted at 10x the tree's diameter is 5.2%. An exploratory trench was conducted at the pool equipment shed and foundation using an air knife in combination with hand tools. The depth of the trench was done to 2' as the majority of roots are in the top 2' of soil. 3 pine tree roots were encountered measuring 1" in diameter or larger. The size of the roots are as followed: 1.7", 1", and 1.2". Impacts are expected to be minor to nonexistent for the pine tree as no roots measuring 2" in diameter or larger are to be cut. Hand excavation under the Project Arborist supervision is required for excavating the foundation of the pool house when working within 10x the tree's diameter as well as the pool equipment shed. All roots encountered measuring 1" in diameter or larger will need to be documented in the required monthly inspections. Encountered roots are recommended to be cleanly cut with cut root ends on the tree side covered in layers of wetted down burlap. This will help to avoid root desiccation. Between the pool house and tree, it is recommended to irrigate the soil when within 10x the tree's diameter using 200 gallons of water before the start of excavation for the pool house foundation and again 2 weeks later. This will act as mitigation for the minor impacts. Irrigation will be prescribed during the monthly inspections as needed.

Showing exploratory trench

Showing largest pine root encountered at 1.7" diameter

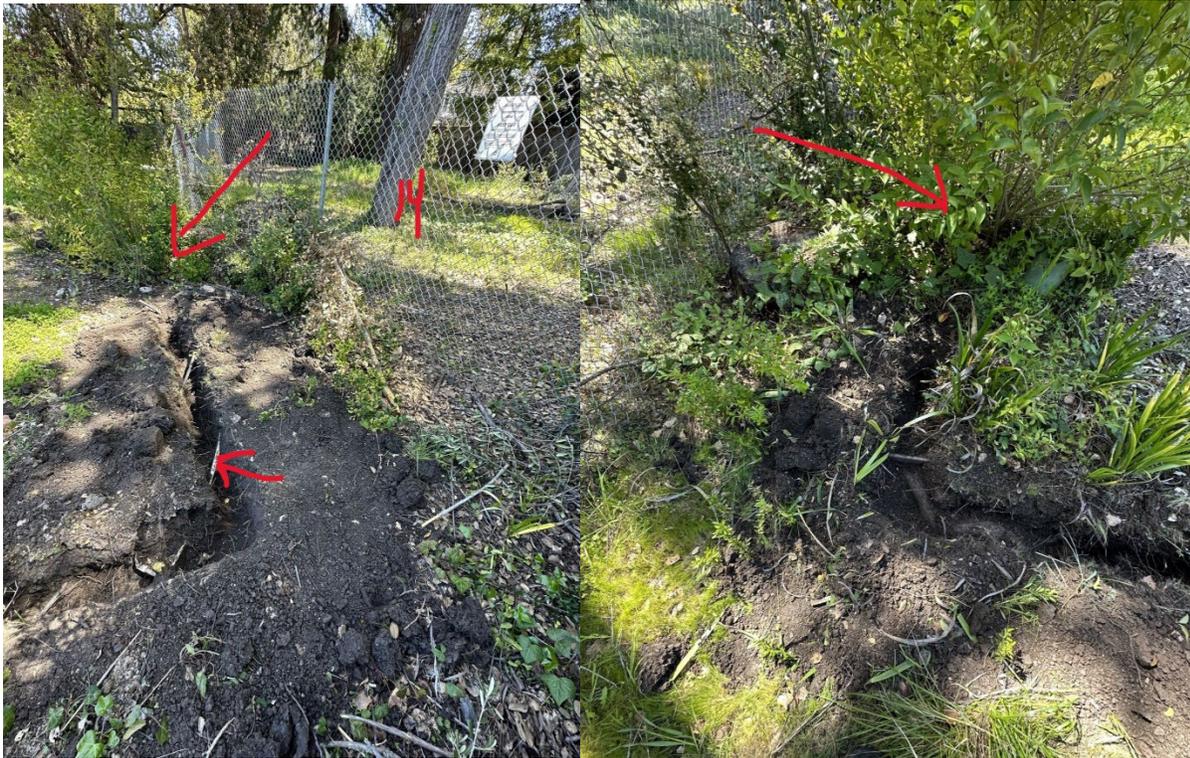
Coast live oak tree #14 is located at 12'8" from the proposed home or at 5.4x the trees diameter. A decomposed granite area is located at 9'3" from the tree or at 4x the tree's diameter. The oak tree is in fair condition and the species has a good relative tolerance to construction impacts as seen in the Matheny and Clark tolerance chart. The percentage of the tree's root zone to be impacted at 10x the tree's diameter is 11.1%. An exploratory trench was completed at the proposed foundation within 10x the tree's diameter. The depth of the exploratory trench for the foundation was done to 2'. A large pine tree stump was located in the center of the home foundation exploratory trench. All roots encountered were from the decaying pine stump. Irrigation lines were also encountered at the foundation location indicating previous

excavation in this area. No oak tree roots were encountered. Impacts are expected to be minor for the oak tree. Hand excavation under the Project Arborist supervision is required for excavating the foundation of the main home and decomposed granite area when working within 10x the tree's diameter. All roots encountered measuring 1" in diameter or larger will need to be documented in the required monthly inspections. Any encountered roots are recommended to be cleanly cut with cut root ends on the tree side covered in layers of wetted down burlap. This will help to avoid desiccation. The decomposed granite area is recommended to be built in a way the required no more than 6" of excavation. All excavation is to be done by hand under the Project Arborist supervision when within 10x the tree's diameter. Any roots encountered are recommended to be retained within the decomposed granite area by packing rock or granite around tree roots. Between the home and tree and decomposed granite area, it is recommended to irrigate the soil when within 10x the tree's diameter using 200 gallons of water before the start of excavation for the foundation and again 2 weeks later. This will act as mitigation for the minor impacts. The tree is also recommended to receive a Cambistat treatment to help control the growth of the tree and to promote new root growth and will act as an additional mitigation measure.

Showing exploratory trench at home foundation near oak tree #14, red arrows showing large stump and irrigation lines encountered
