89 Douglass Way Atherton, Ca Arborist Report 2023

Date: 8/24/23

Subject Re: Tree Protection for Proposed Pool and pickleball court at 89 Douglass Way, Atherton

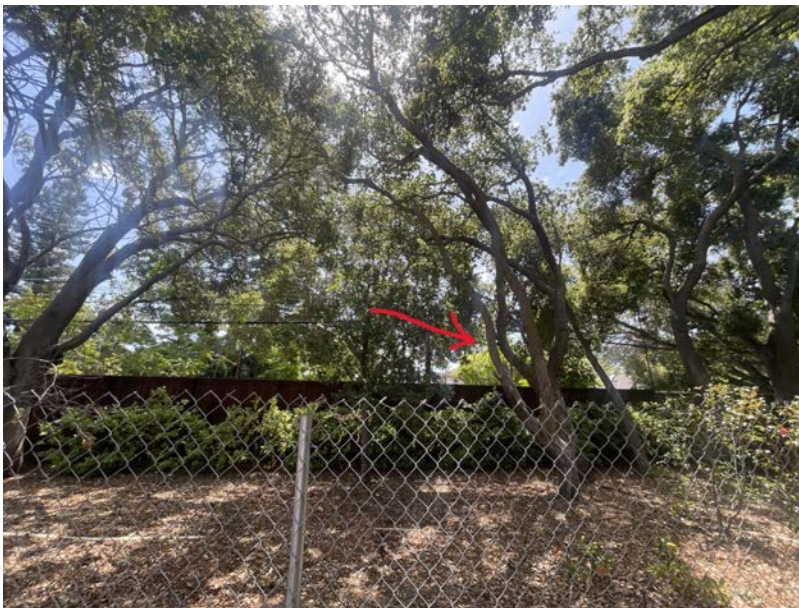
Coast live oak trees #7 and #11 are both growing in heavily suppressed conditions causing the trees to grow at a lean into the site. The surrounding larger oak trees #5, 6, 10 and 12 are much larger than these two oak trees and are well placed on the lot further back towards the property lines. The two oak trees in question will always grow at a lean due the suppressed growing conditions. The loads on the tree defects (leans) are only expected to increase overtime and would eventually lead to large limb failures or total tree failures. The constant pruning needed to mitigate the poor form of the trees is not fair for the property owner, when many other large oak trees exist behind the trees proposed to be removed. No screening will be impacted by the proposed tree removals. Oak trees #7 and #11 are hazardous to the site due to the heavy leans of both trees and tree removal is recommended.

Showing oak tree #11

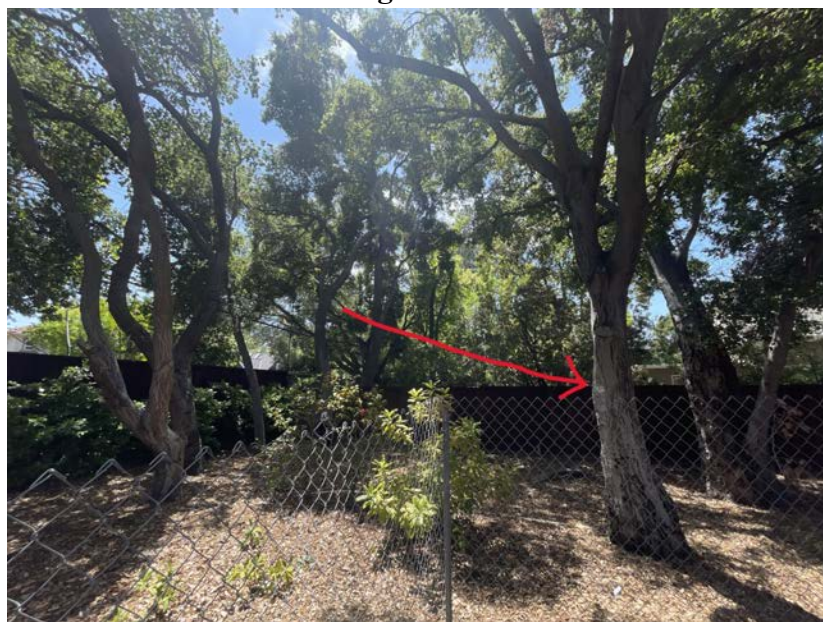
7	Yes	(R)	Coast live oak (<i>Quercus agrifolia</i>)	18.5	9.3	12.3	15.4	35/25	Poor	Poor	Poor	Poor	30	Poor condition. Widespread tip dieback. Thin canopy. Lower trunk swelling. Sycamore borer (aesthetic). Codominant stems. Lions tailed. Leaf necrosis.
10	Yes	(P)	Coast live oak (<i>Quercus agrifolia</i>)	20.5	10.3	13.7	17.1	30/15	Fair	Fair	Fair	Good	60	Leaf necrosis. Good trunk flare. Acute angles of attachments. Sycamore borer (aesthetic). Lions tailed.
11	Yes	(R)	Coast live oak (<i>Quercus agrifolia</i>)	15	7.5	10.0	12.5	30/20	Poor	Poor	Poor	Poor	30	6' dead limb. Signs of stress and decline. Thing canopy. Low vigor. Leaf necrosis. Hypoxylon. Compacted soil. Lacks lower limbs
12	Yes	(P)	Coast live oak (<i>Quercus agrifolia</i>)	28.5	14.3	19.0	23.8	35/25	Fair	Fair	Fair	Good	60	Leaf necrosis. Acute angles of attachments between codominant stems. Good trunk flare. Thin canopy. Lions tailed. Consider support cable.

Showing oak tree #7
