Tree Survey Arborist Report and Construction Review

82 Linda Vista Ave
Atherton, CA 94027

April 1, 2022

Prepared by: Colin Blackie

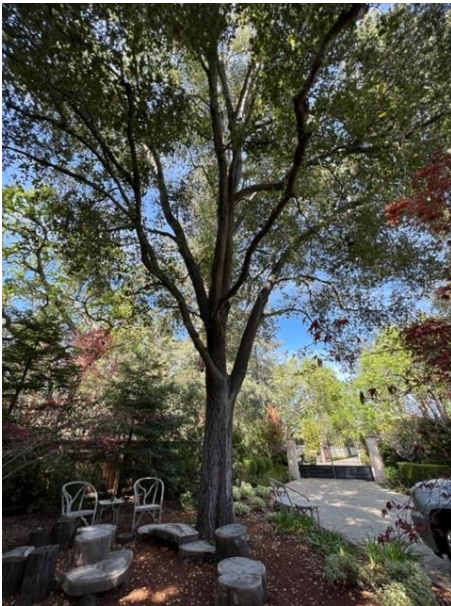
Tree #1

TAG NO.	COMMON NAME	DIAMETER AT BREAST HEIGHT"	H'/W'	HEALTH	STRUCTURE	PROTECTED (X)	TREE DISPOSITION	NOTES, RECOMMENDATIONS
1	Coast live oak	29.0	60'/60'	g	f	x	A	Neighbor's tree 5' from fence. Thin canopy. Neighbor's tree 4' from fence
2	Coast redwood	48.0	120'/30'	fp	g	x	B	
3	Coast live oak	28.0	50'/50'	g	f	x	A	
4	Coast redwood	18.0	48'/20'	g	g	x	A	
5	Coast redwood	16.5	45'/18'	g	g	x	A	
6	Coast redwood	18.0	45'/18'	g	g	x	A	
7	Coast redwood	18.3	45'/18'	g	g	x	A	
A = Retain, condition warrants long-term preservation							6	
B = Preservable, but may not be worthy of extensive effort or design accommodation							1	
C = Recommend removal due to existing condition and/or structure							0	
TOTAL TREES							7	
TOTAL PROTECTED						7

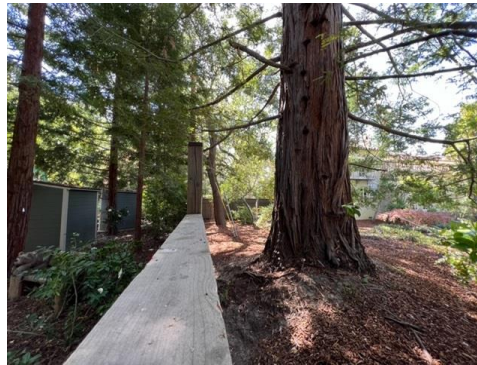
1. We are requesting Tree #2, the 48" Coast Redwood (*Sequoia sempervirens*), to have a tree protection zone (TPZ) exception reduced to 7.48x trunk diameter at breast height (DBH).

same goal. With the protection measures and construction practices in place, we do not anticipate Tree #2 and Tree #4 being negatively affected by the proposed ADU.

3. Tree #2 is located on a neighboring property and was assessed visually by the Project Arborist at the time of the tree survey. The Project Architect has since had a follow-up meeting with the town planner onsite and determined that the tree is 48" diameter, consistent with the original topographic survey.

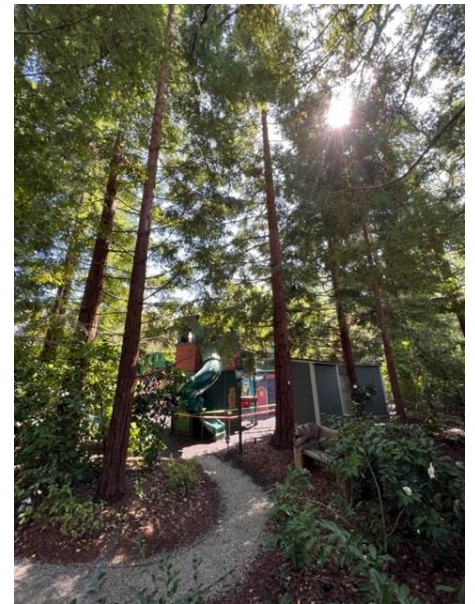
Trees# 4-7

- a. We are requesting Tree #4, the 18" Coast Redwood (*Sequoia sempervirens*) to have a tree protection zone (TPZ) exception reduced to 6.22x DBH.
2. Per the Project Architect, Tommy Frost, there will be only one new structural pile installed within the 8x DBH TPZ of Tree #2 and Tree #4. As stated in the arborist report, there will be no additional excavation required to install the slab on piles and grade beams ADU foundation. The ADU foundation will be laid on the same footprint as an existing playground on the property. These trees were both considered preservable due to their existing condition at the time of the tree survey. With the use of the pre-existing playground foundation footprint and pier on slabs and grade beams foundation for the ADU, we do not expect there to be significant impacts to the two trees in question. Should any 2" or greater diameter roots be discovered during the structural pile installation, the Project Arborist shall make a site visit to assess potential ramifications to the trees and provide additional recommendations to preserve the health of the trees. To mitigate construction stresses to Tree #2 and Tree #4, we recommend cyclone fencing be installed at the TPZ exception encroachment distances. We recommend hand spreading 6"-8" of mulch within each tree protection zone to enhance nutrient cycling and moisture retention in the soil. Additionally, we recommend irrigating the trees of concern to a depth of 12" every 4 weeks until winter rains are able to accomplish the
