Arborist Report

*244 Park Ln,
Atherton, CA 94027*

*Inspection Date:
August 3, 2022*

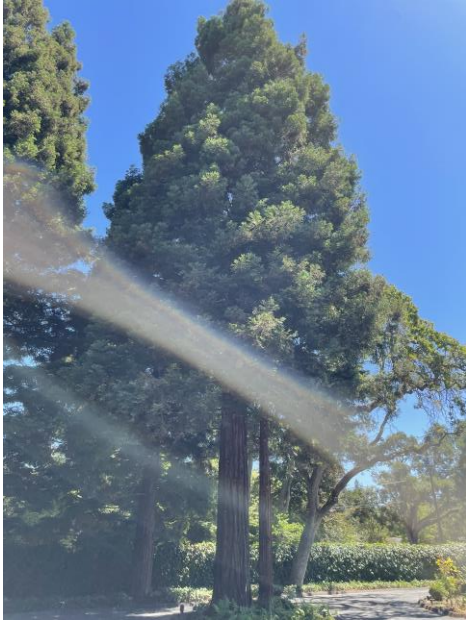
Trees #13 and #14

14	Coast redwood	16.6	45'/7'	fp	f	x	C	Growing directly into dominant redwood canopy, limb breakage issues imminent, RR
15	Valley oak	32.7	45'/45'	fp	fp	x	C	CD at 5.5', RCE, cable, DWR, EWR
16	Coast redwood	91.6	100'/45'	f	fp	x	B	CD at 7', Cable, some girdling roots, DWR, EWR
17	Coast redwood	51.2	80'/45'	fg	fg	x	B	DWR, EWR, some small girdling roots
18	Coast redwood	61.3	95'/28'	f	fg	x	B	DWR, EWR
19	Coast live oak	22	50'/35'	fp	fp	x	C	CD at 35', heavy lean towards street, DWR, EWR, growing against fence, RCE
20	Coast live oak	18.9	55'/40'	f	fp	x	C	Growing through fence, leaning over flag lot driveway, DWR, EWR, bacterial ooze at 15'
21	Coast live oak	34.7	55'/35'	f	fp	x	B	Outside fence on flag lot driveway, CD at 6', RCE, DWR, EWR, cable
		A = Retain, condition warrants long-term preservation					0	
		B = Preservable, tree is a benefit and may be worthy of extensive effort or design accommodation.					15
