# Tree Management Experts

**RE: 20 Tuscaloosa Avenue**  
**Atherton, CA**

**Date: 11/02/22**

## **ARBORIST REPORT and TREE PROTECTION REPORT**

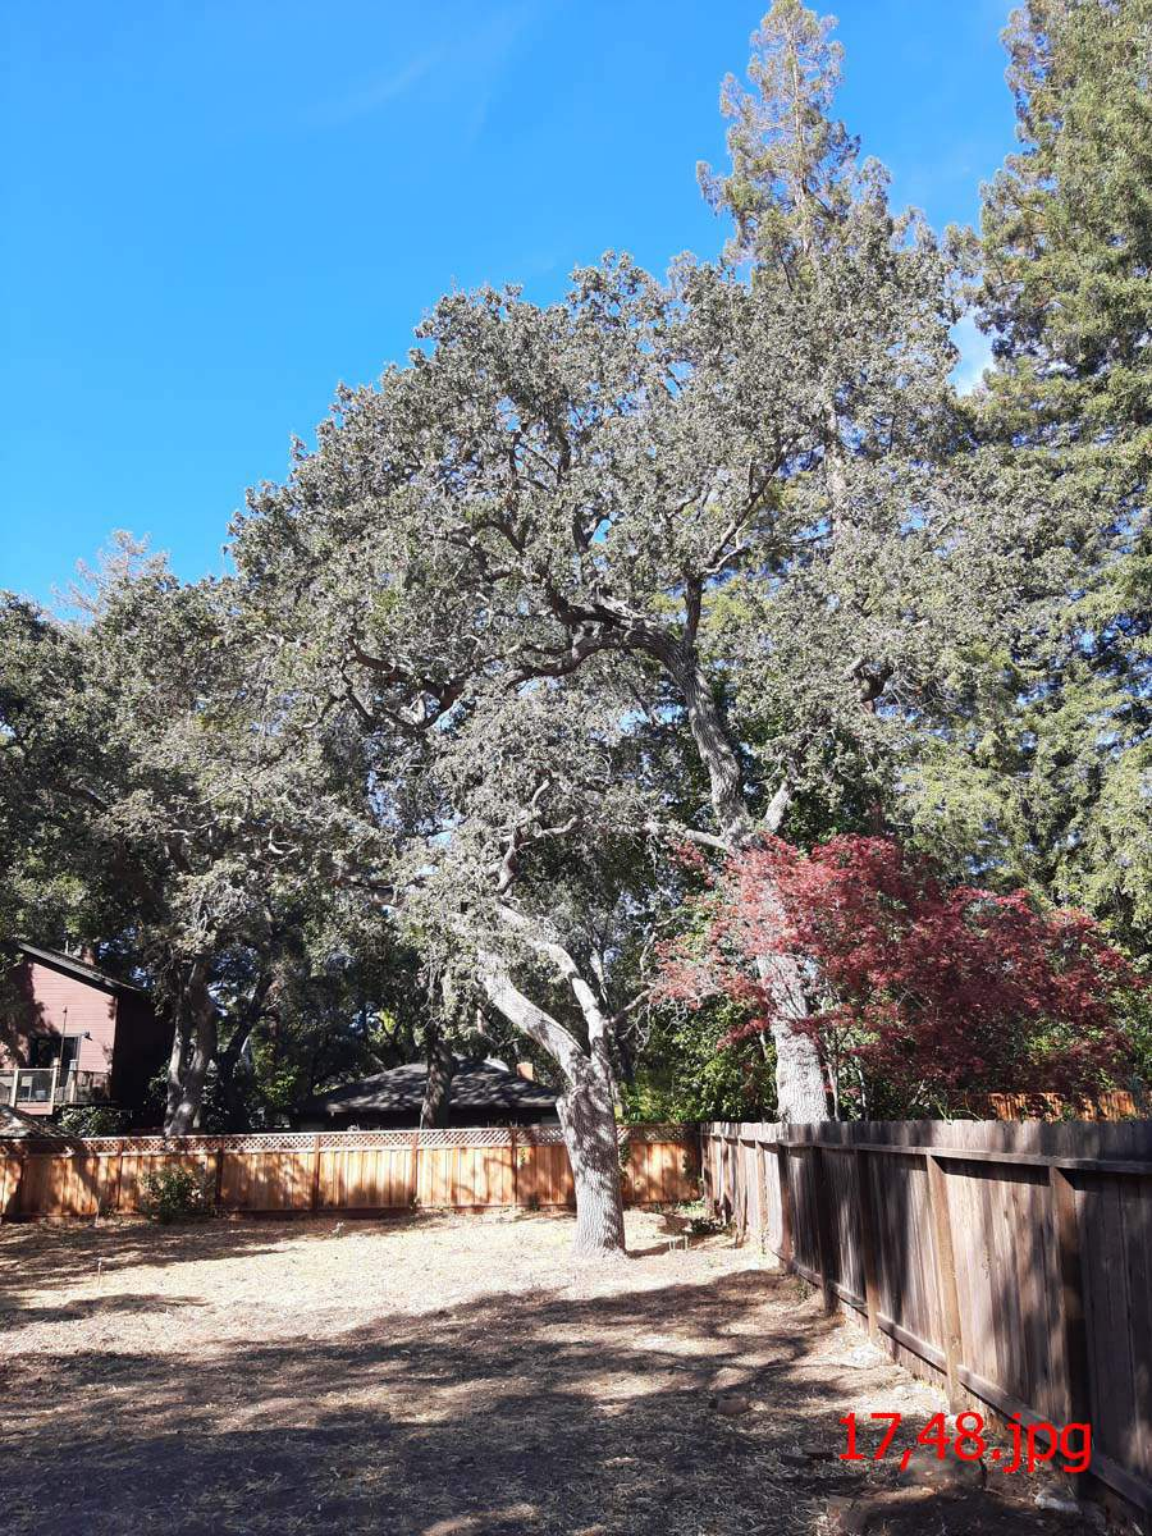
17,48.jpg

Tree 17 is a valley oak (*Quercus lobata*) with a DBH of 27.2 inches. It is severely one-sided. The tree has been suppressed throughout its growth by Tree 48 on the neighboring property at 16 Tuscaloosa. Its limbs are heavily over-extended. The canopy of the tree is declining and thinning. The risk presented by the tree could be mitigated by carrying out heavy reduction pruning, this would necessitate large diameter pruning cuts. However, with the current health and vigor of the tree, it is unlikely that the tree would be able to recover from these pruning wounds and would continue to decline.

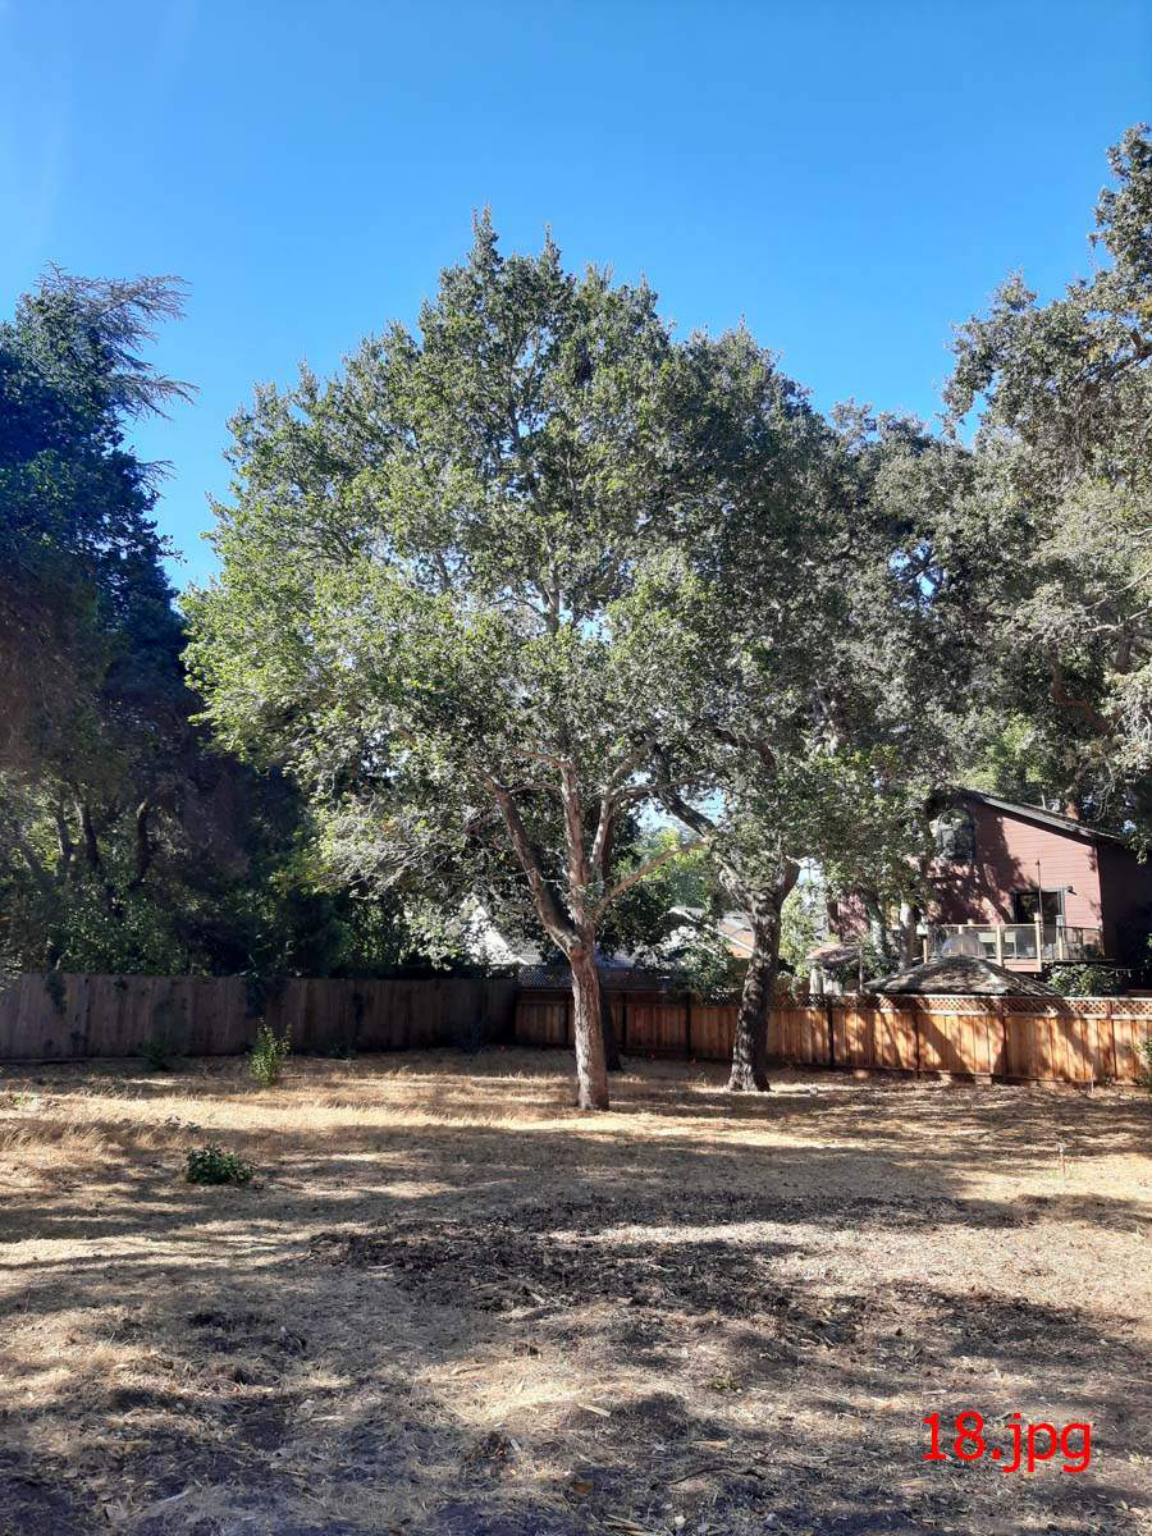
18.jpg

Tree 18 is a coast live oak (*Quercus agrifolia*) with a DBH of 16.9 inches. The is generally in good condition. It is crowded by the neighboring trees (19 and 20). The planned tennis court will require the removal of this tree, as the tree lies within the footprint of the planned court. The minimum length of the court is 120 feet. With a 100 foot wide lot, the court must be oriented North-South and only the back yard of the property has space for this. Per the Atherton Heritage Tree Ordinance, the owner is applying to remove this tree as part of Planning Commission Review under Atherton Code 8.10.040.D parts 3, 4 and 6.

Parts 3 and 4 of the code speak to good forestry practices, number of trees, and potential negative effects of removing a Heritage Tree. The current layout has three trees closely spaced with competing canopies. Tree 18 is the smallest of the group (18, 19, & 20). Removing it will provide more space for the other two trees to grow and perform better. There is extensive natural regeneration of native oaks in this area, and small sprouts are present throughout the property. The tree is in the backyard and screened from neighboring properties and its removal will have a negligible effect on shading, noise, wind effects, historic value, scenic beauty, health, safety, etc.

Part 6 of the code allows for the removal of Heritage Trees “to allow reasonable use or other enjoyment of the property when there is no demonstrated feasible alternative to the Removal”. While a tennis court is not a necessity, the owners purchased this property with the intention of installing such an amenity and as the property has a large number of Heritage Trees that will be preserved, the overall impact on the Urban Forest in Atherton will be negligible. Because of the locations of these other Heritage Trees and the space necessary for building the tennis court, there is no alternate location on site for the court.

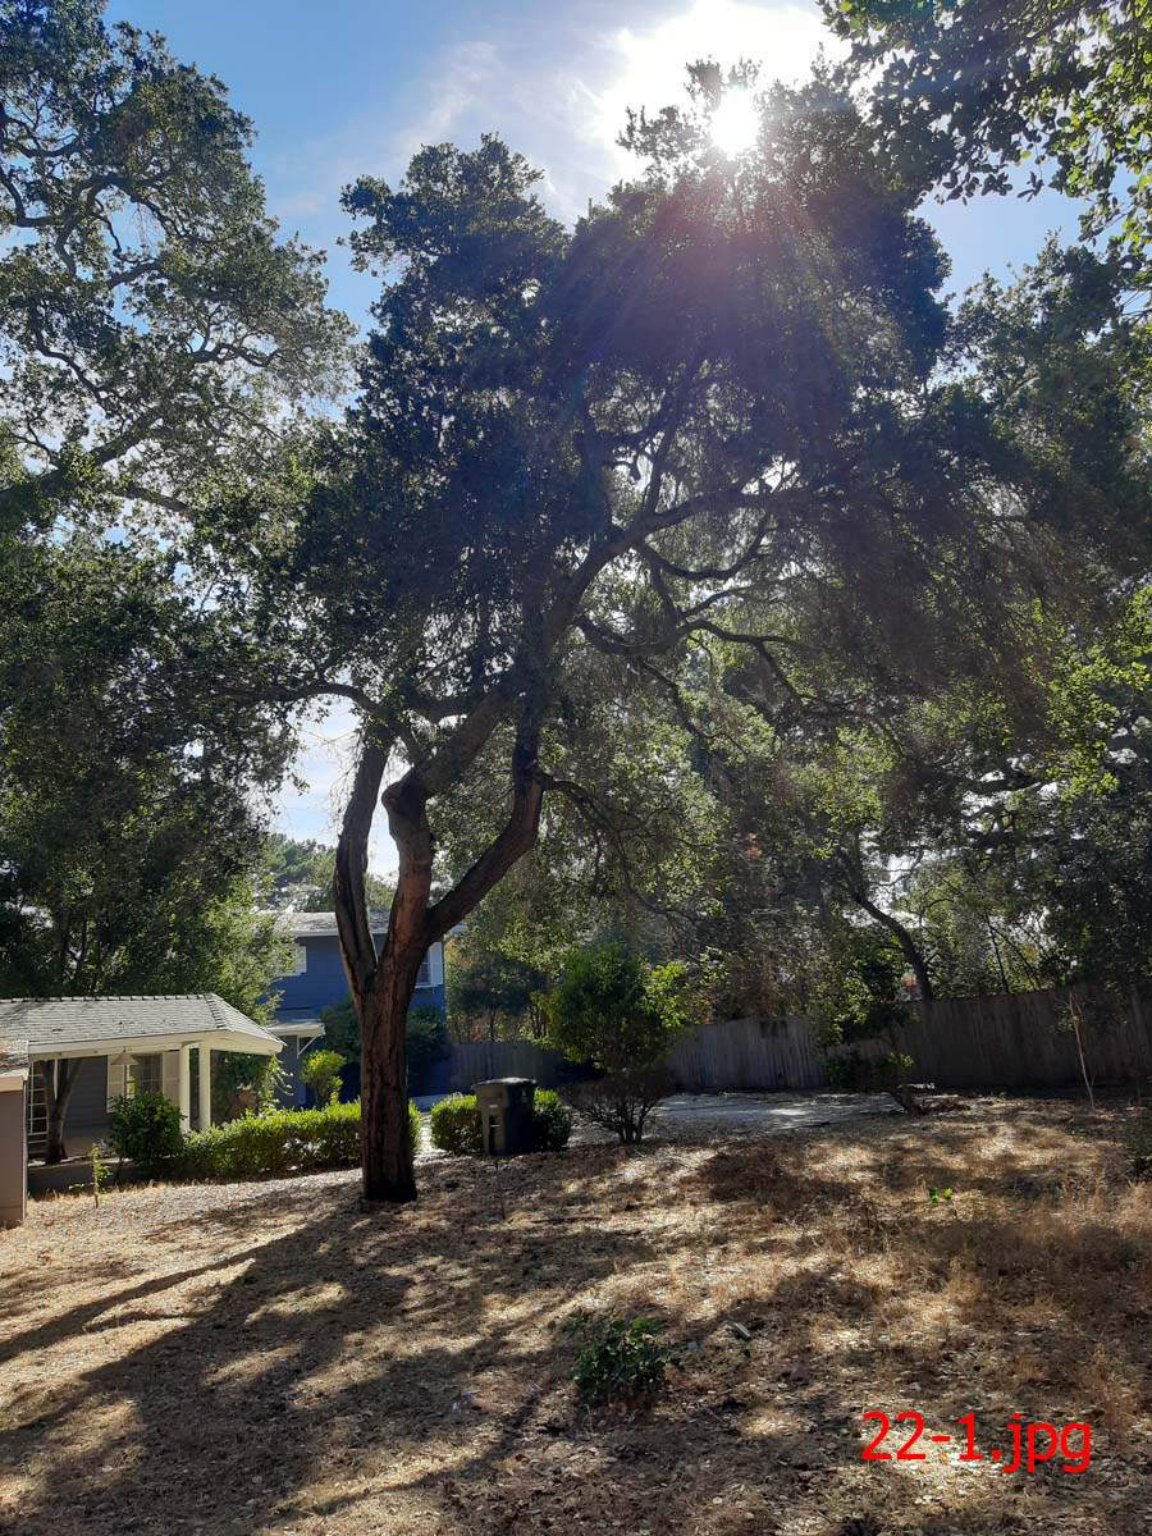
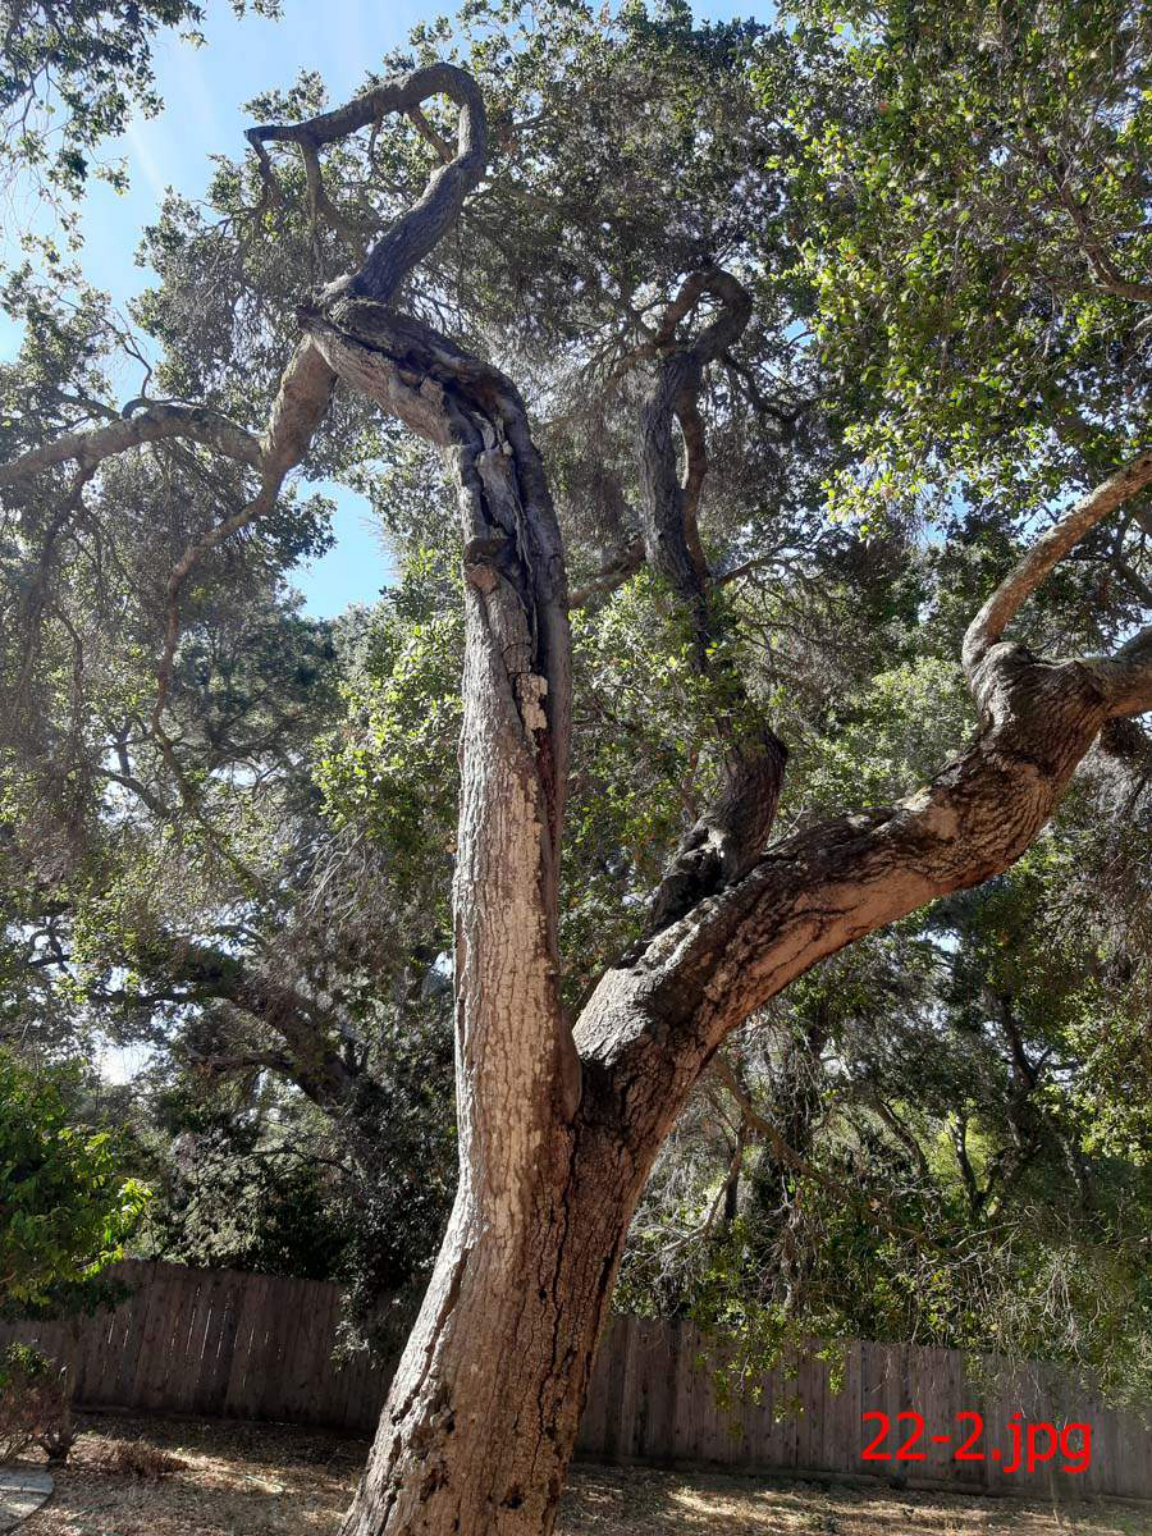
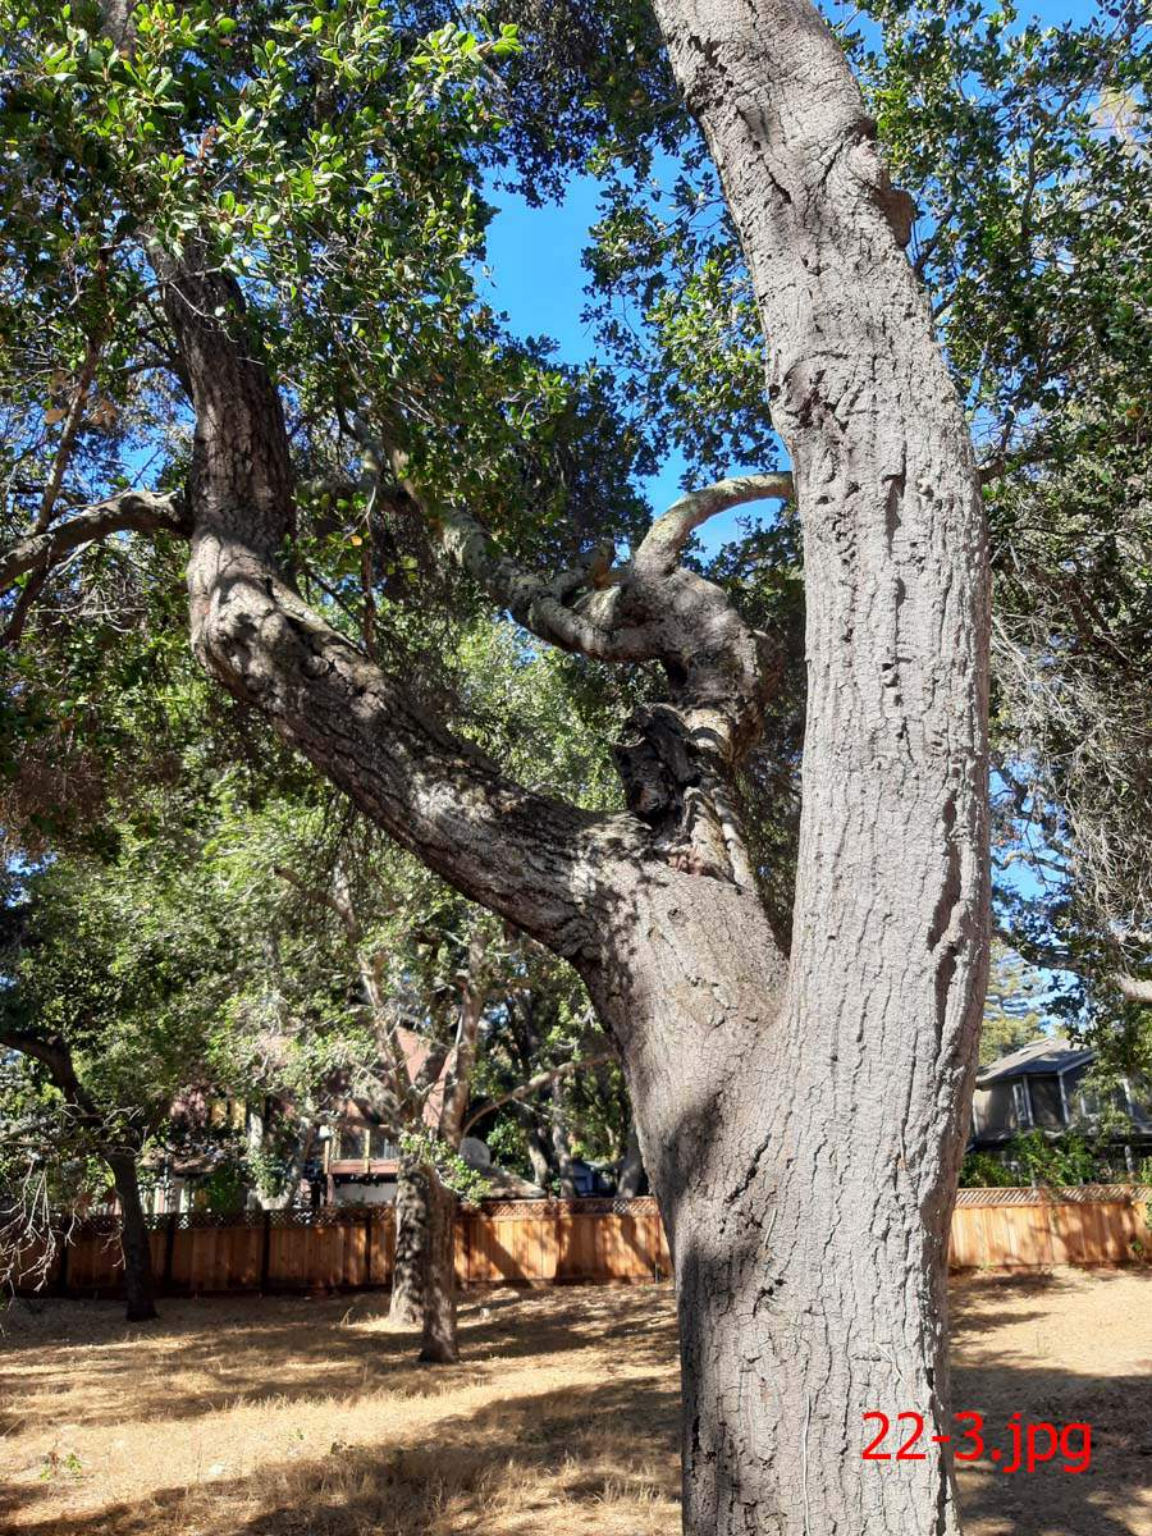
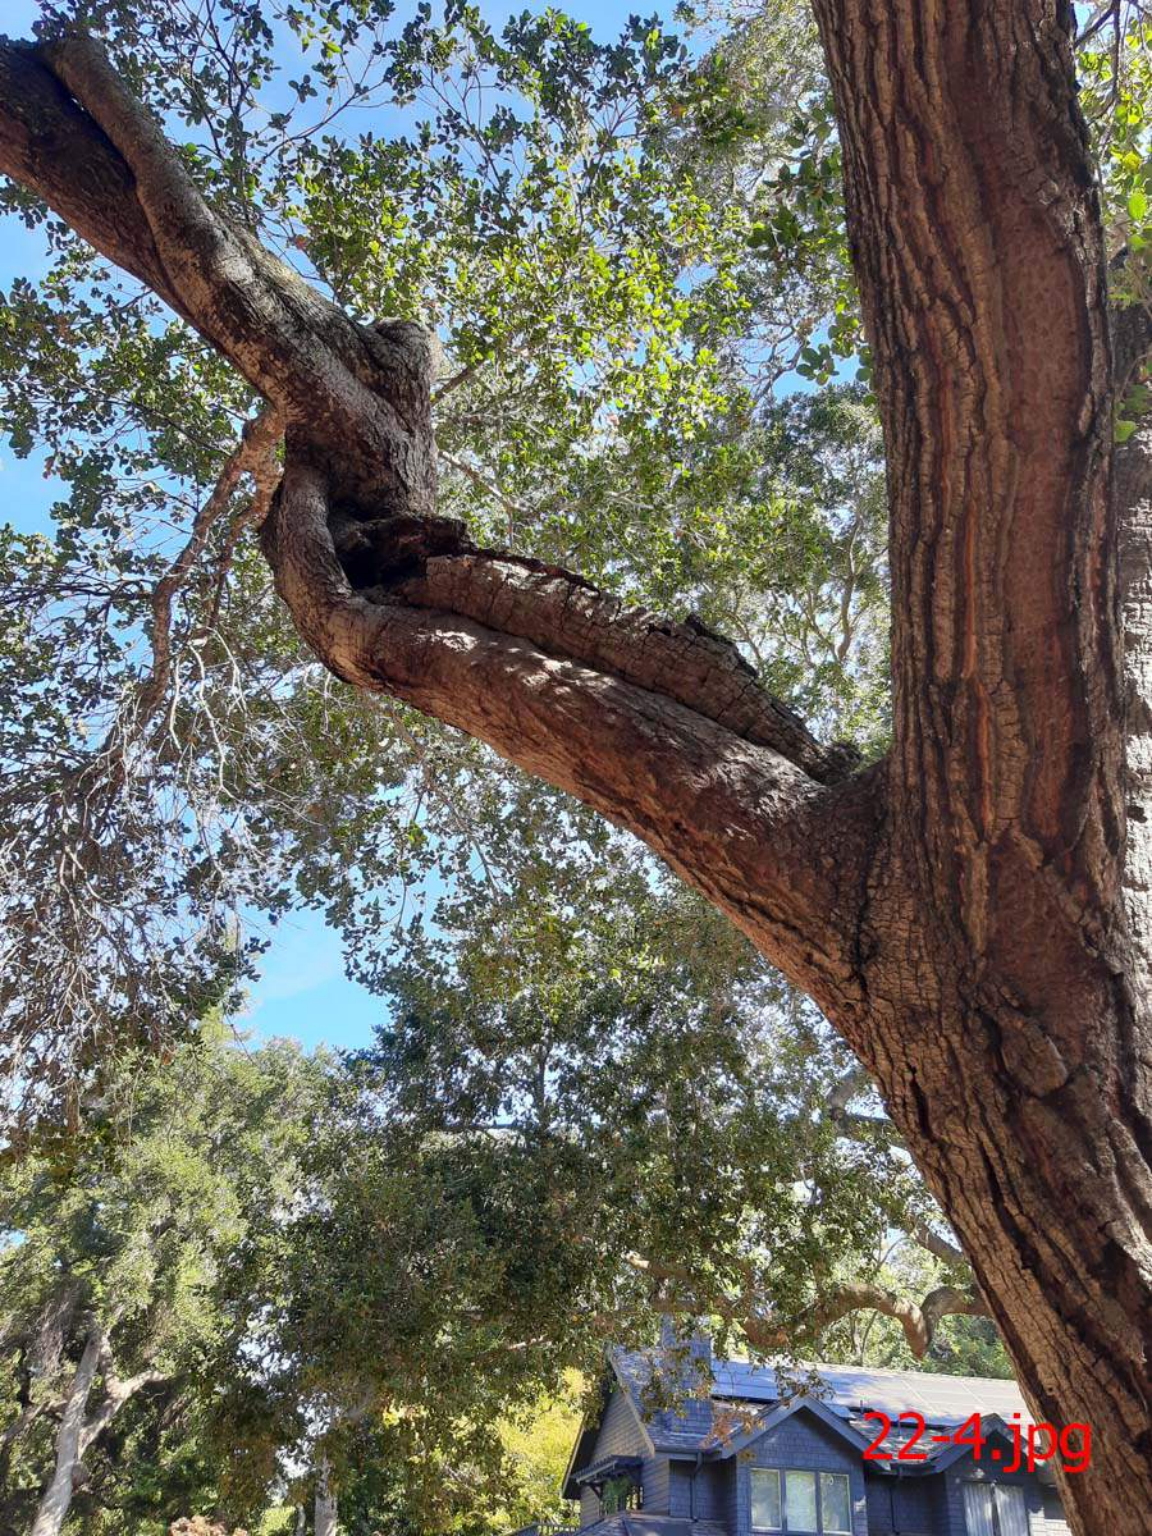
Tree 22 is a coast live oak with a DBH of 22.0 inches. This tree is heavily decayed and could collapse at any time. In particular, the top sides of all the scaffold branches are heavily decayed. Angiosperm trees use tension wood to support themselves, the lack of this wood, means that the tree has very little tissue reinforcing it and could fail unpredictably. Because the decay is so advanced, there is no pruning or cabling option that would reinforce the tree. We recommend it be removed as hazard tree.

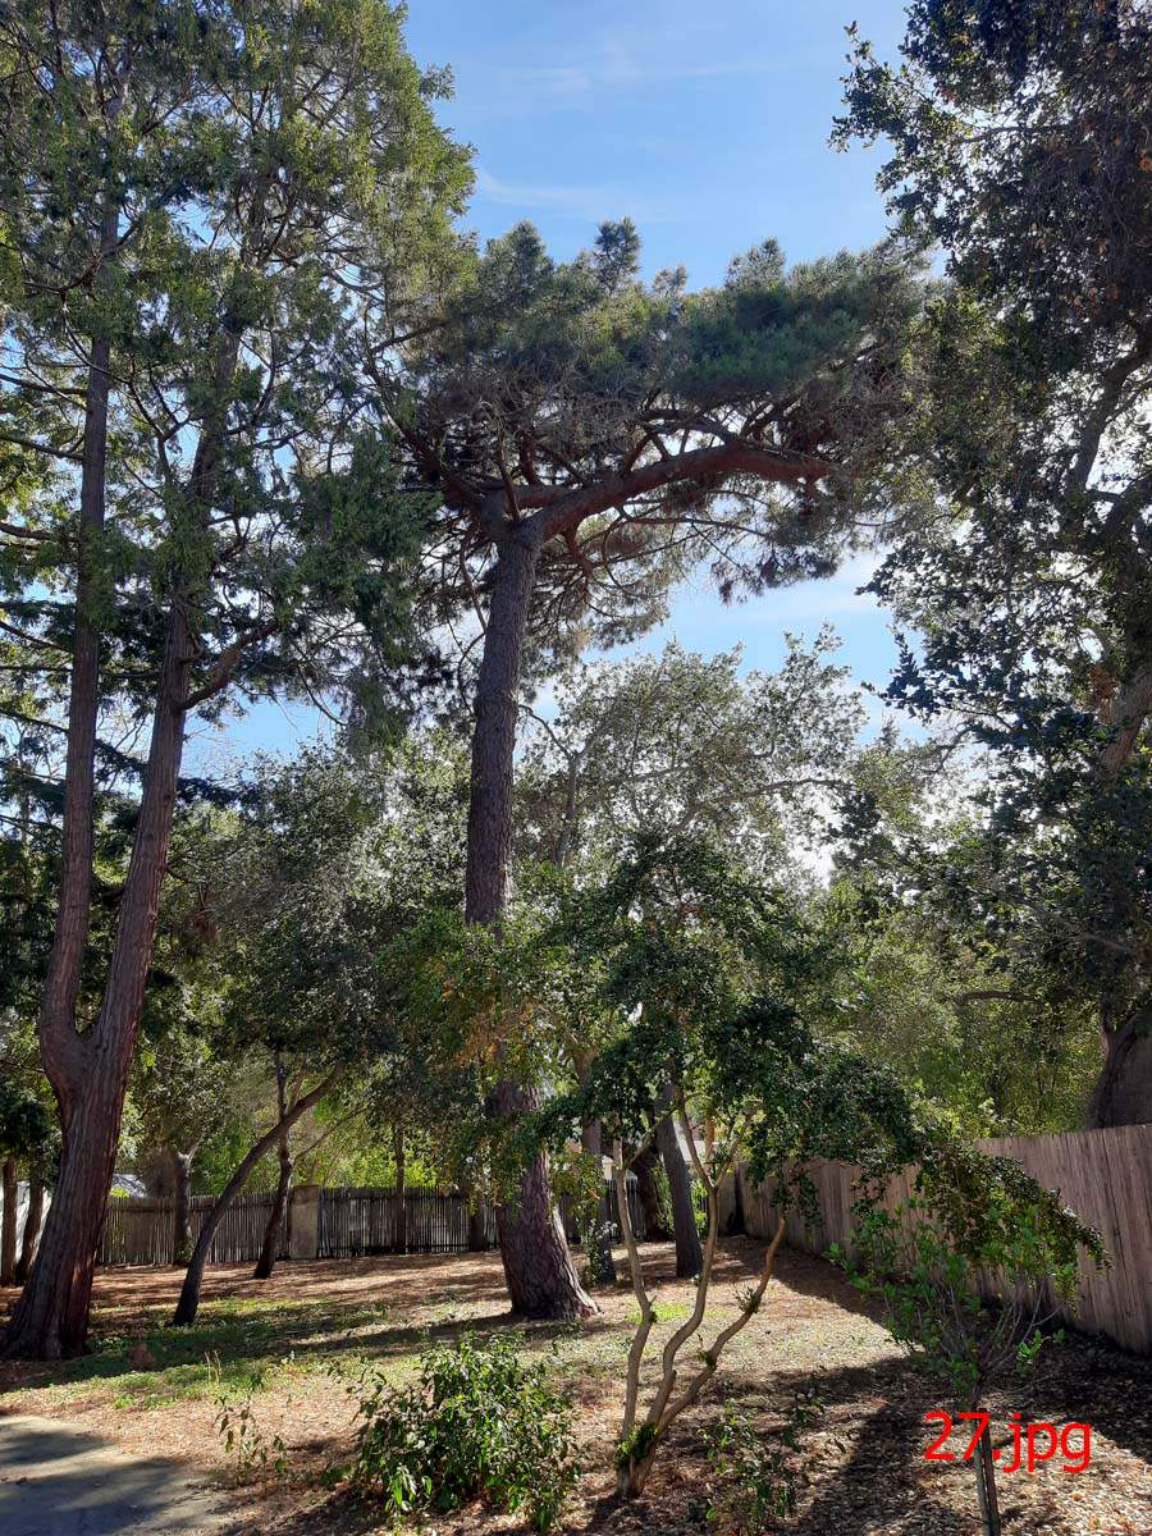
27.jpg

Tree 27 is a Canary Island pine (*Pinus canariensis*) with a DBH of 30.7 inches. This tree was topped or lost its top at some point in the past. This has resulted in it having two large scaffold branches growing from its top almost horizontally. These branches are very overextended and one shows a large longitudinal crack likely as a result of excessive end-weight. Because the tree is so disfigured and is in the process of actively failing, we recommend it be removed as a priority hazard removal.

27	<i>Pinus canariensis</i>	Canary Island pine	30.7	30.7	70	60	X		Very Poor											X		X								25' 7"	20' 6"	15' 4"	12' 9"	7' 8"	hazard beam aloft in main scaffold
28	<i>Calocedrus decurrens</i>	incense-cedar	23.3	23.3	70	40	X		Fair	X													X	X			X			19' 5"	15' 6"	11' 8"	9' 9"	5' 10"	
29	<i>Quercus agrifolia</i>	coast live oak	7.0	7.0	15	15			Fair		X			X									X							5' 10"	4' 8"	3' 6"	2' 11"	1' 9"	
30	<i>Sequoia sempervirens</i>	coast redwood	37.8	37.8	110	50	X		Good															X						31' 6"	25' 2"	18' 11"	15' 9"	9' 5"	
31	<i>Quercus agrifolia</i>	coast live oak	13.6	13.6	30	30			Fair		X	X											X							11' 4"	9' 1"	6' 10"	5' 8"	3' 5"	
32	<i>Quercus agrifolia</i>	coast live oak	13.6	13.6	30	30			Poor				X	X									X							11' 4"	9' 1"	6' 10"	5' 8"	3' 5"	borer damage heavily decayed, tangled in comm lines
33	<i>Schinus molle</i>	Peruvian pepper	24.9	24.9	20	25	X		Very Poor		X	X	X										X							20' 9"	16' 7"	12' 5"	10' 5"	6' 3"

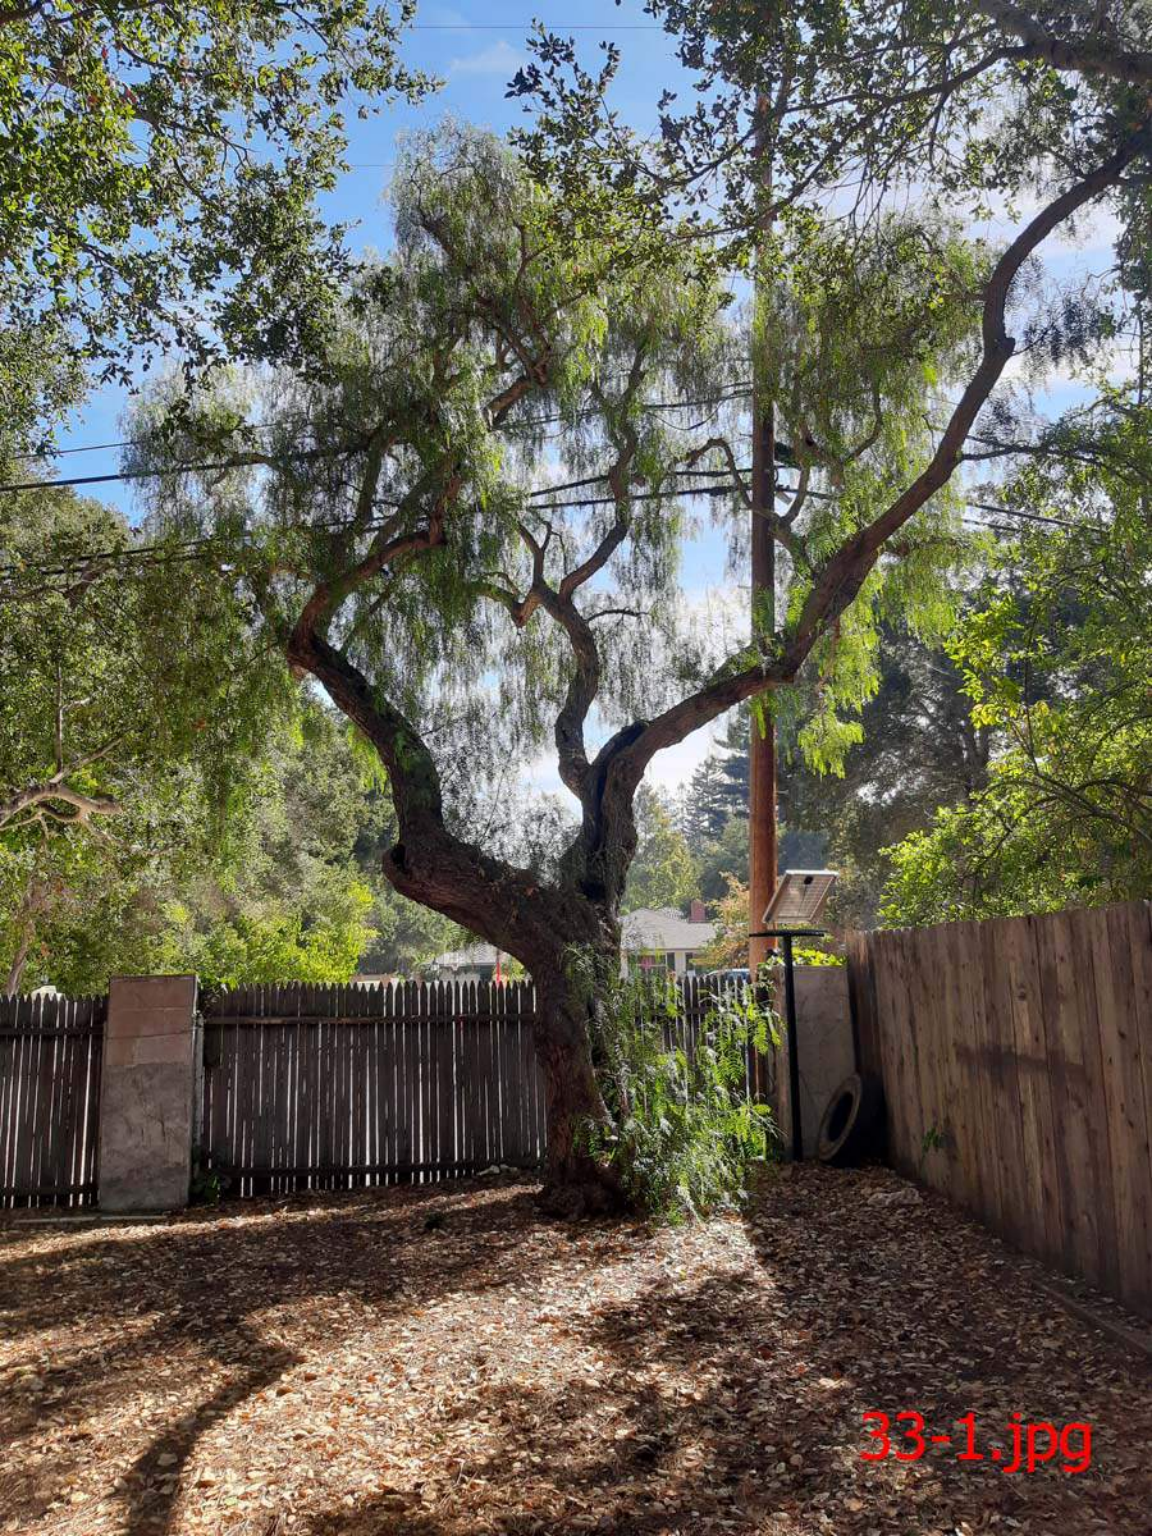
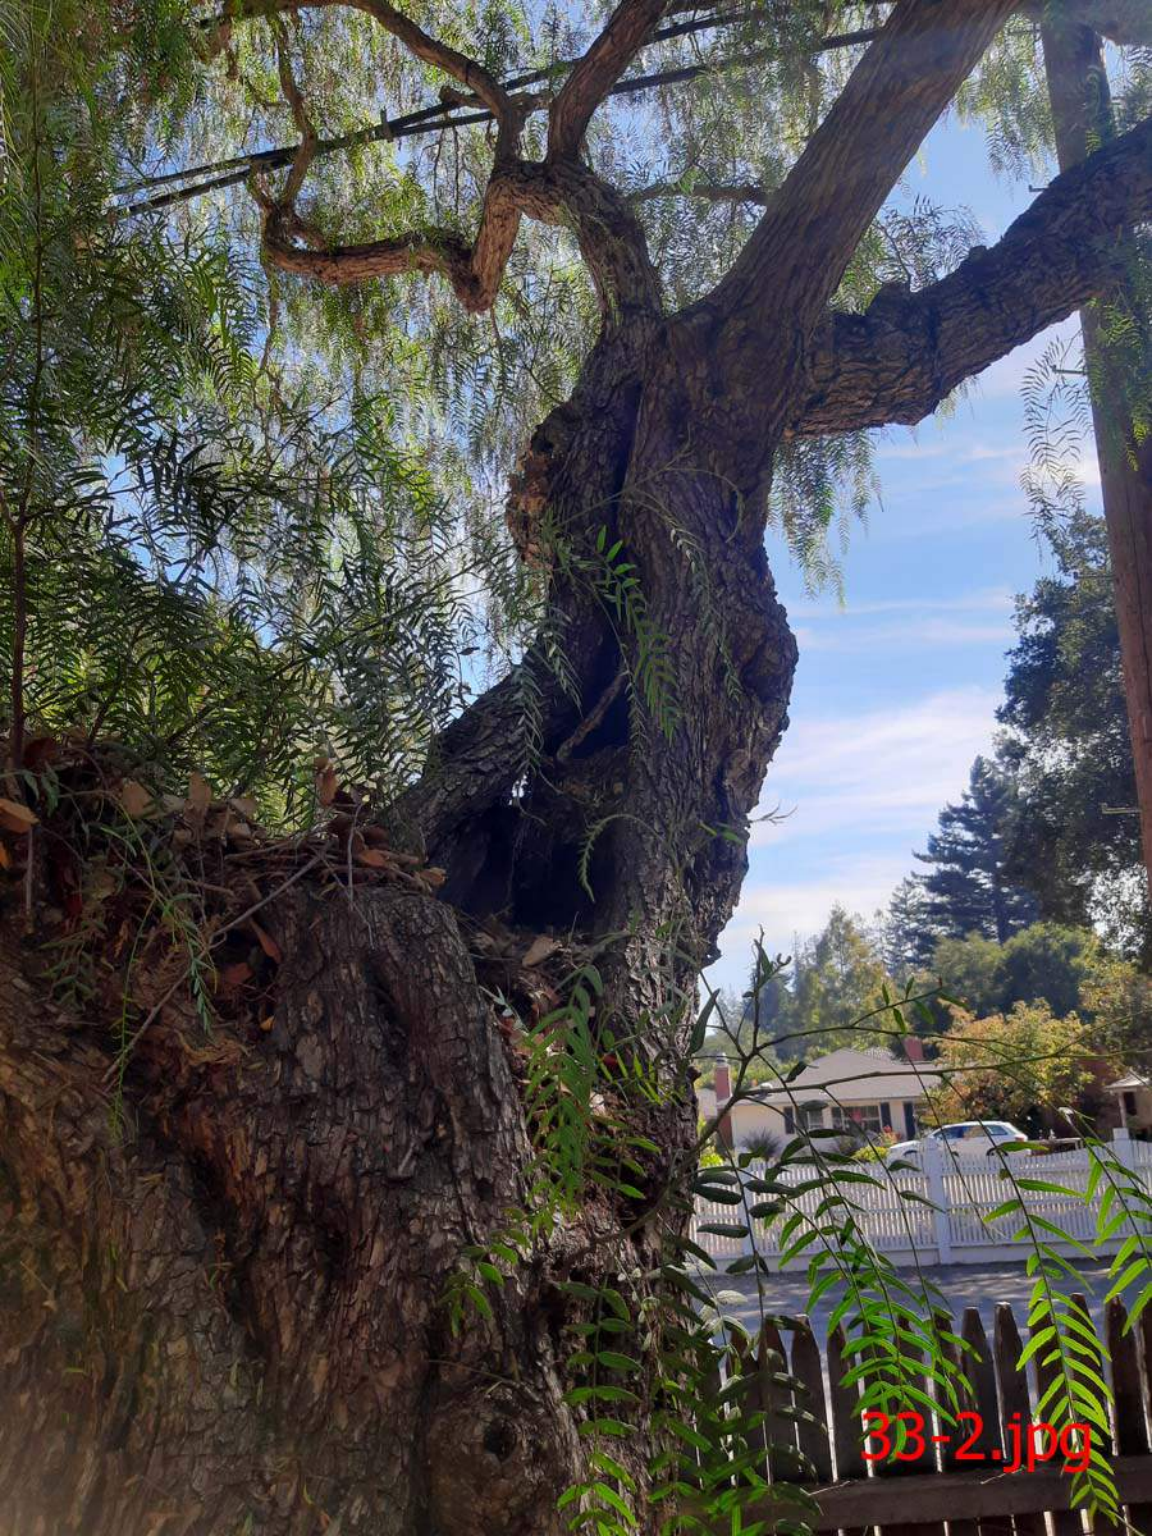
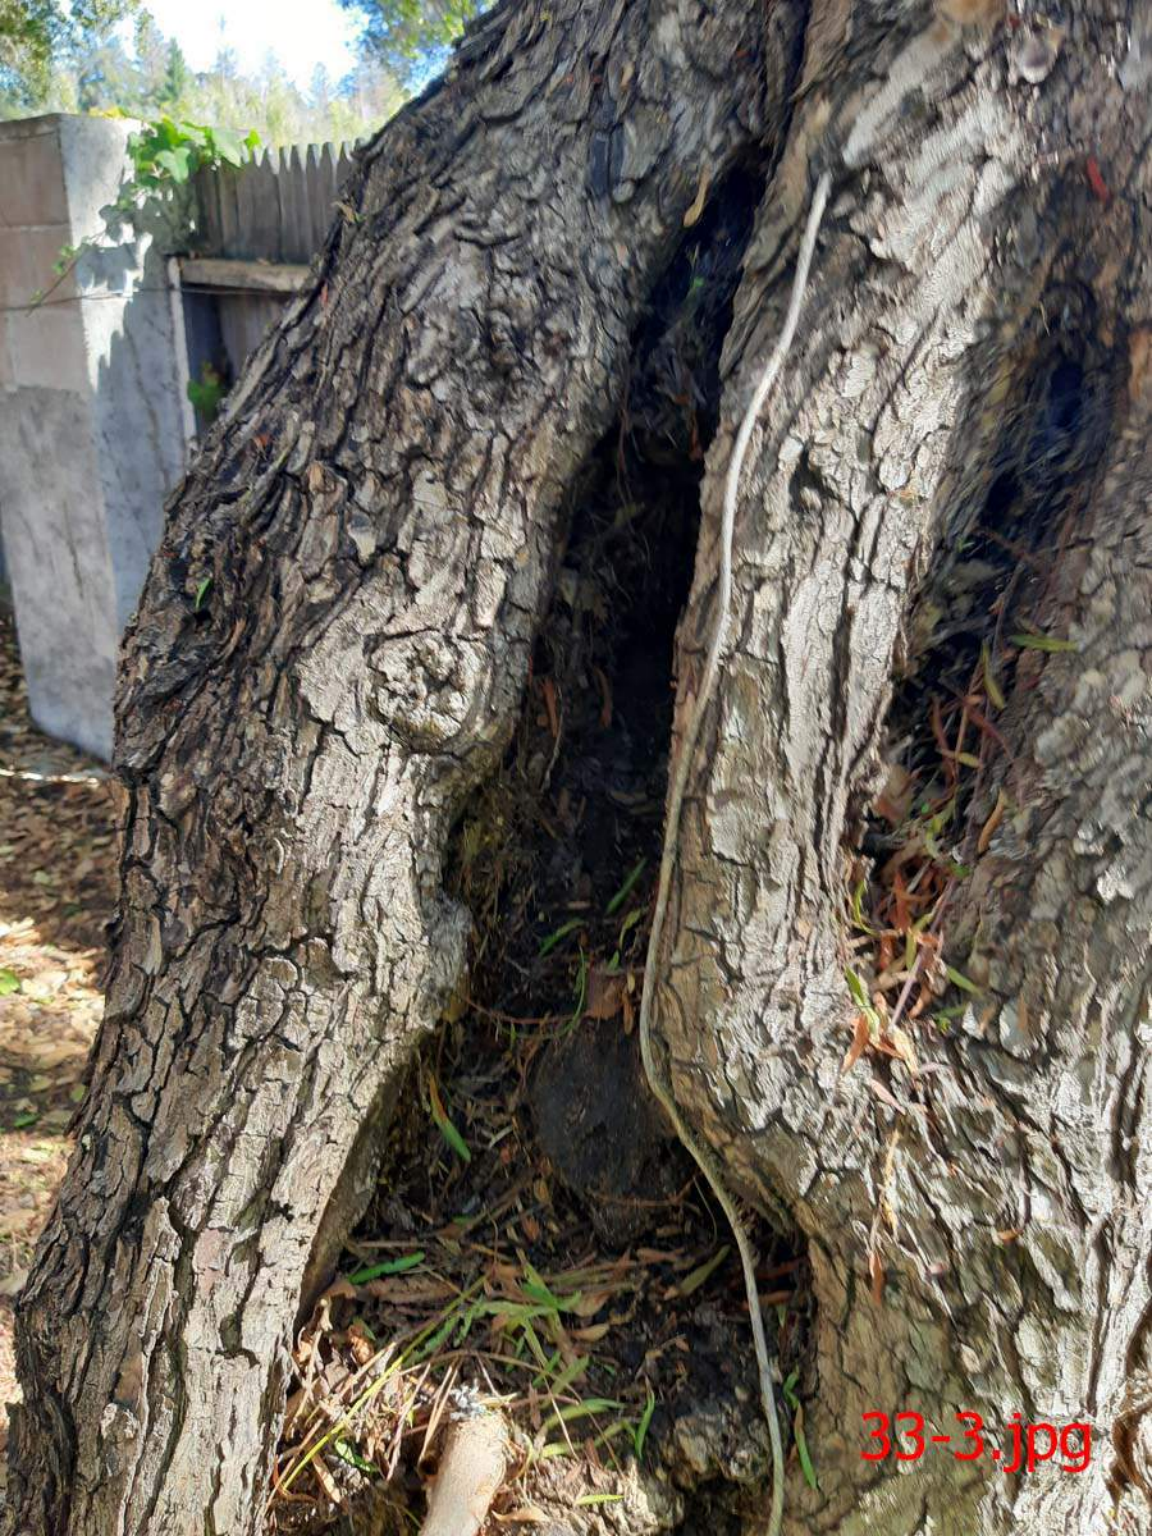
Tree 33 is a Peruvian pepper (*Schinus molle*) with a DBH of 24.9 inches. This tree is heavily decayed and leaning toward the street. While it is not large enough to strike the pavement, it is growing through the pole-to-pole communication lines running streetside and could strike parked cars. There is no effective mitigation to preserve the tree. It should be removed.-
