Kielty Arborist Services LLC

March 8th, 2021, Revised January 16th, 2023, Revised March 31st, 2023

Site: 240 Oak Grove Avenue, Atherton

As requested on Thursday, March 4th, 2021, and again on December 14th, 2022 Kielty Arborist Services LLC visited the above site for the purpose of developing a tree inventory report and tree protection plan for the proposed construction. An ADU, pool, and tennis court are proposed for this site, and as required, a tree inventory and tree protection plan are required when submitting plans to the town of Atherton. Site plan A1.0 dated 9/30/22 was reviewed for writing this report. This Tree Inventory Report is not a Tree Risk Assessment. As such, no trees were assessed for risk in accordance with industry standards unless stated otherwise state, nor are there any tree risk ratings or risk mitigation recommendations provided within this preservation plan unless stated otherwise.

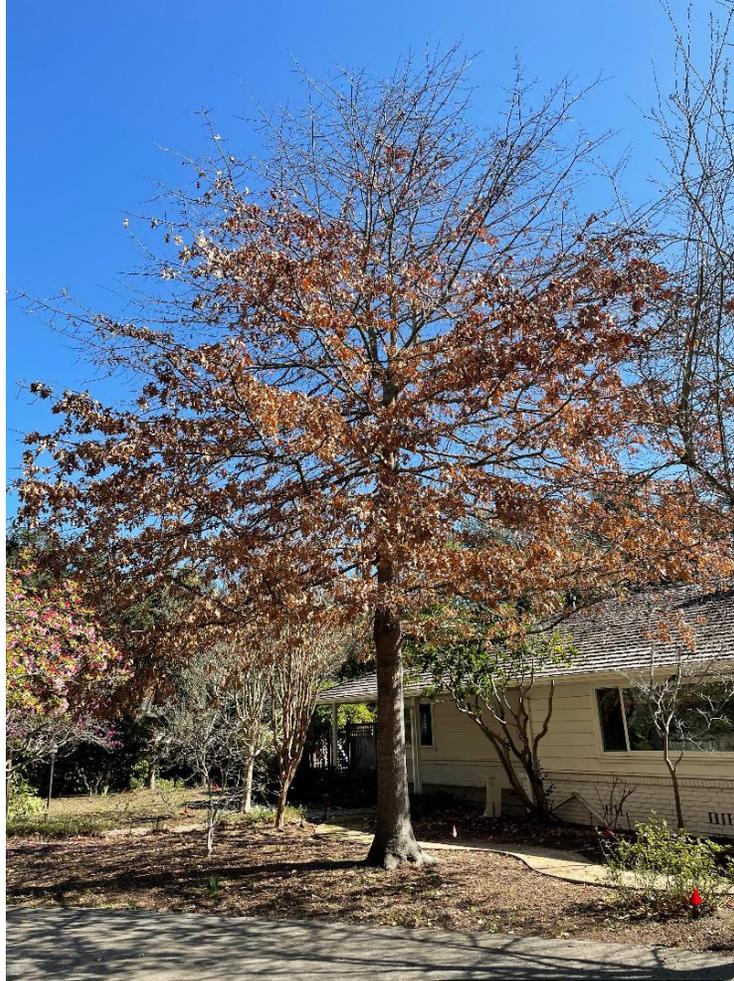
Tree#	Species	DBH	CON	HT/SP	Comments
1P	Scarlet oak (<i>Quercus coccinea</i>)	15.9	65	40/30	Good vigor, fair form, codominant at 30 feet.
	10 times diameter= 13.2'				
	8 times diameter= 10.6'				
	6 times diameter= 7.9'				
	Appraised value= \$3,810

Showing tree #1

Discussion: The tree is in fair condition. The structure of the tree has a defect at the top of the canopy as the tree has been topped at a height of 30 feet. Crown restoration pruning is recommended.

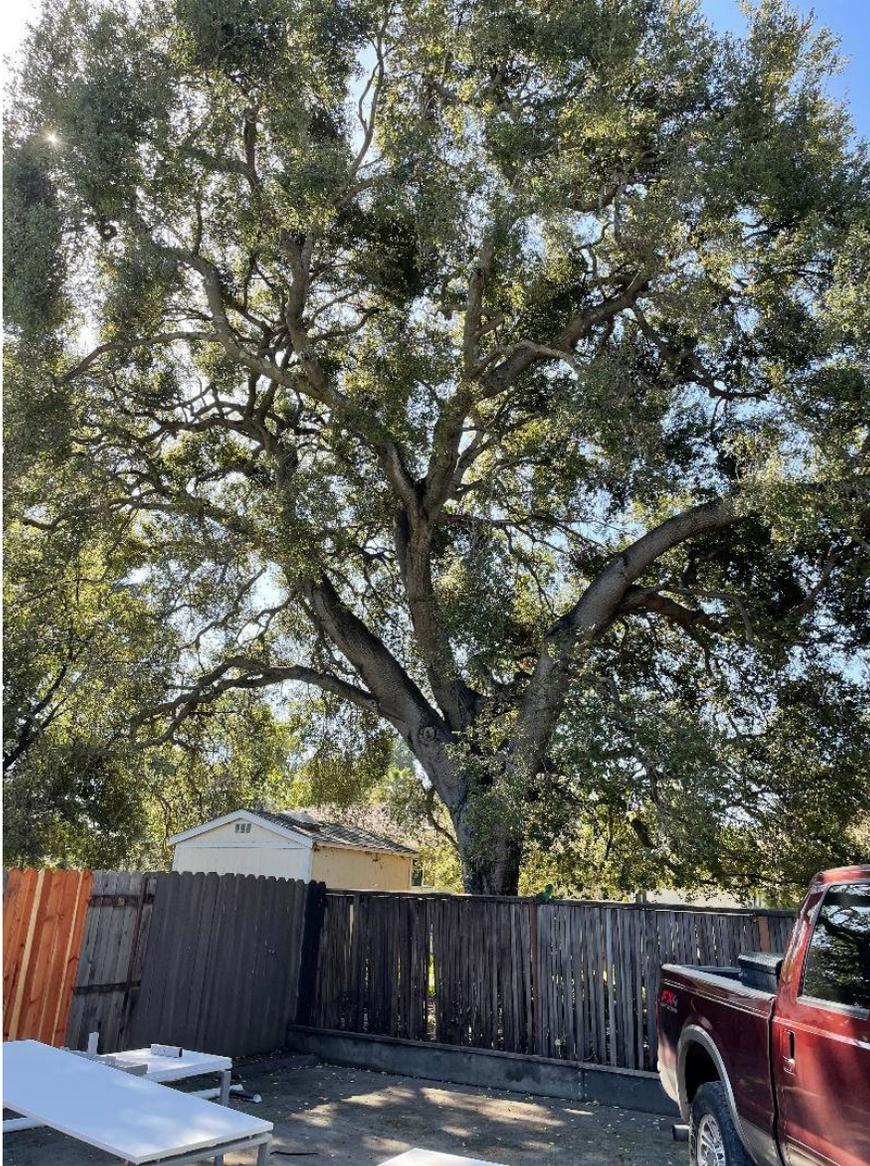
<u>Tree#</u>	<u>Species</u>	<u>DBH</u>	<u>CON</u>	<u>HT/SP</u>	<u>Comments</u>
3*P	Coast live oak (<i>Quercus agrifolia</i>)	39est	60	40/35	Good vigor, fair form, codominant at 8 feet, history of limb loss, estimated 12 feet from property line, mature, limited visual inspection.
	10 times diameter= 32.5'				
	8 times diameter= 26'				
	6 times diameter= 19.5'				
	Appraised value= \$15,200

Showing oak tree #3

Discussion: The tree is in fair condition. A history of limb loss was observed in the canopy. The tree estimated at 12 feet from the property line. The tree is mature. The inspection of the tree was limited due to being located on the neighboring property.

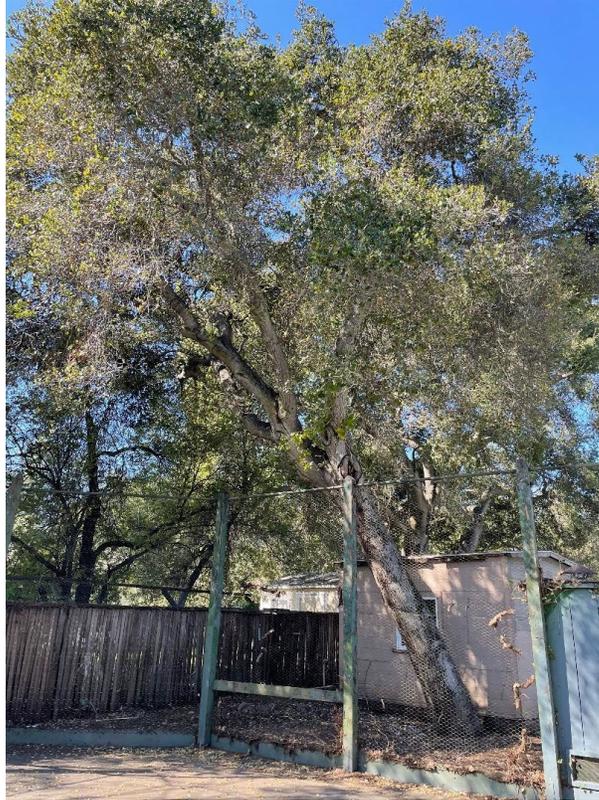
<u>Tree#</u>	<u>Species</u>	<u>DBH</u>	<u>CON</u>	<u>HT/SP</u>	<u>Comments</u>
4P/R	Coast live oak (<i>Quercus agrifolia</i>) 10 times diameter= 19.9' 8 times diameter= 15.9' 6 times diameter= 11.9' Appraised value= \$6,100	23.9	45	40/35	Good vigor, poor form, leans over tennis court, at shed foundation, excessive decay on leaders.

Showing oak tree #4

Discussion: The oak tree is in poor condition. The tree leans over the tennis court area and is located at the shed foundation. The tree has been heavily pruned in the past for tennis court clearance. Areas of decay were observed on the limbs of the tree due to poor past pruning cuts. The decay on the limbs observed is excessive. This tree has a high risk of limb failure due to decay on heavy lateral leaders. The decay in combination with the decay observed makes for a hazardous tree. Tree removal is recommended.

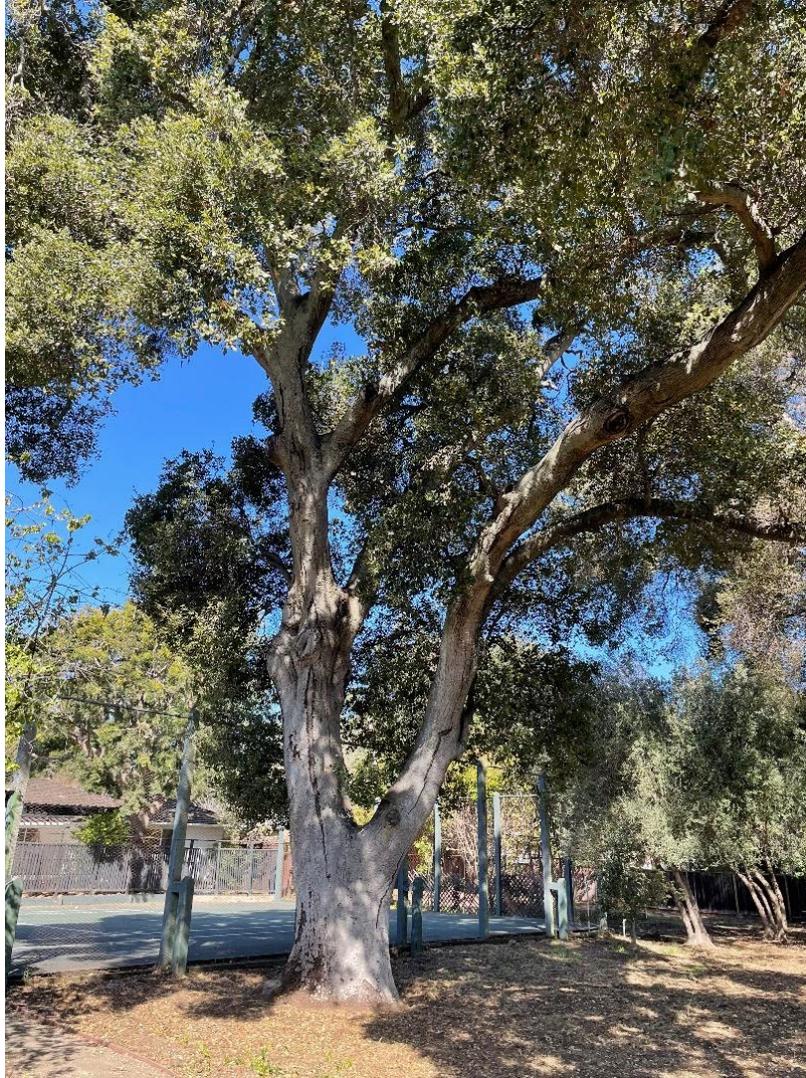
Tree#	Species	DBH	CON	HT/SP	Comments
8P	Coast live oak (<i>Quercus agrifolia</i>)	45.2	65	35/35	Good vigor, fair form, mature, cabled in past, cables look to be rusted, inspection of cables needed, codominant at 8 feet, decay on limbs from past pruning.
	10 times diameter= 37.6'				
	8 times diameter= 30.1'				
	6 times diameter= 22.6'				
	Appraised value= \$23,500

Showing mature oak tree #8

Discussion: Oak tree #8 is in fair condition. The tree is mature for the species. Cables were observed on the codominant leaders. The cables appear to be rusted and old. It is recommended to have the cables inspected and re-installed. Decay on many of the limbs was observed. Crown reduction pruning is recommended to reduce risk of limb loss.

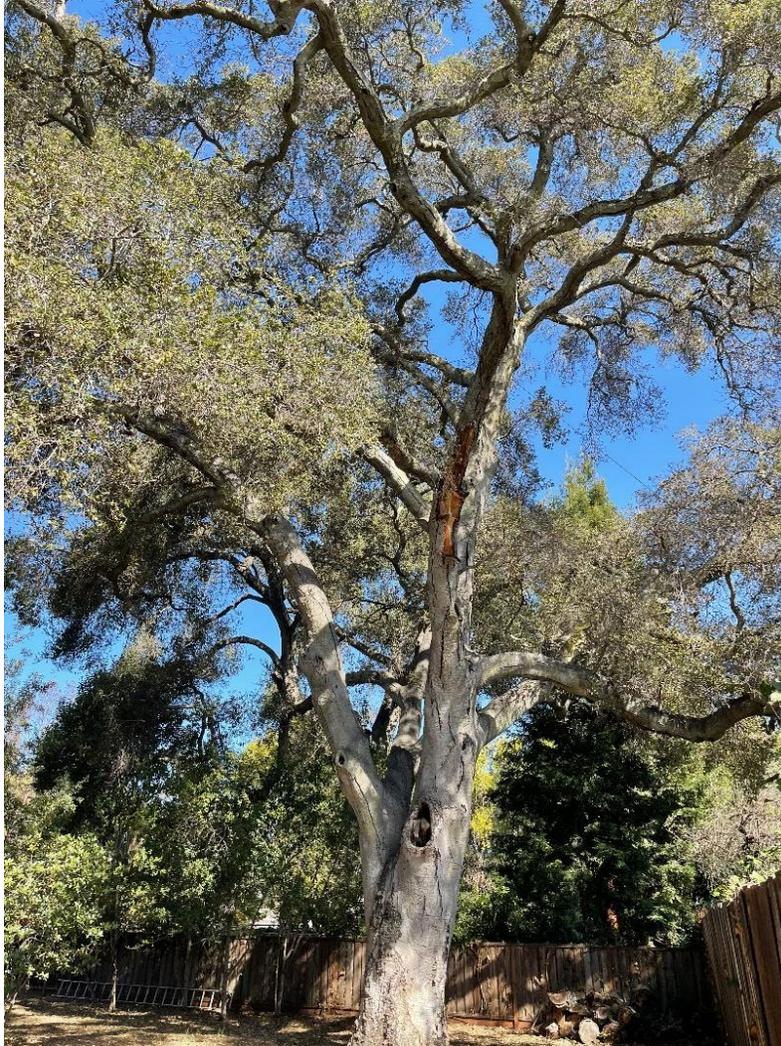
Tree#	Species	DBH	CON	HT/SP	Comments
9P	Coast live oak (<i>Quercus agrifolia</i>)	52.8	45	55/55	Fair to poor vigor, fair form, history of limb loss, mature, cabled in past, cables need inspection, large areas of decay on leaders.
	10 times diameter= 44'				
	8 times diameter= 35.2'				
	6 times diameter= 26.4'				
	Appraised value= \$21,300

Showing mature oak tree #9

Discussion: Oak tree #9 is in decline (poor condition). The tree's vigor is in decline and is likely an indicator of declining health. The tree is mature and has lost a large limb recently. A large decay pocket is visible on the codominant leader near the codominant union. A risk assessment is recommended. Cables were observed on the codominant leaders. The cables appear to be rusted and old. It is recommended to have the cables inspected and re-installed.

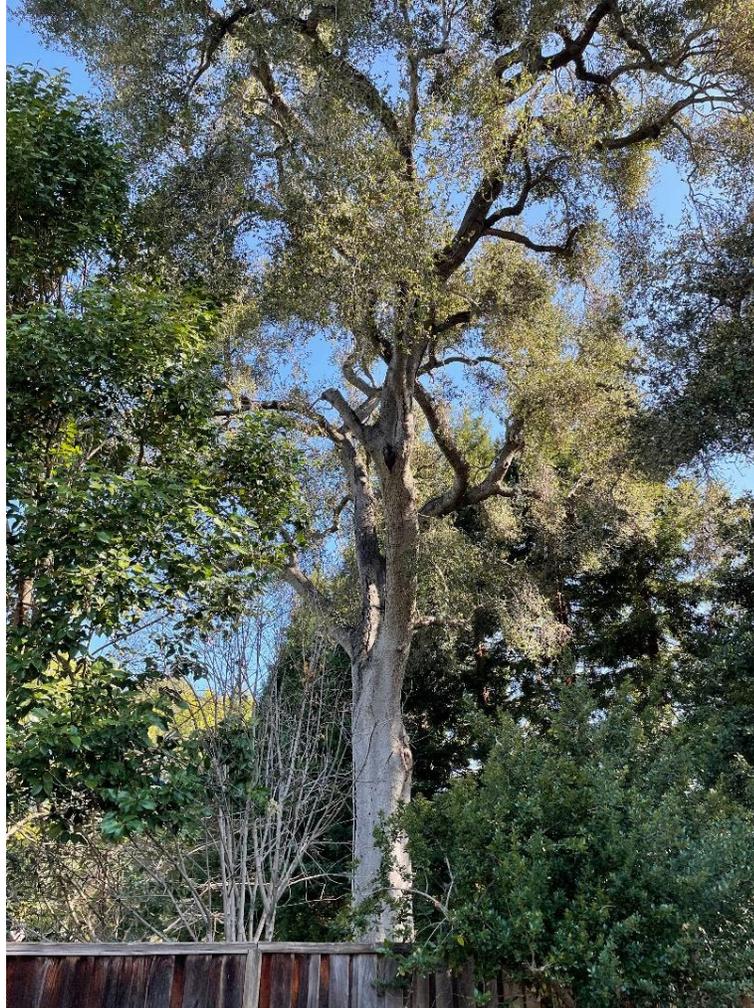
Tree#	Species	DBH	CON	HT/SP	Comments
10*P	Coast live oak (<i>Quercus agrifolia</i>) 10 times diameter= 20' 8 times diameter= 16' 6 times diameter= 12' Appraised value= \$7,800	24.0	60	60/50	Fair vigor, fair form, limited visual inspection, 20 feet from property line, history of limb loss, near turf.

Showing neighboring oak tree #10

Discussion: Oak tree #10 is in fair condition. The tree is located on the neighboring property at an estimated 20 feet from the property line. A limited visual assessment was conducted. A history of limb loss was observed.

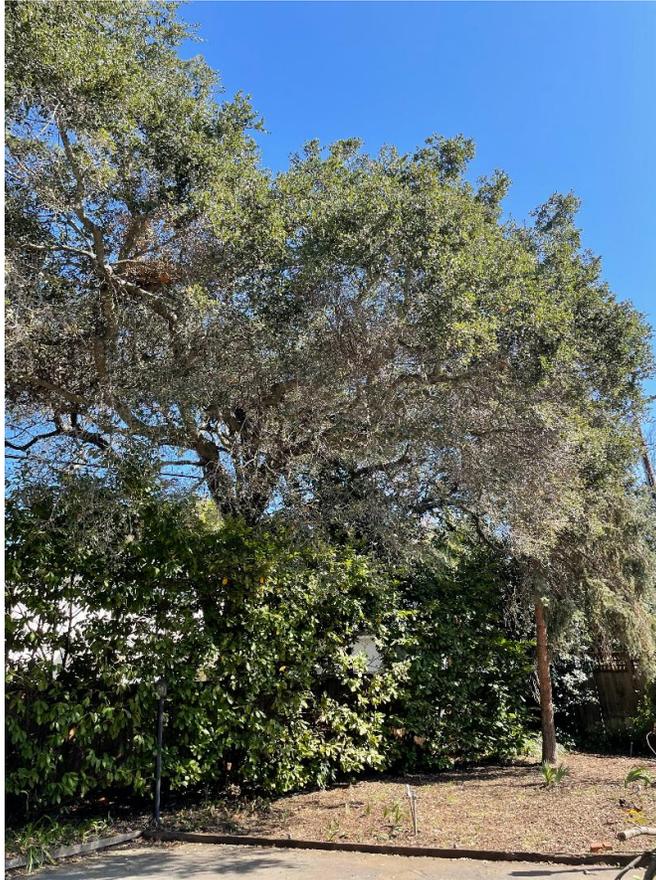
<u>Tree#</u>	<u>Species</u>	<u>DBH</u>	<u>CON</u>	<u>HT/SP</u>	<u>Comments</u>
13	Hazardous tree- Removed with approval by Town Arborist				
14	Hazardous tree- Removed with approval by Town Arborist				
15	Bay <i>(Umbellularia californica)</i>	10.8	40	20/15	Fair vigor, poor form, topped.
16*P	Coast live oak <i>(Quercus agrifolia)</i> 10 times diameter= 15' 8 times diameter= 12' 6 times diameter= 9' Appraised value= \$3,170	18est	50	30/35	Fair vigor, poor form, topped for utilities, 1 foot from property line.

Showing topped oak tree #16

Discussion: Oak tree #16 is in fair condition (lower end). The tree has been topped in the past for utility line clearance creating an off balanced canopy. The vigor, of the tree is fair with areas of minor dead wood observed.

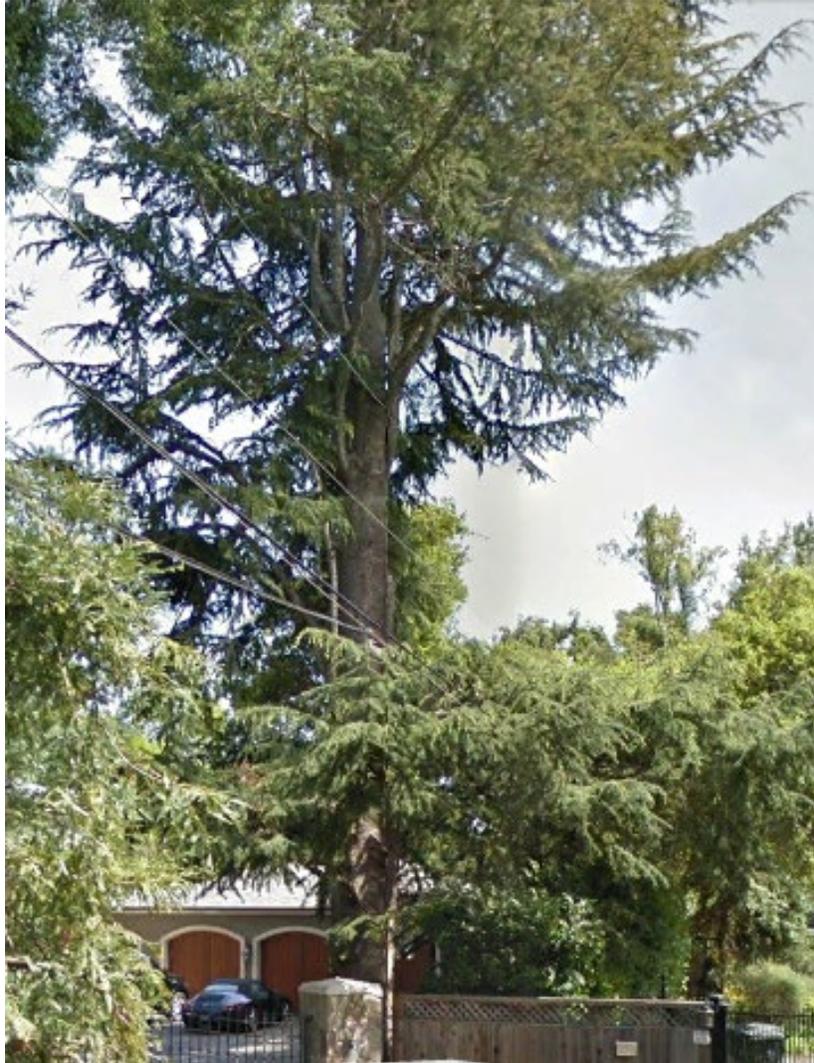
Tree#	Species	DBH	CON	HT/SP	Comments
17*P	Deodar cedar (<i>Cedrus deodara</i>)	34est	50	80/35	Good vigor, poor form, codominant throughout canopy, limited visual inspection.
	10 times diameter= 28.3'				
	8 times diameter= 22.6'				
	6 times diameter= 17'				
	Appraised value= \$10,900

Showing neighbor's codominant Deodar cedar tree #17

Discussion: Deodar cedar tree #17 is in fair condition (lower end). The tree has poor structure due to the loss of apical dominance. The tree is on the neighbor's property and should be maintained by the neighbor.

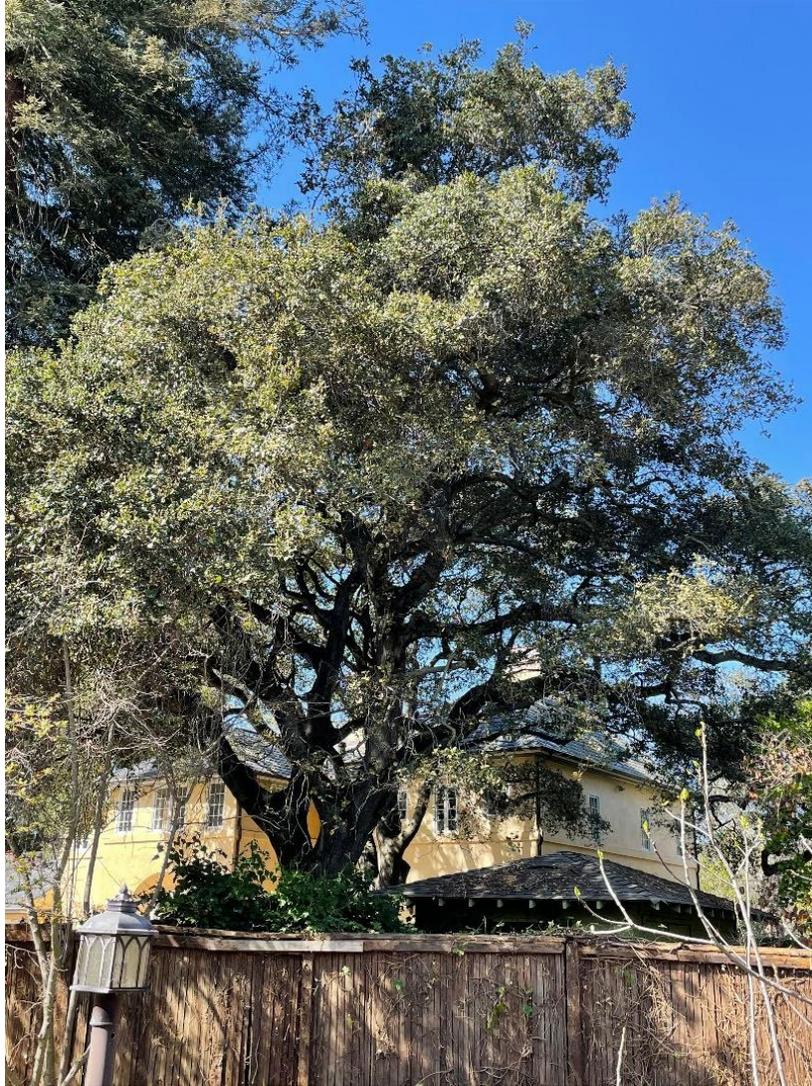
<u>Tree#</u>	<u>Species</u>	<u>DBH</u>	<u>CON</u>	<u>HT/SP</u>	<u>Comments</u>
18*P	Coast live oak (<i>Quercus agrifolia</i>)	28est	65	45/60	Good vigor, fair form, 25 feet from property line, canopy into property by 10 feet, limited visual inspection.
	10 times diameter= 23.3'				
	8 times diameter= 18.6'				
	6 times diameter= 14'				
	Appraised value= \$4,800

Showing neighboring oak tree #18

Discussion: Neighbor's oak tree #18 is in fair condition. The tree has a wide spreading canopy that grows into the site. The tree is estimated at 25 feet from the property line.

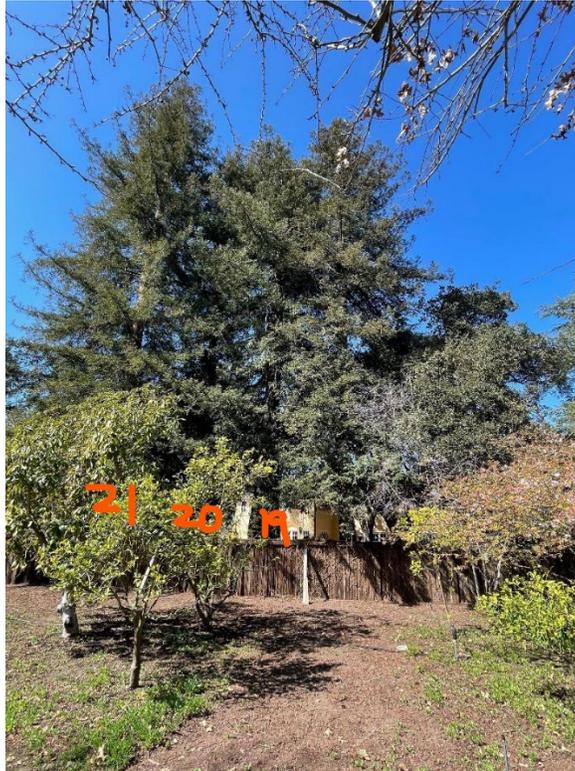
<u>Tree#</u>	<u>Species</u>	<u>DBH</u>	<u>CON</u>	<u>HT/SP</u>	<u>Comments</u>
19*P	Redwood (<i>Sequoia sempervirens</i>)	18est	70	75/25	Good vigor, fair form, limited visual inspection, 5 feet from property line.
	10 times diameter= 15'				
	8 times diameter= 12'				
	6 times diameter= 9'				
	Appraised value= \$4,700				
20*P	Redwood (<i>Sequoia sempervirens</i>)	18est	70	75/25	Good vigor, fair form, limited visual inspection, 5 feet from property line.
	10 times diameter= 15'				
	8 times diameter= 12'				
	6 times diameter= 9'				
	Appraised value= \$4,700				
21*P	Redwood (<i>Sequoia sempervirens</i>)	25est	70	75/25	Good vigor, fair form, limited visual inspection, 5 feet from property line.
	10 times diameter= 20.8'				
	8 times diameter= 16.6'				
	6 times diameter= 12.5'				
	Appraised value= \$7,900

Showing redwood trees #19-21

Discussion: The neighbors redwood trees are in good condition. Drought stress symptoms (normal for species) were observed in the tree canopies.

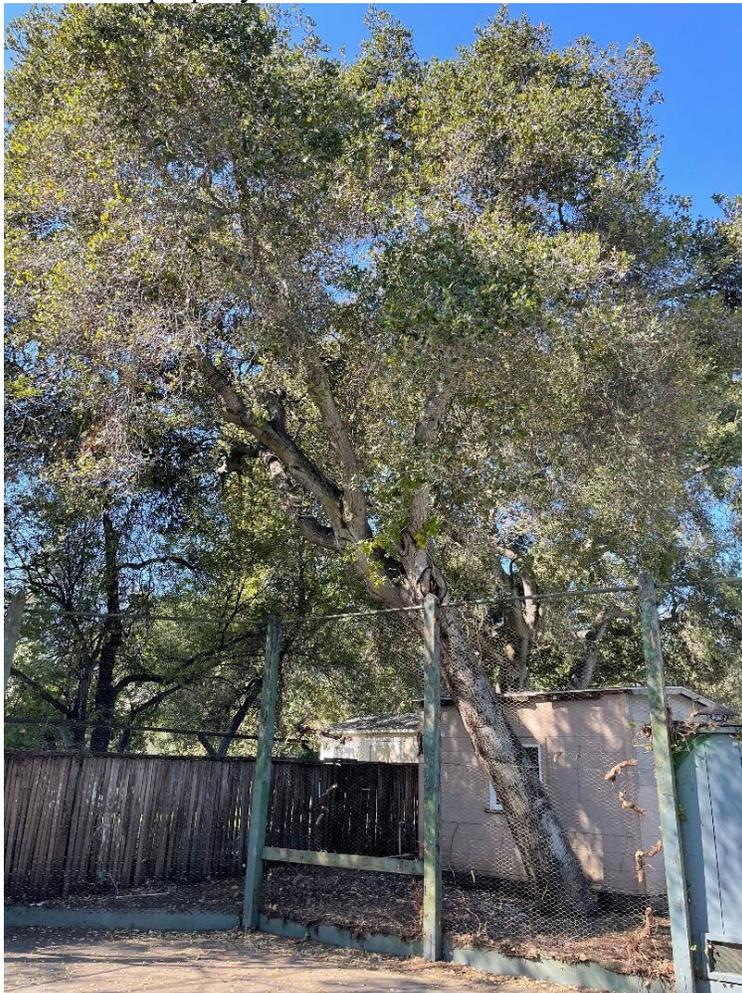
Oak tree #4 is the only heritage tree removal proposed on site. Tree removal is required to facilitate the construction of the proposed ADU and pool. The proposed work would require excavation on two sides of the tree. Impacts from excavation are expected to be high on the leaning tree. This location for the ADU and pool make the most sense as noted in the site study. Oak tree #4 was given a poor condition rating. The tree is poorly located at the shed foundation and leans over the existing tennis court/proposed pool area. Demolition of the shed could result in root impacts made on the tension side of the tree's lean. Roots on the tension side of a tree's lean are critical for tree stability. Demolition of the tennis court on the compression side of the tree's lean could also lead to root impacts. The tree has large decay pockets observed on the large leaders from past pruning events that were not done correctly. Limb failure risk is high due to the decay observed in combination with the tree's lean. Tree removal is recommended as the tree is hazardous and to facilitate the proposed construction. New trees are to be planted at the property line to further screen the property. No screening is likely to be impacted as many small trees are located on the neighboring side as seen in the photo below. There will be adequate room for trees at the southern property line.

Showing oak tree #4

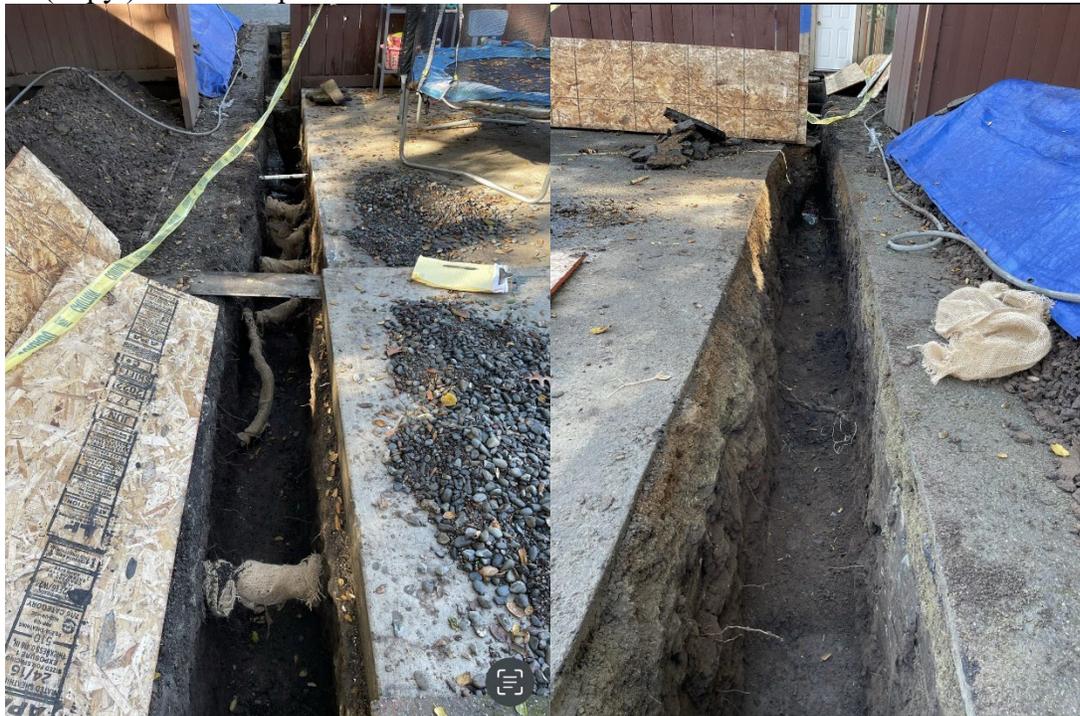
<u>Root size</u>	<u>Depth of root</u>
4"	2' deep
3.2"	1' deep
2"	2' deep
3"	2' deep
2"	6" deep
1" (4 qty.)	6" deep

Showing encountered roots within the Landscape area wrapped in burlap

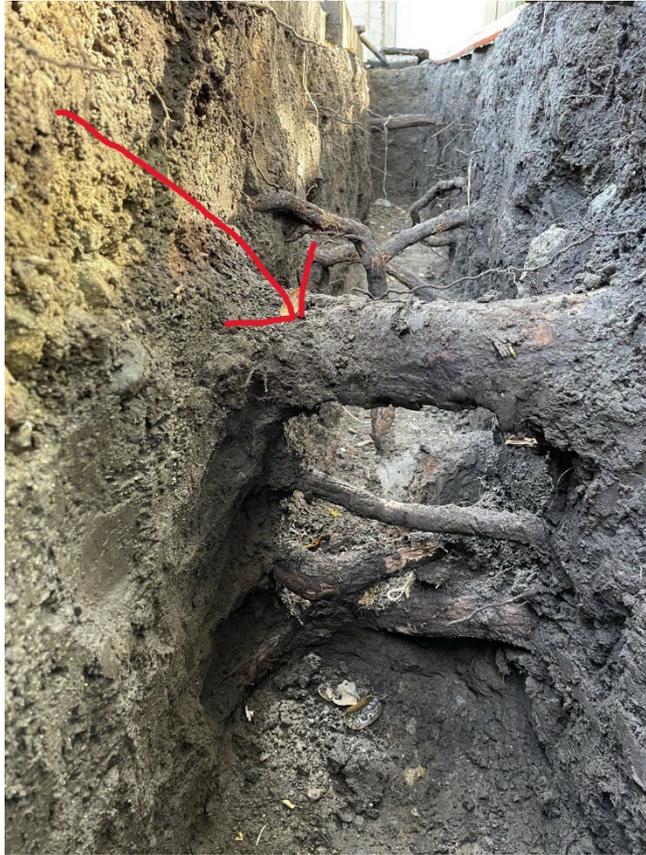
Showing largest root (3.2") to be cut

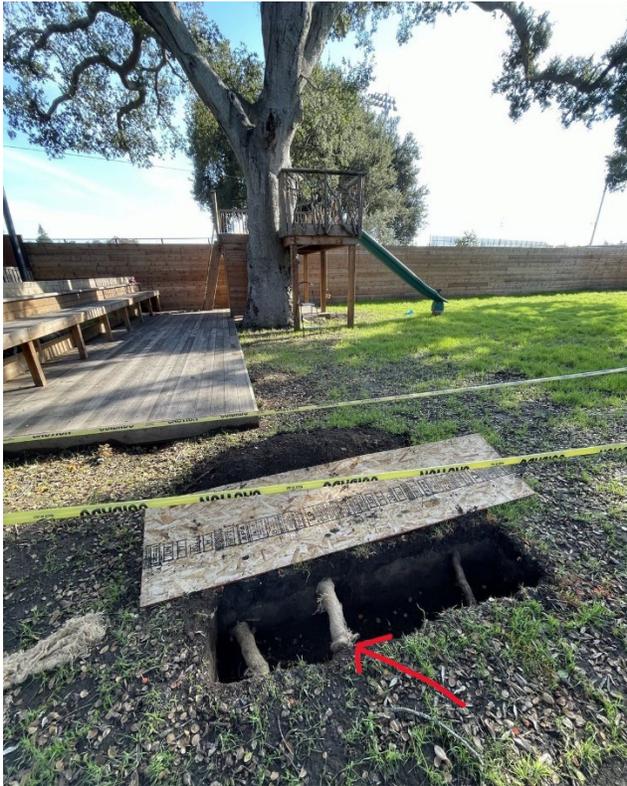
Showing largest root encountered near oak #9

It is recommended to cleanly cut roots as needed growing along the edge of the proposed tennis court. A hand saw or loppers shall be used under the Project Arborist supervision when cutting tree roots. Impacts to both trees are expected to be minor. Between the tennis court and trees, it is recommended to irrigate the soil when within 10x the tree's diameter using 200 gallons of water in early spring of 2023 and again before the start of fall. This will act as mitigation for the minor impacts. A licensed tree care provider is recommended to be used to inject the water into the soil. This will also help to aerate the soil and provide additional benefits for the trees.

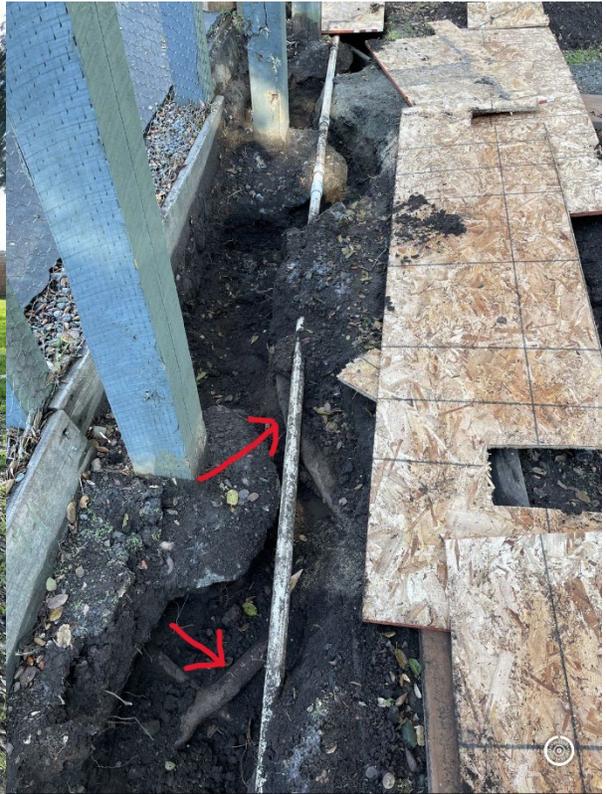
Showing roots growing parallel to existing Tennis court near oak #8

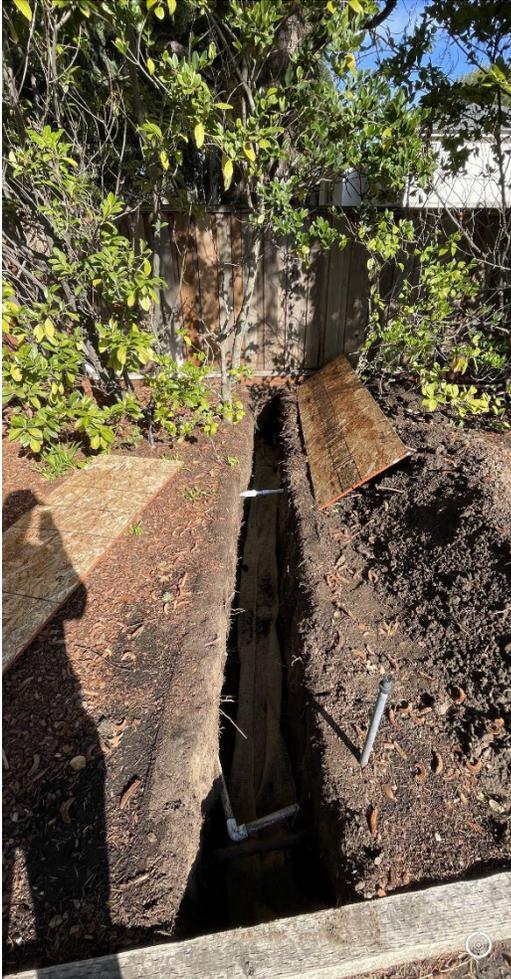
The trench was excavated to a depth of 18". No roots of a significant size were encountered. Only small fibrous roots were encountered (under 1"). Signs of past trenching in this area for irrigation lines as well as fence post may have helped to discourage root growth in this area.

Showing exploratory trench

No impacts are expected for the construction of the front gate as no roots were encountered. No mitigation measures are needed. The construction of the gate when within 10x the diameter of Cedar tree #17 will need to be done by hand under the direct supervision of the Project Arborist.
