Memo

To: The Atherton Planning Commission
From: Sally D Bentz, Town Arborist
CC: Laylonni Laster, Assistant Planner
Date: April 2nd, 2025
Re: Heritage Tree Removal Application at 170 Atherton Ave.

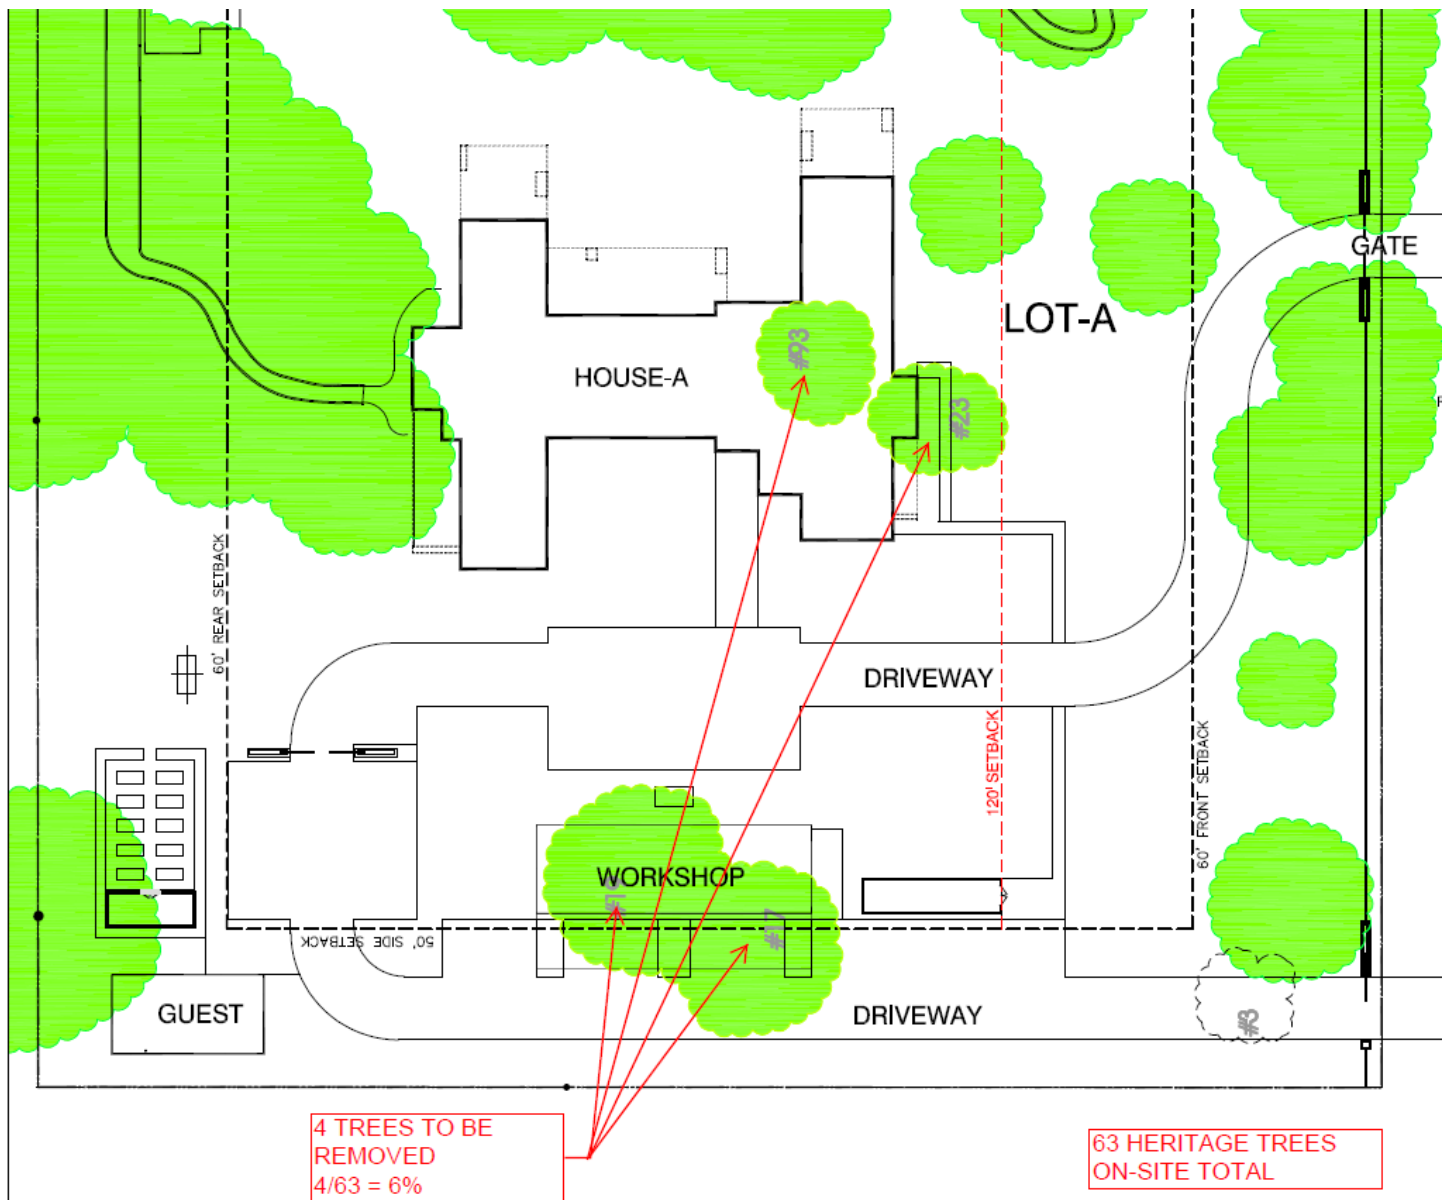
TREE INVENTORY SURVEY

Tree Tag #	Tree Picture #1	Protected Tree	Preserve or Remove	Common Name / Scientific Name	Trunk (in.)	Height (ft.) / Canopy Spread (ft.)	Health Rating	Structural Rating	Form Rating	Suitability for Preservation During Construction	Overall Condition (0-100%)	Notes, explanations, descriptions
3	 	Yes	(P)	Coast Live Oak <i>Quercus agrifolia</i>	19.6	25/26	Fair	Poor	Fair	Fair	50%	Deadwood throughout canopy, near irrigation, compacted soils, codominant at grade.
17	 	Yes	(R)	Coast Live Oak <i>Quercus agrifolia</i>	30.4	50/35	Fair	Poor	Fair	Poor	45%	Tree leans towards existing home, codominant at 10 feet with decay at union, decay observed along large lateral limbs due to past pruning, cables in canopy, deadwood, hazardous.
19	 	Yes	(R)	Coast Live Oak <i>Quercus agrifolia</i>	30.5	50/50	Poor	Poor	Fair	Poor	40%	Tree 6 feet from utility lines, heartwood decay at base, overextended limbs, abundance of deadwood, lion's tail, hazardous due to heartwood decay, damaged roots from poor landscaping, hazardous.

23	 	Yes	(R)	Coast Live Oak <i>Quercus agrifolia</i>	16-22	50/46	Fair-Poor	Poor	Fair	Poor	40%	Codominant at 2 feet, excessive deadwood throughout canopy, multiple cables installed, near over-irrigated landscape, hazardous.
93	 	Yes	(R)	Coast Live Oak <i>Quercus agrifolia</i>	22.5	46/40	Fair-Poor	Fair	Good	Fair	45%	Deadwood throughout canopy, codominant at 8 feet, near overly irrigated landscaping, hazardous.

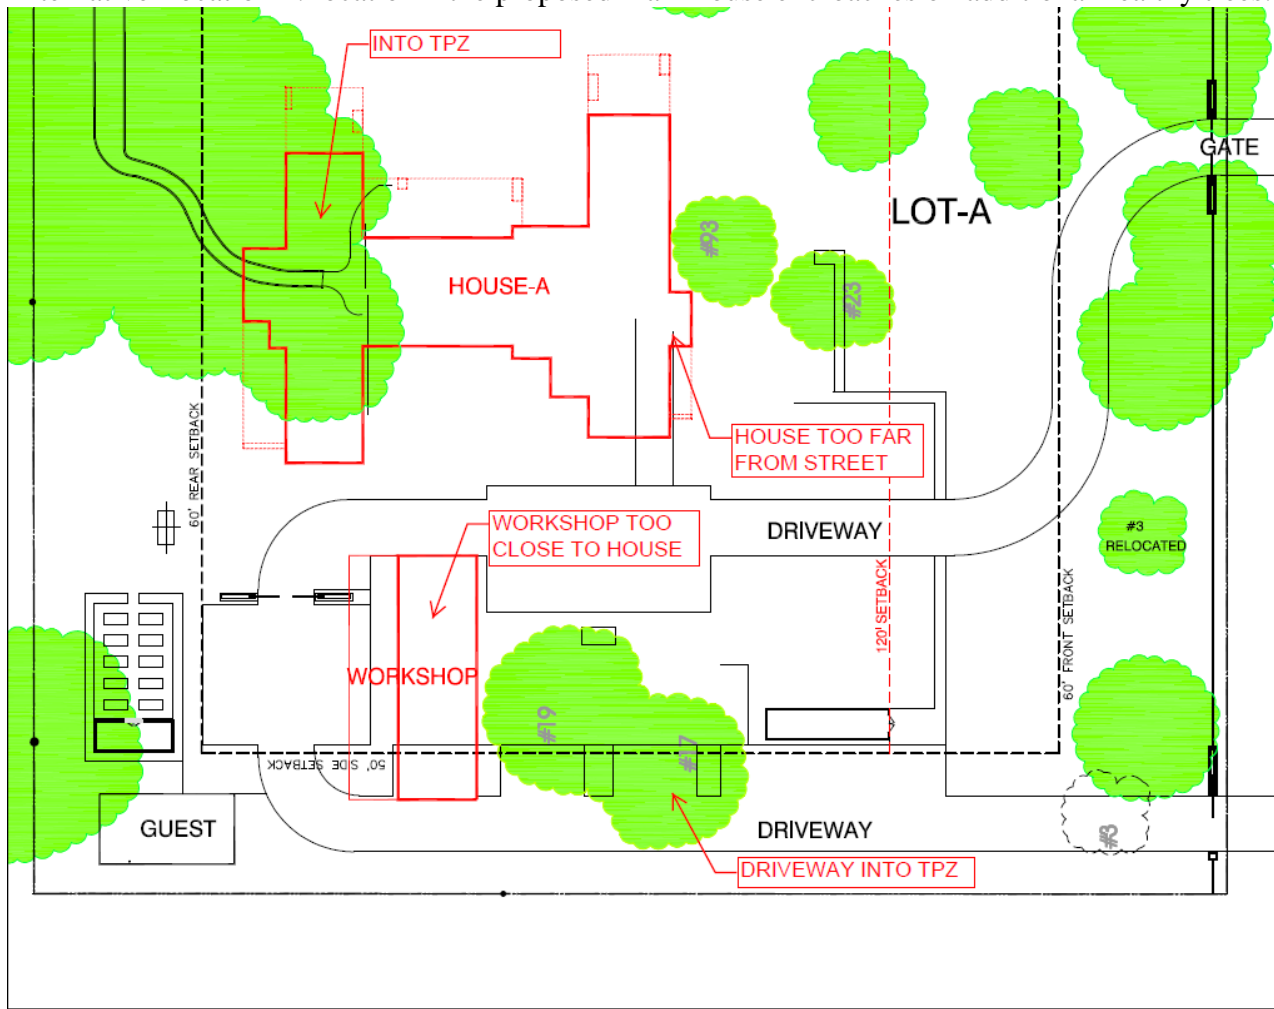
SITE PLAN - ALT 1

Alternative Location 1: location 1 the proposed main house encroaches on additional healthy trees.

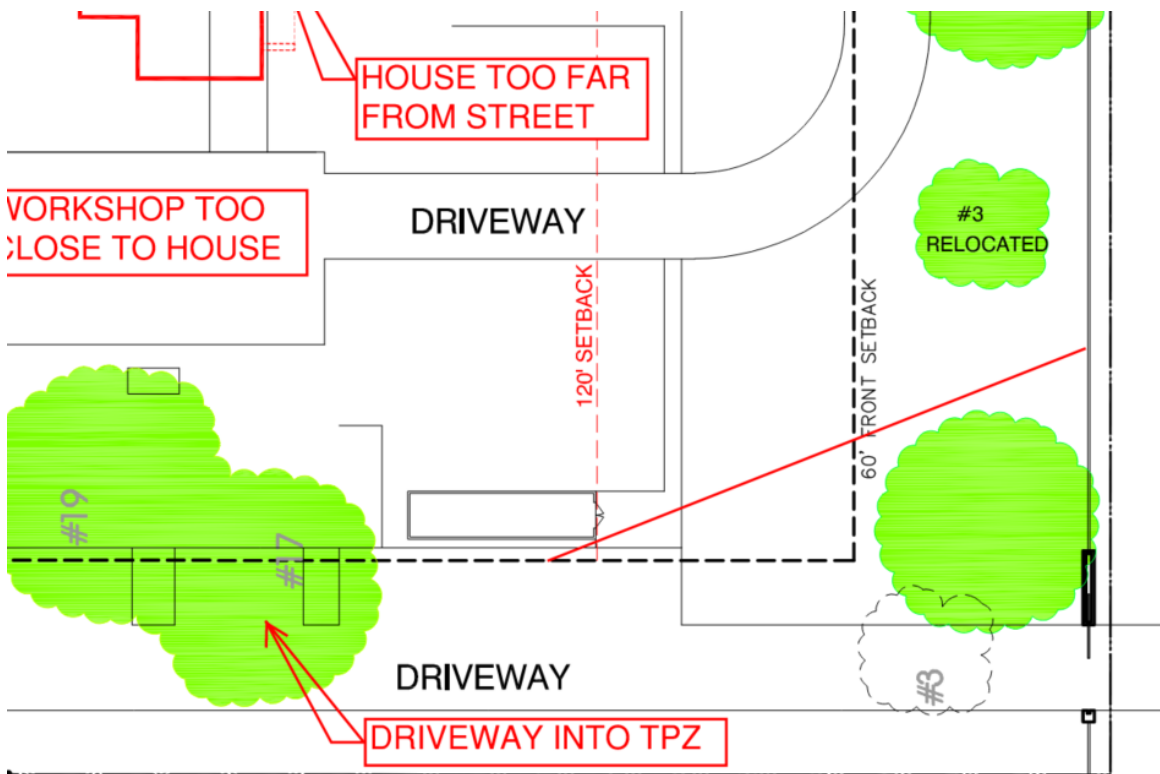
Tree #3 – The tree is located in the proposed driveway. However, the tree has shown signs of improvement. Mr. Kielty states that following targeted fertilization treatments, the tree has responded well, exhibiting enhanced vigor and foliage density. With its well-balanced canopy and structurally sound form, it is now considered a strong candidate for successful relocation.

For moving tree requests we treat them like removals. If the tree is moved and dies within 5 years, we can assess a fine on the tree. Because the tree is seeing signs of recovery, I do not think it should be moved. I think the driveway location can be moved. Below I marked with a red line where the driveway could be without removing tree #3.

If the Commission wish to grant the moving of the tree than I recommend a condition of approval be that an appraised value of the tree times two would be the fine for if the tree dies within 5 years. Also, a condition would be to follow Mr. Kielty’s recommendations regarding transplanting.
