## Memo

**Re:** Tree Protection Zone (TPZ) Exception 345 Stockbridge

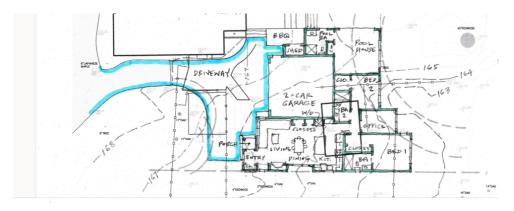
There is an existing driveway and hardscape. There was also a shed located in the area. As part of this proposal the applicant will be removing some of the existing hardscape near trees A & B and moving the driveway further back than existing conditions. Because of the condition of the Oaks and tolerance to construction impacts I can recommend the 6x TPZ for the driveway for trees A & B.

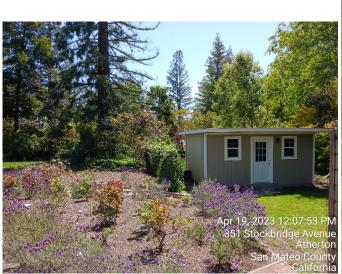
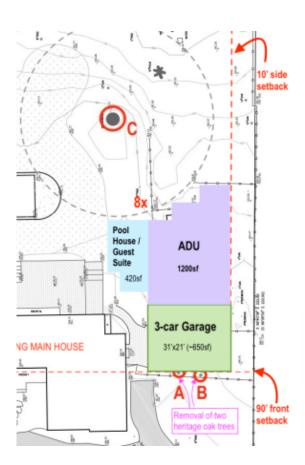
In July of 2022 I sent the homeowner a letter requiring the removal of Redwood, Tree C. The owner watered the tree on a regular basis which took much time and money and brought the tree back to life.

The applicant is asking for 6x TPZ for one structure that will be a garage, pool house and ADU. The existing conditions have a grade change, a shed and an area where a dead Redwood was.

<u>Tree C</u> - Existing site and empty area is location of the dead removed Redwood:

Tree C will need to continue to be watered during the extent of this project. I can recommend the 6x TPZ for the proposed structure because of the existing conditions and slab on grade within 8x TPZ.

- Hand excavation only within 8x TPZ
- The area under the drip line of trees should be thoroughly irrigated to a soil depth of 18" every 3-4 weeks during the dry months.
- Mulch should cover all bare soils within the tree protection fencing. This material must be 6-8 inches in depth after spreading, which must be done by hand. Coarse wood chips are preferred because they are organic and degrade naturally over time.
