Kielty Arborist Services LLC

May 1st, 2023

Site: 29 Stockbridge, Atherton CA

As requested on Wednesday, January 18th, 2023, and again on April 12th 2023, Kielty Arborist Services LLC visited the above site for the purpose of providing a Tree Inventory Report/Tree Protection Plan for the proposed construction. A new home, pool house, pool, detached garage and sports court are proposed on site, and as required a tree protection plan is needed when submitting plans to the town of Atherton. Site plan A1.0 dated 4/28/23 was reviewed for writing this report. This Tree Inventory Report is not a Tree Risk Assessment. As such, no trees were assessed for risk in accordance with industry standards, nor are there any tree risk ratings or risk mitigation recommendations provided within this preservation plan unless stated otherwise.

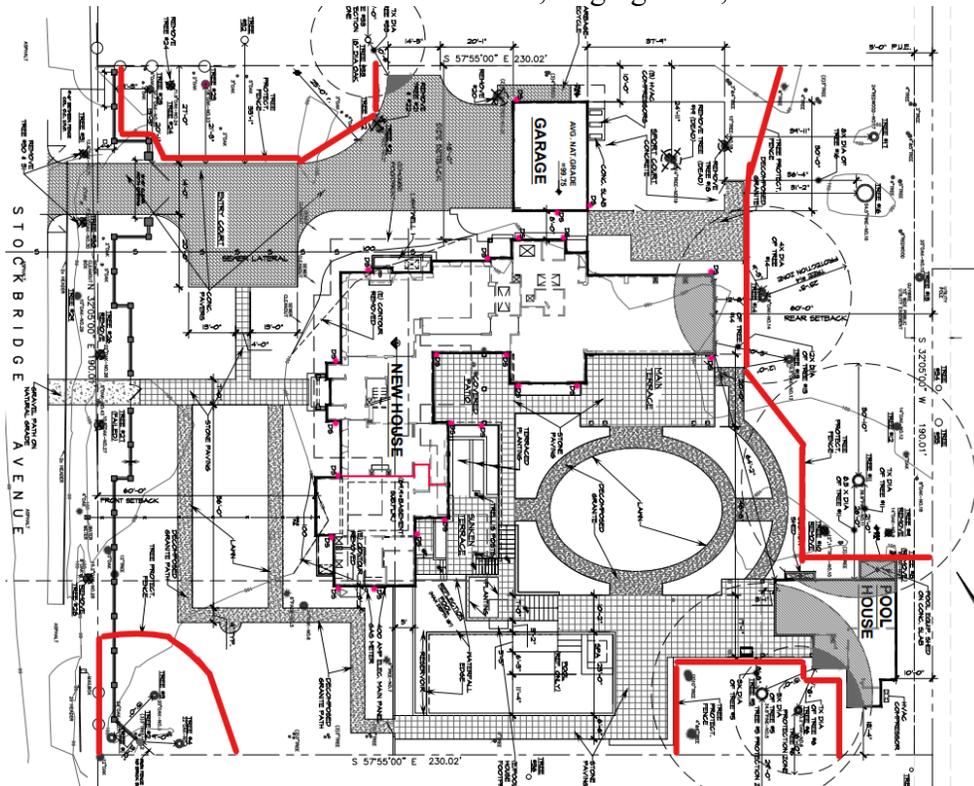
Showing the recommended placement of tree protection fencing.

Tree protection zones should be established and maintained throughout the entire length of the project. Fencing for the protection zones should be 6 foot tall metal chain link (minimum 12 gauge) supported by 2 inch galvanized iron post pounded into the ground by no less than 2 feet. The support poles should be spaced no more than 10 feet apart on center. This detail shall appear on grading, guarantee demolition, and building permit plans. The location for the protection fencing is recommended to be placed at 8 or 10x diameter where possible. Any deviation in determining the tree protection zone will require approval by the Town Arborist. I have approved tree protection fencing being reduced for trees near the proposed work on site. No excavation shall be allowed inside tree protection zones without the Site Arborist on site. Signs should be placed on fencing signifying "Tree Protection Zone - Keep Out". No materials or equipment should be stored or cleaned inside the tree protection zones. It is recommended to mulch the tree protection zones using 4-6 inches of wood chips. Tree protection fencing can only be removed at the end of the project by approval from the Town Arborist. The town of Atherton will require a Tree Protection Procedure Acknowledgement Signature to be signed by the owner of the property or contractor, acknowledging the existence of Heritage Trees on the property and that the Town's Standards and Specifications will be followed throughout the length of the project. Verification that all tree protection fencing measures have been installed will be needed before the issuing of permits as required by the Town. A site meeting with the general contractor, Town Arborist, and Site Arborist before the project starts will be required to review tree protection measures and to establish haul routes, staging areas, etc.
