89 Douglass Way Atherton, Ca Arborist Report 2023

Date: 8/24/23

Subject Re: Tree Protection for Proposed Pool and pickleball court at 89 Douglass Way, Atherton

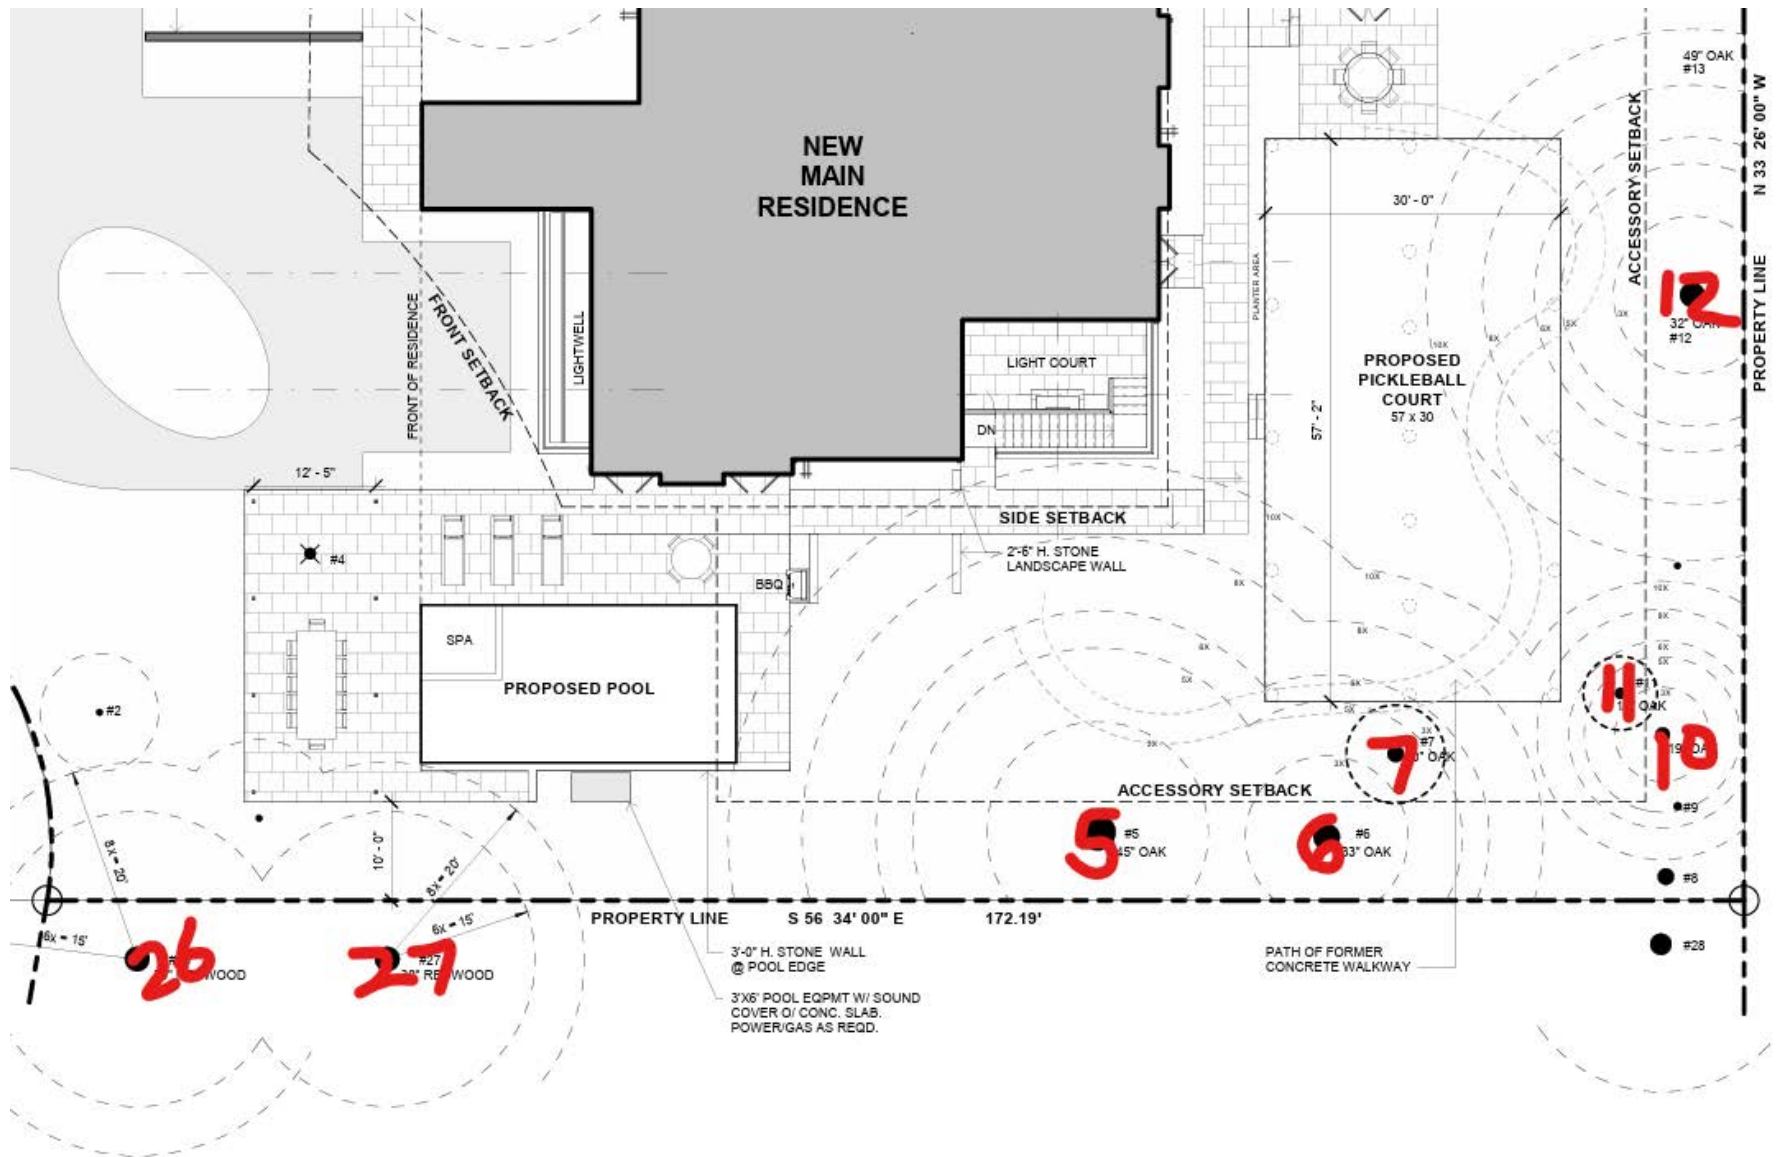
TREE LOCATION MAP

Coast live oak trees #7 and #11 are both growing in heavily suppressed conditions causing the trees to grow at a lean into the site. The surrounding larger oak trees #5, 6, 10 and 12 are much larger than these two oak trees and are well placed on the lot further back towards the property lines. The two oak trees in question will always grow at a lean due the suppressed growing conditions. The loads on the tree defects (leans) are only expected to increase overtime and would eventually lead to large limb failures or total tree failures. The constant pruning needed to mitigate the poor form of the trees is not fair for the property owner, when many other large oak trees exist behind the trees proposed to be removed. No screening will be impacted by the proposed tree removals. Oak trees #7 and #11 are hazardous to the site due to the heavy leans of both trees and tree removal is recommended.
