# Tree Management Experts

**RE: 20 Tuscaloosa Avenue**  
**Atherton, CA**

**Date: 11/02/22**

## **ARBORIST REPORT and TREE PROTECTION REPORT**

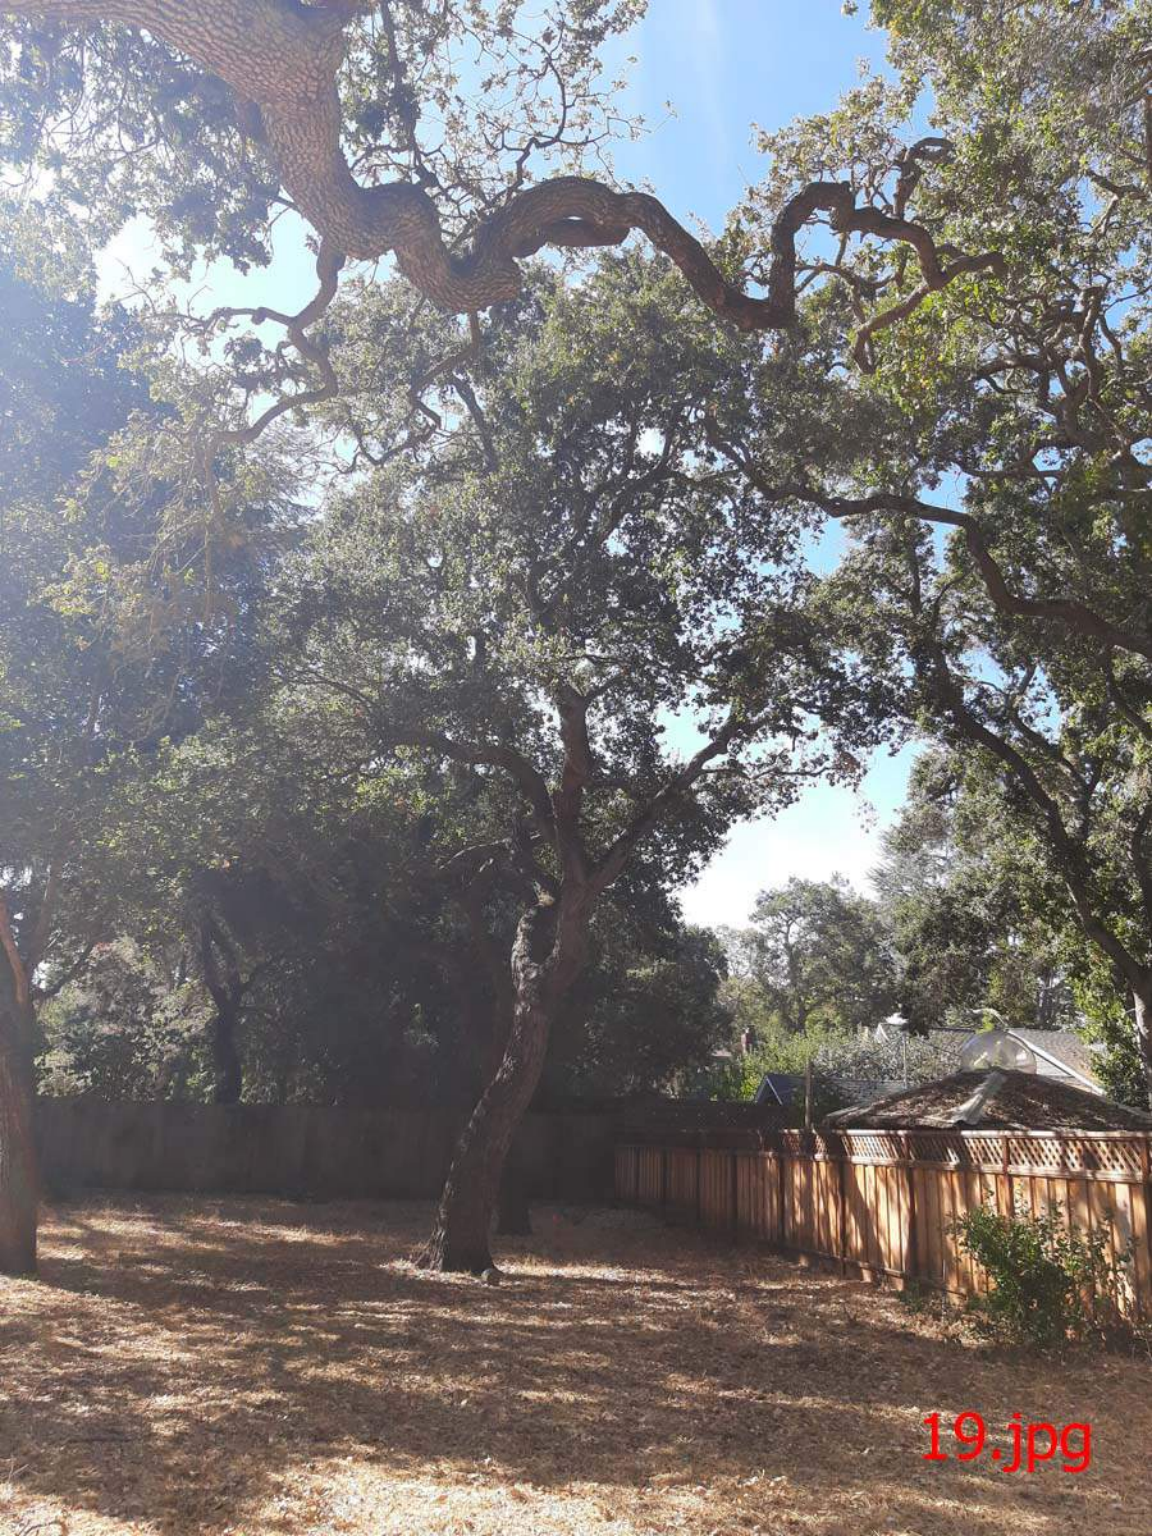
19.jpg

19	Quercus agrifolia	coast live oak	25.0	25.0	40	50	X		Good													X	X	X					20' 10"	16' 8"	12' 6"	10' 5"	6' 3"	crossing/rubbing branches with tree 20
20	Quercus agrifolia	coast live oak	18.1	18.1	25	30	X		Fair		X		X									X	X	X					15' 1"	12' 1"	9' 1"	7' 7"	4' 6"	crossing/rubbing branches with tree 20
21	Cotoneaster spp.	cotoneaster	8.0	8.0	20	20			Very Poor									X	X		X								6' 8"	5' 4"	4' 0"	3' 4"	2' 0"	
22	Quercus agrifolia	coast live oak	22.0	22.0	30	30	X		Very Poor		X	X								X	X								18' 4"	14' 8"	11' 0"	9' 2"	5' 6"	major decay, aloft hazard tree
23	Quercus agrifolia	coast live oak	13.0	13.0	20	20			Poor	X	X	X										X							10' 10"	8' 8"	6' 6"	5' 5"	3' 3"	chained to tree 24
