Kielty Arborist Services LLC

March 8th, 2021, Revised January 16th, 2023, Revised March 31st, 2023

Site: 240 Oak Grove Avenue, Atherton

As requested on Thursday, March 4th, 2021, and again on December 14th, 2022 Kielty Arborist Services LLC visited the above site for the purpose of developing a tree inventory report and tree protection plan for the proposed construction. An ADU, pool, and tennis court are proposed for this site, and as required, a tree inventory and tree protection plan are required when submitting plans to the town of Atherton. Site plan A1.0 dated 9/30/22 was reviewed for writing this report. This Tree Inventory Report is not a Tree Risk Assessment. As such, no trees were assessed for risk in accordance with industry standards unless stated otherwise state, nor are there any tree risk ratings or risk mitigation recommendations provided within this preservation plan unless stated otherwise.

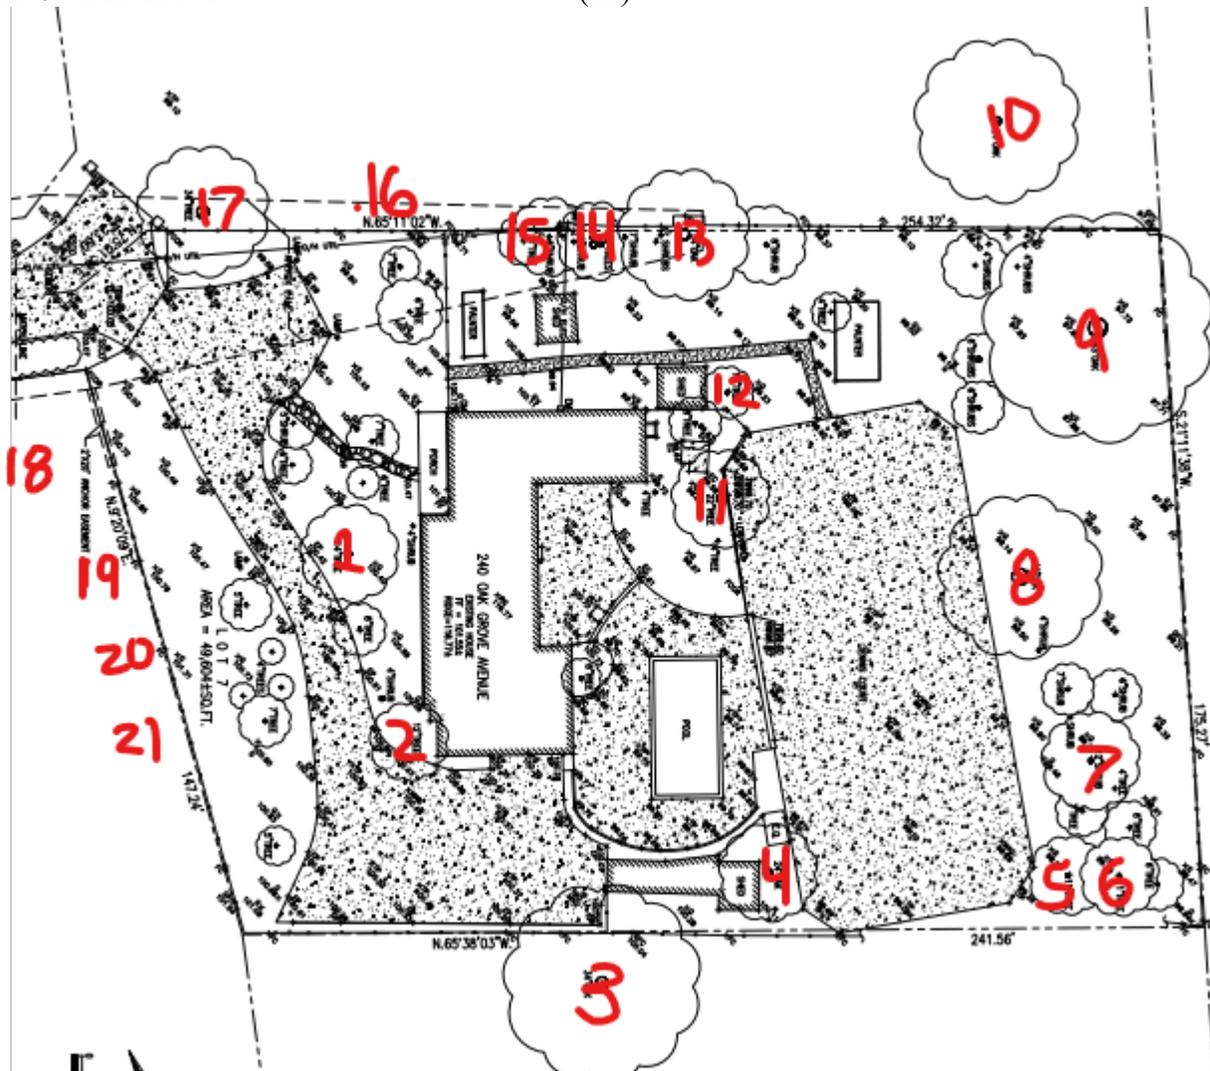
Showing redwood trees #19-21

Discussion: The neighbors redwood trees are in good condition. Drought stress symptoms (normal for species) were observed in the tree canopies.

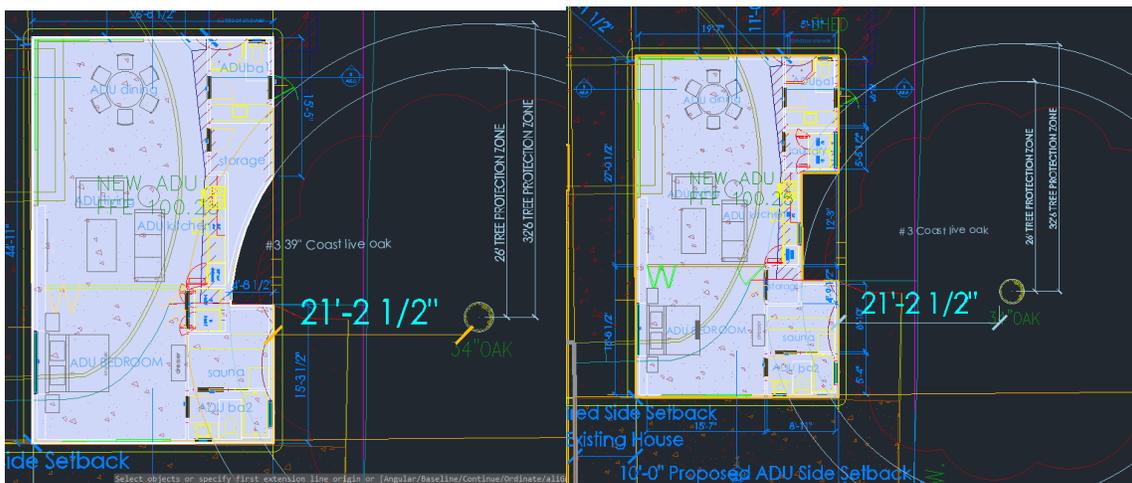
Showing option 1(left) showing option 2 (right)

Two new ADU designs have been drawn by the architect. Both designs will require a town arborist exception that will need to be approved by the planning commission. The proposed ADU design has been re-designed for two reasons. First, the diameter of the oak tree is larger than previously thought as the neighbor has provided the correct diameter of 39" and is a 5" difference from the previous recoded diameter of 34". Secondly, after completing the exploratory trench at the previously proposed ADU foundation, no roots were found in the existing asphalt area, and roots were found at the previously proposed foundation outside of the asphalt driveway within the existing landscape area. Both proposed ADU options now show the ADU at 8x the tree's diameter in the area beyond the asphalt driveway where roots were found. Both ADU options maintain a distance of 21'2.5" or 6.5x the diameter of the tree when within the existing asphalt area where no roots were found. The proposed ADU in both options maintain a distance of 8x the tree's diameter where beyond the existing asphalt area. The neighboring oak tree is healthy and in fair condition. Coast Live Oak trees have a good tolerance to construction impacts as seen in the Matheny and Clark Tree Tolerance Chart. 6.96% of the tree's root zone at 10x the tree's diameter will be impacted by the proposed ADU construction in option 1 and 8.3% of the trees root zone at 10x the tree's diameter will be impacted by the proposed ADU construction in option 2. Impacts are expected to be minor for both options. Hand excavation under the Project Arborist supervision is required for excavating the foundation of the ADU when working within 10x the tree's diameter. All roots encountered measuring 1" in diameter or larger will need to be documented in the required monthly inspections. Encountered roots are recommended to be cleanly cut with cut root ends on the tree side covered in layers of wetted down burlap. This will help to avoid desiccation. Between the ADU and property line, it is recommended to irrigate the soil when within 10x the tree's diameter using 200 gallons of water before the start of construction and again in the month of September. This will act as mitigation for the minor impacts. A licensed tree care provider is recommended to be used to inject the water into the soil. This will also help to aerate the soil and provide additional benefits for the tree.

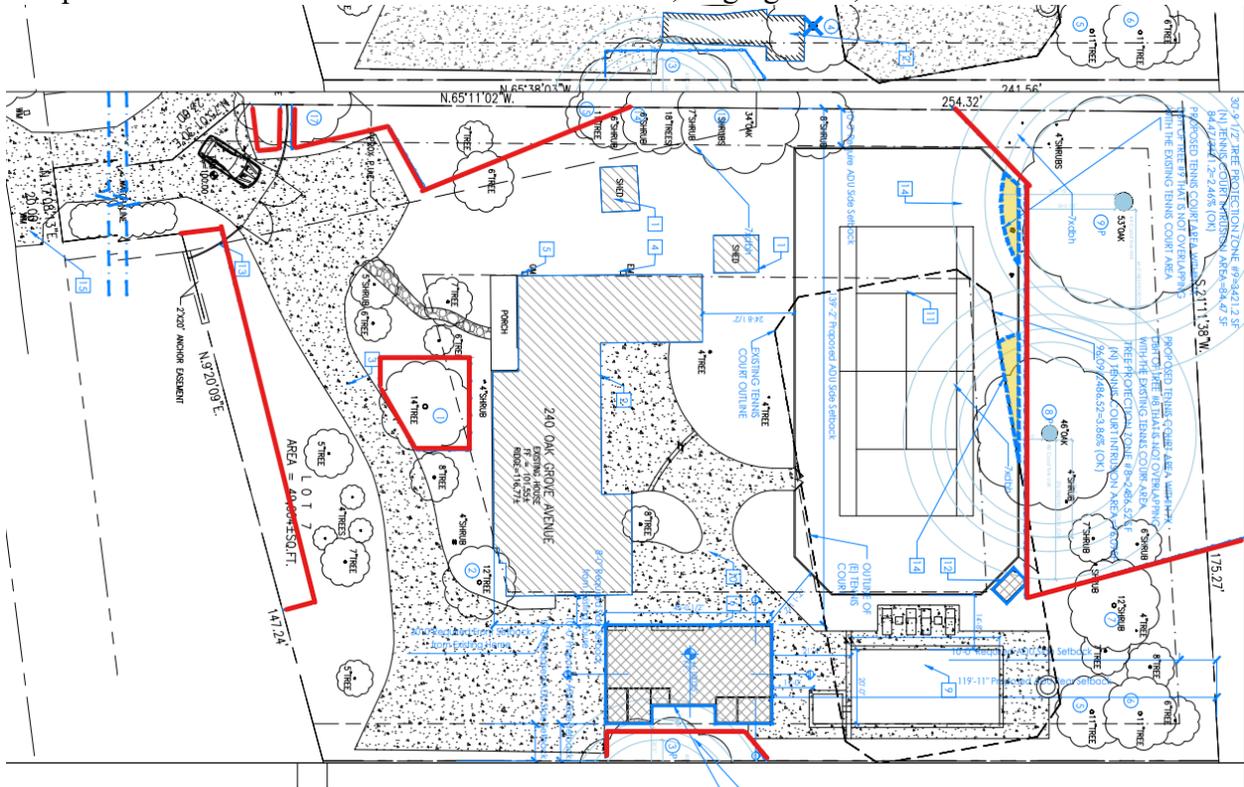
Red lines showing the recommended tree protection fencing for the protected trees on site

In the town of Atherton, tree protection fencing should be placed at 8 to 10 times diameter as required. Tree protection zones should be established and maintained throughout the entire length of the project. Fencing for the protection zones should be 6 foot tall metal chain link (minimum 12 gauge) supported by 2 inch galvanized iron post pounded into the ground by no less than 2 feet. The support poles should be spaced no more than 10 feet apart on center. This detail shall appear on grading, demolition, and building permit plans. The location for the protection fencing can be determined by the formula: 8-10 times diameter. Any deviation in determining the tree protection zone will require approval by the Town Arborist. I have approved tree protection fencing being reduced for trees near the proposed work on site to a minimum of 8 times diameter. Where the proposed work is to take place underneath the dripline of a protected tree, the fencing shall be placed as close as possible to the proposed work. No excavation shall be allowed inside tree protection zones without the Site Arborist consent. Signs should be placed on fencing signifying "Tree Protection Zone - Keep Out". No materials or equipment should be stored or cleaned inside the tree protection zones. It is recommended to mulch the tree protection zones using 4-6 inches of wood chips. Tree protection fencing can
