#	SHEET #	SHEET NAME
200	AC-0	COVER SHEET - CARPORT
201	AC-0.1	FLOOR AREA DIAGRAMS 1
202	AC-0.2	FLOOR AREA DIAGRAMS - CONDITIONED & UNCONDITIONED SPACE 1
203	AC-0.3	ARBORIST REPORT 1
204	AC-0.3.1	ARBORIST REPORT CONT. 1
205	AC-0.3.2	ARBORIST REPORT - CARPORT
206	AC-0.4	PROPOSED TPZ PLAN 1
207	AC-0.5	3D VIEWS / MATERIAL BOARD / PROPERTY FLOOD ZONE DATA 1
208	AC-1.0	PROPOSED PLOT PLAN - ENTRY GATE 1
209	AC-1.1	PROPOSED PLOT PLAN 1
210	AC-1.2	PROPOSED CARPORT FLOOR PLAN & ELEVATIONS 1
211	AC-2.0	PROPOSED CARPORT ROOF PLAN & SECTIONS Copy 1
212	CP-S1	CARPORT - FOUNDATION AND ROOF PLAN 1

251 SELBY LN.
ATHERTON CA. 94027

AC-0

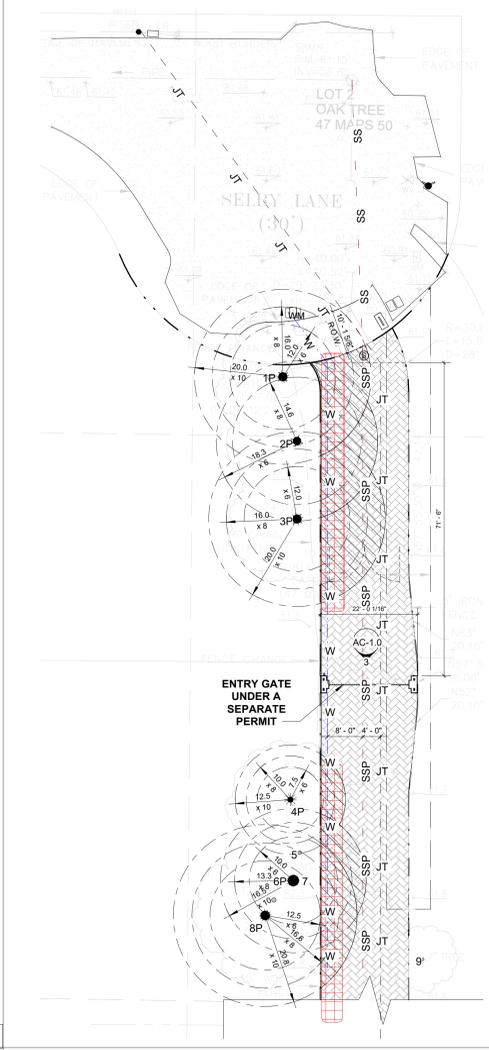
PROPOSED SITE PLAN - 2, Copy 1
1/16" = 1'-0"

NOTE 5: SEE UTILITY TRENCH DETAILS ON C-5.2.

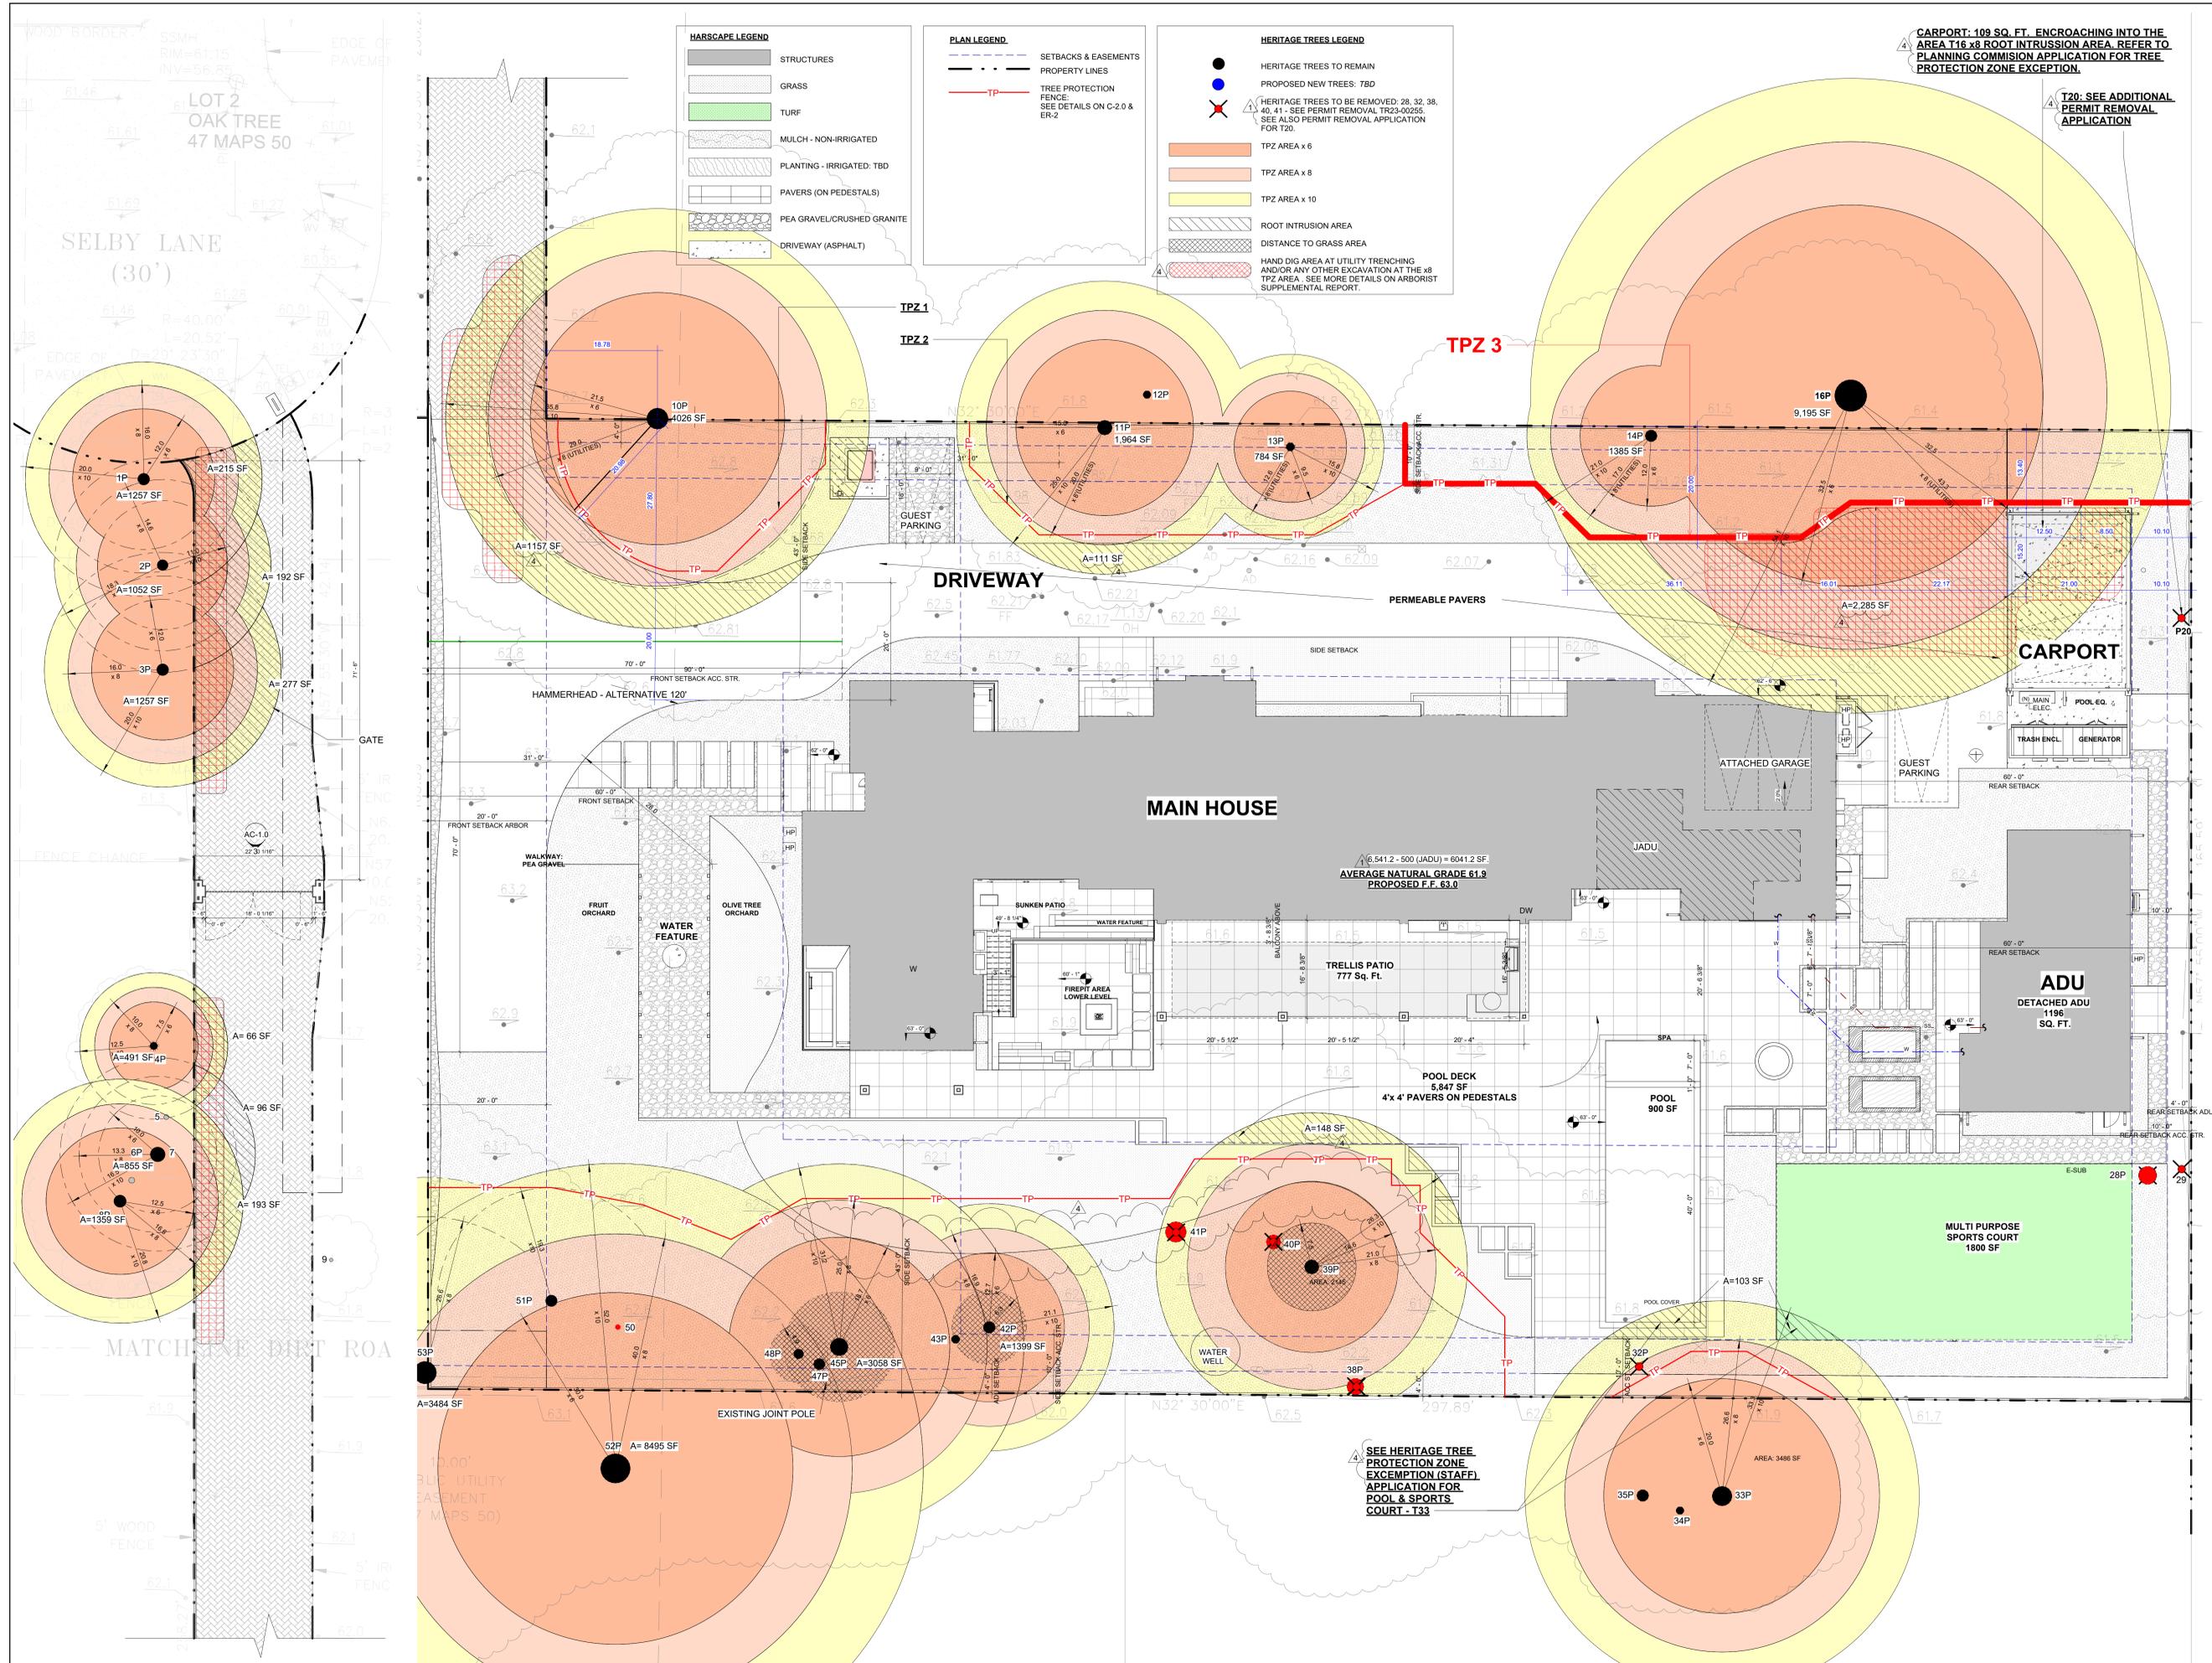
1 PROPOSED TPZ PLAN - Dependent 1
 1" = 10'-0"

2 PROPOSED TPZ PLAN N - ENTRY GATE - Dependent 1
 1" = 10'-0"

In the town of Atherton, tree protection fencing should be placed at 8 to 10 times diameter as required. Tree protection zones should be established and maintained throughout the entire length of the project. Fencing for the protection zones should be 6 foot tall metal chain link (minimum 12 gauge) supported by 2 inch galvanized iron post pounded into the ground by no less than 4 feet. The support poles should be spaced no more than 10 feet apart on center. This detail shall appear on grading, excavation, and building permit plans. The location for the protection fencing can be determined by the formula: 8-10 times diameter. Any deviation in determining the tree protection zone will require approval by the Town Arborist. I have approved tree protection fencing being reduced for trees near the proposed work on site. Where the proposed work is to take place within the 10x diameter area of a protected tree, the fencing shall be placed as close as possible to the proposed work. No excavation shall be allowed inside tree protection zones without the Site Arborist consent. Signs should be placed on fencing signifying "Tree Protection Zone - Keep Out". No materials or equipment should be stored or cleaned inside the tree protection zones. It is recommended to mulch the tree protection zones using 4-6 inches of wood chips. Tree protection fencing can only be removed at the end of the project by approval from the Town Arborist. The town of Atherton will require a Tree Protection Procedure Acknowledgment Signature to be signed by the owner of the property or contractor, acknowledging the existence of Heritage Trees on the property and that the Town's Standards and Specifications will be followed throughout the length of the project. Verification that all tree protection fencing measures have been installed will be needed before the issuing of permits as required by the Town. A site meeting with the general contractor, Town Arborist, and Site Arborist before the project starts will be required to review tree protection measures and to establish haul routes, staging areas, etc.

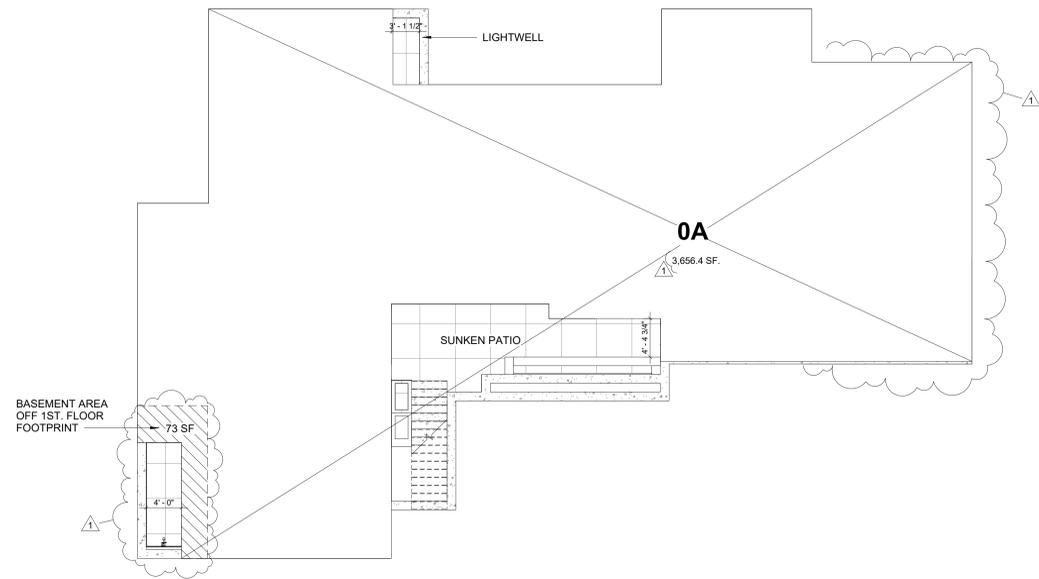
1 BASEMENT - FAR - Dependent 1
1/8" = 1'-0"

SECTION		AREA
1ST. FLOOR		
1A	6042.1 SF	
1B	500.0 SF	
JADU CREDIT (UP TO 500 SF)		500.0 SF
TOTAL 1ST. FLOOR		6042.1 SF
2ND. FLOOR		
2A	3790.6 SF	
TOTAL 2ND. FLOOR		3790.6 SF
BASEMENT		
0A	3656.4 SF	
TOTAL (FAR EXEMPT)		3656.4 SF
TOTAL PROPOSED FAR		9832.7 SF
DETACHED ADU		
1C	1196.0 SF	
ADU CREDIT @10' FROM PROPERTY LINE UP TO 1200 SF		
ALLOWABLE COVERAGE		992.8 SF
MAX COVERED PATIOS IS 5 OF 9,856 SQ.FT.		
492.8 + 500 SQ. FT = 992.8 SQ. FT.		
CARPORT		
1D	672.0 SF	
TOTAL PROPOSED COVERAGE		672.0 SF

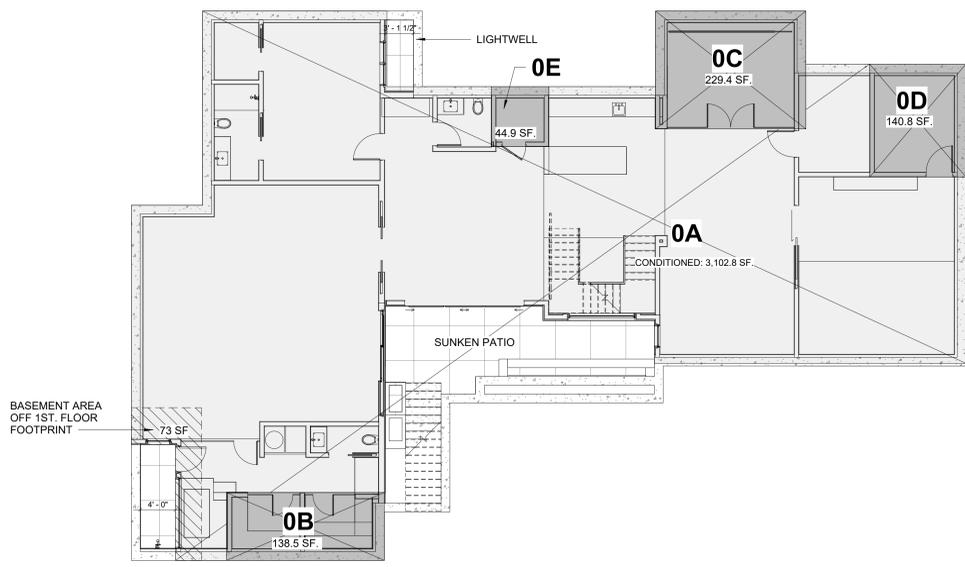
1 BASEMENT - FAR Copy 1 - Dependent 1
1/8" = 1'-0"

SECTION	AREA
1ST. FLOOR	5266.3 SF
JADU	500.0 SF
TOTAL 1ST FLOOR CONDITIONED AREA	5766.3 SF
GARAGE, MECHANICAL, POOL STORAGE & ELEC. ROOM	707.2 SF
ELEVATOR	41.0 SF
FIREPLACE	11.6 SF
FIREPLACE	16 SF
TOTAL 1ST FLOOR UNCONDITIONED AREA	775.8 SF
2ND. FLOOR	3715 SF
TOTAL 2ND. FLOOR CONDITIONED AREA	3715 SF
STORAGE	34.6 SF
ELEVATOR	41.0 SF
TOTAL 2ND. FLOOR UNCONDITIONED AREA	75.6 SF
BASEMENT	3102.8 SF
TOTAL BASEMENT CONDITIONED AREA	3102.8 SF
S/PA	138.5 SF
WINE ROOM	229.4 SF
MECHANICAL	140.8 SF
ELEVATOR	44.9 SF
TOTAL BASEMENT FLOOR UNCONDITIONED AREA	553.6 SF
TOTAL CONDITIONED AREA	12584.1 SF
TOTAL UNCONDITIONED AREA	1405.0 SF
TOTAL BUILT AREA	13989.1 SF

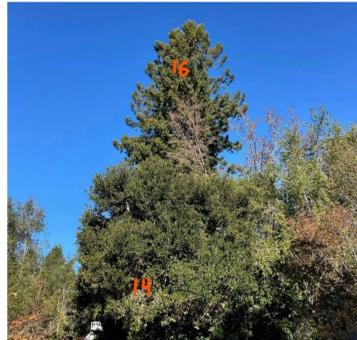
16P Redwood (65est 80 100/30) Good vigor, good form.

Showing trees #14 and #16

The proposed carport near neighboring redwood tree #16 is located at 6x the diameter of the tree. The entire proposed foundation within 10x the diameter of the tree is recommended/required to be excavated by hand in combination with hand tools such as an air knife, rotary hammer with clay spade attachment, or shovels, while under the direct supervision of the Project Arborist. All roots encountered within the foundation area measuring 1.5" in diameter or larger are recommended to be retained for the Project Arborist to inspect before being cleanly cut. Once inspected and documented, the roots will need to be cleanly cut using a hand saw or loppers. Cut root ends on the tree side are recommended to be painted with a tree pruning sealer/grafting compound then covered by 3 layers of wetted-down burlap to help avoid root desiccation. The contractor shall wet down the burlap daily while exposed. The area between the tree and the foundation (tree protection zone) is recommended to be irrigated every other week during the dry season until the top foot of the soil is saturated. This will act as a mitigation measure for the minor impacts. The Redwood trees have a good tolerance to construction impacts as seen in the Matheny and Clark Relative Tolerance of Selected Species to Development Impacts. The combined percentage of root zone impacts including the driveway work is 26.5%. The tree is recommended to be deep water fertilized using Nutriroot as a mitigation measure once roots have been cut. Irrigation between the tree and the driveway/carport is recommended. Every other week during the dry season, 50 gallons of water should be given to the tree. Impacts are expected to be minor.

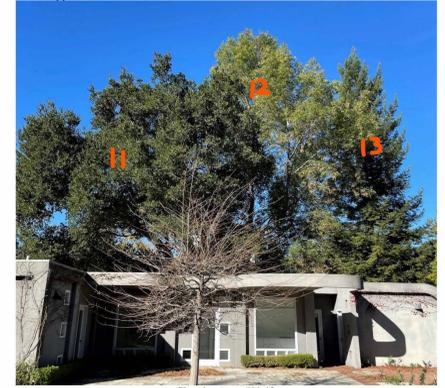
Tree#	Species	DBH	CON	HT/SP	Comments
13P	Redwood (<i>Sequoia sempervirens</i>)	19.0	80	45/20	Good vigor, good form.
		10x diameter=15.8'			
		8x diameter=12.6'			
		6x diameter=9.5'			
		Appraised value= \$5,300

Showing trees #11-13

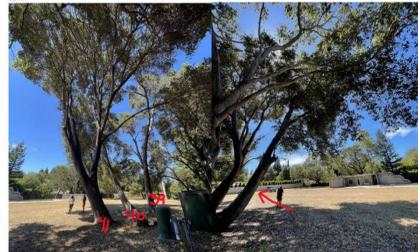
Coast Live Oak trees #39-41 are in fair condition. The trees make up a grove of 3 large Oak trees. Oak trees #39 and #41 suppress oak tree #40. Oak tree #40 grows a lean into the property. Risk of limb failure/tree failure is moderate due to the tree's lean. The other 2 large oak trees #39 and #41 have an upright form and are at a lower risk of failure. It is recommended to remove oak tree #40. Oak tree #40 is hazardous as a new home is to be built on site and the tree will be leaning towards the home and landscaping area. The removal of this tree will change wind loads for trees #41 and #39. Due to the increase in wind loads for trees #39 and #41 risk of failure is increased. All 3 trees are recommended to be removed as they are hazardous to the site.

Showing trees #39-41 Showing tree #40 growing at lean into property

Proposed hardscapes are shown at 8x the diameter of oak tree #39. All excavation for hardscapes when within 10x the diameter of the tree is required to be done by hand under the direct supervision of the Project Arborist. All roots encountered within the foundation area measuring 1.5" in diameter or larger are recommended to be retained for the Project Arborist to inspect before being cleanly cut. Once inspected and documented, the roots will need to be cleanly cut using a hand saw or loppers. Cut root ends on the tree side are recommended to be covered by 3 layers of wetted-down burlap to help avoid root desiccation. The contractor shall wet down the burlap daily while exposed. The area between the tree and the hardscape (tree protection zone) is recommended to be irrigated every other week during the dry season until the top foot of the soil is saturated. This will act as a mitigation measure for the minor impacts. This work will be required to be documented by the town of Atherton with a letter sent to the town arborist. The percentage of root zone impacts for the tree is 6.9%.

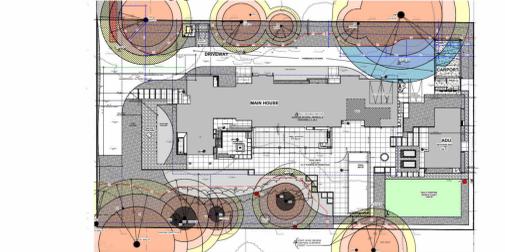
Red lines indicating tree protection zones, and neighboring trees along the driveway entrance to be protected by the existing fence at the property.

Proposed Town Arborist Exception: Driveway Trees #1-4, 6, 8, 10, 11, and 16 will need a Town Arborist Exception as the proposed driveway is shown closer than 8x the diameter of the trees. Trees #1-4, 6, 8 and 8 are neighboring Redwood trees along the entrance to the property. The Redwood trees are in good condition except for Redwood tree #4 which is in poor condition. This is the only feasible place a driveway entrance can be built for the property. The existing entrance into the property is a landscaped area where roots from the trees in question are likely to be found. The proposed driveway will also need to pass over the root zone of Coast Live Oak trees #10, 11, and neighboring Redwood tree #16. Redwood trees and Coast Live Oak trees have a good tolerance to construction impacts as seen in the Matheny and Clark Relative Tolerance of Selected Species to Development Impacts. The driveway design will be required to be root-friendly and be one with minimal disturbance into grade to reduce the need to cut roots as much as possible when closer than 8x the tree diameters. The driveway is recommended to be constructed using Biaxial Geogrid (Tensar BX-1100 or equivalent) is then recommended to be placed on the soil with only hand-tamped compaction preparation used. The geogrid material is to be used as a subgrade layer below aggregate (rock/gravel) and will need to be pinned down to the soil. It is a stiff synthetic permeable material consisting of sets of tensile ribs pre-tensioned in two directions to allow the pinning down of surrounding soil, stone, or other material. Geogrid is often used over soft soils or tree root zones and improves filtration, reduces base thickness needed, compaction of underlying parent soil (85%) and incidents of tire ruts and soil migration. By using Tensar BX-1100 Biaxial Geogrid compaction can be minimized to relieve the roots from strain caused by passing cars. With Tensar BX-1100 geogrid, compaction can be limited to 85%, and is more than adequate for future root growth. Any edging needed is recommended to be supported above ground by individual stakes. This way the driveway can be constructed as close to top of grade as possible while retaining as many roots as possible. Impacts to the trees would be minor if constructed in this manner. One month before construction is to start the neighboring Redwood trees along the driveway entrance are recommended to be irrigated from the proposed driveway side of the property using 300 gallons of clean water as mitigation for the minor impacts. The remaining trees all have large, landscaped areas between the trees and the driveway where minor supplemental irrigation can be prescribed as a mitigation measure for the expected minor impacts. Oak trees #10 and #11 are recommended to be irrigated at the proposed driveway edge every other week for one year using 40 gallons of water at a time per tree. This will act as mitigation for the minor impacts. After one year irrigation near the oaks is recommended to be suspended. Redwood tree #16 is recommended to be irrigated every other week during the dry season with 40 gallons of clean water within the landscaped area. This type of irrigation is recommended to continue throughout the lifespan of the Redwood tree.

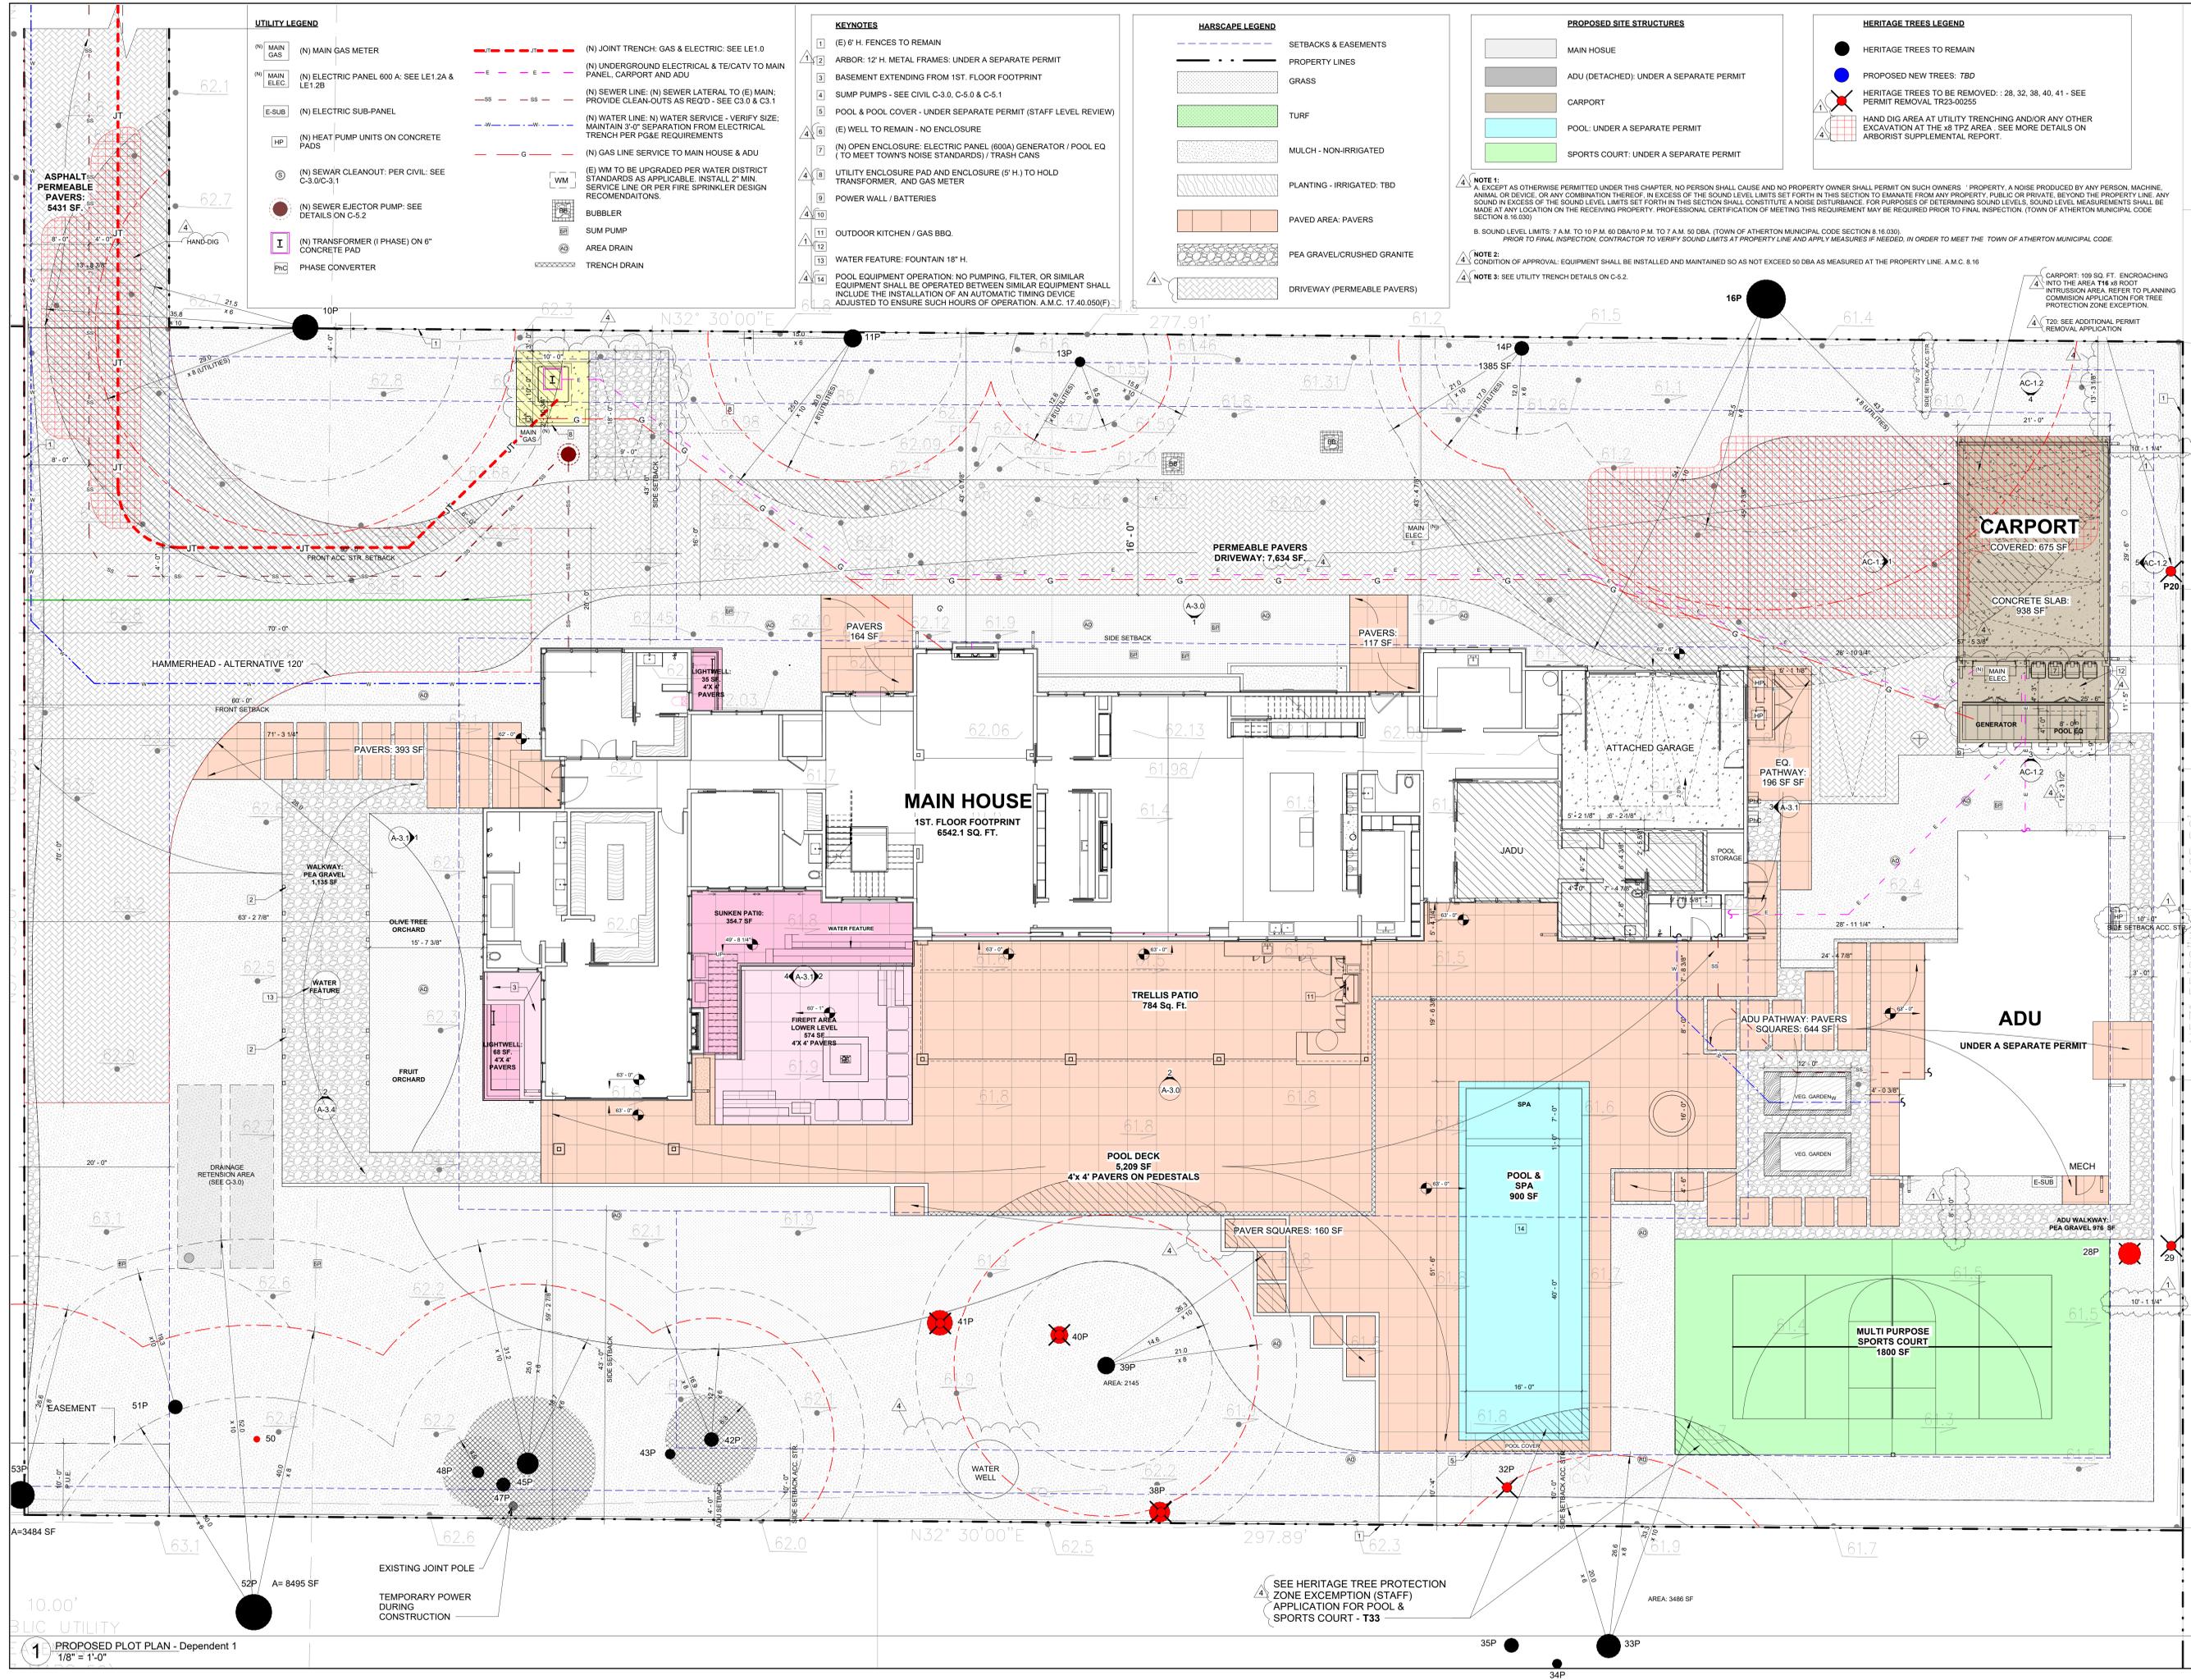
10.00' PUBLIC UTILITY
 1 PROPOSED PLOT PLAN - Dependent 1
 1/8" = 1'-0"

UTILITY LEGEND

(N) MAIN GAS	(N) MAIN GAS METER	(N) JOINT TRENCH: GAS & ELECTRIC: SEE LE1.0
(N) MAIN ELEC.	(N) ELECTRIC PANEL 600 A: SEE LE1.2A & LE1.2B	(N) UNDERGROUND ELECTRICAL & TE/CATV TO MAIN PANEL, CARPORT AND ADU

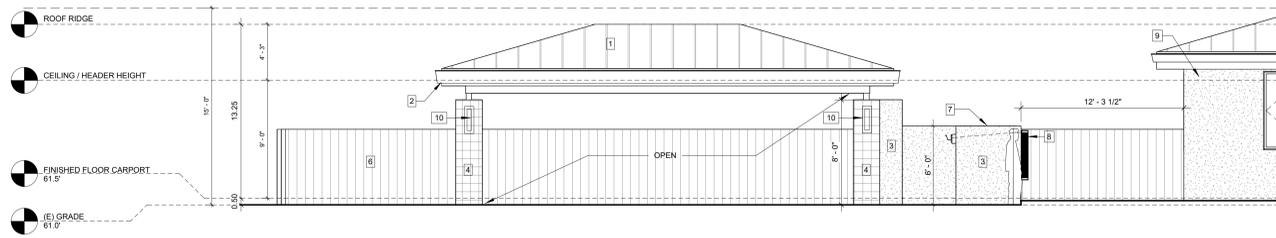
1 CARPORT SOUTH ELEVATION Copy 1
3/16" = 1'-0"

- KEYNOTES:**
- METAL ROOF, STANDING SEAM MS METAL SALES: MAGNA LOCK / DARK BRONZE
 - WOOD PAINTED FASCIA TO MATCH ROOF AND GUTTERS
 - SMOOTH STUCCO PAINTED: BENJAMIN MOORE 904 WHITE BLUSH
 - STONE VENEER: SALADO STONE / WHITE
 - DOWNSPUTS & GUTTERS: METAL / ANODIZED METAL / RECTANGULAR PROFILE 3.5" W. x 8" H / COLOR: TO MATCH ROOF
 - FENCE BEYOND
 - COVERED ENCLOSURE FOR GENERATOR AND POOL EQUIPMENT
 - SOLAR BATTERIES: DEFERRED PERMIT
 - DETACHED ADU - UNDER A SEPARATE PERMIT
 - EXTERIOR LIGHTS SCONCES: SHIELDED OR DOWNLIGHT. SEE DETAILS ON SHEET 4/A-8.4 / SEE LED 1: "LED ON LIGHT SCHEDULE"

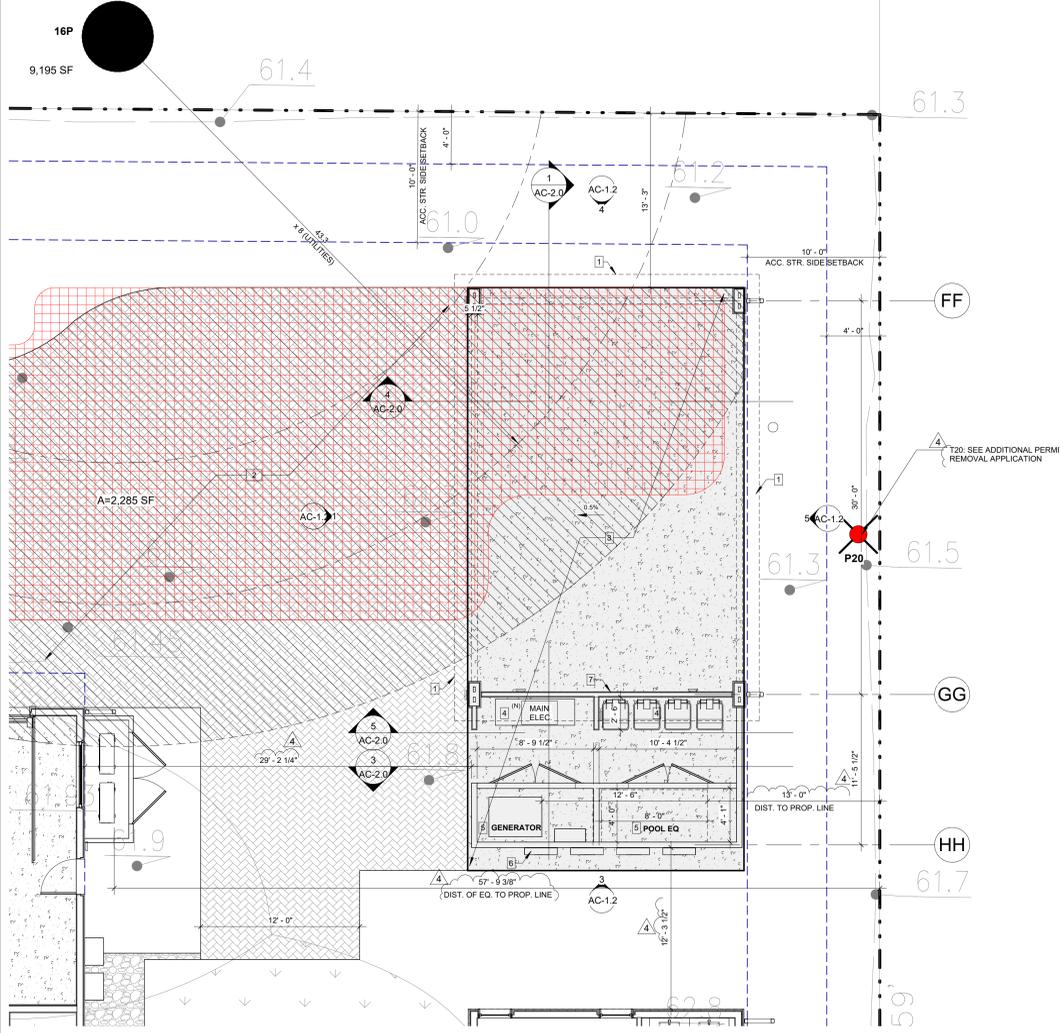
2 PROPOSED CARPORT FLOOR PLAN Copy 1
3/16" = 1'-0"

4 HAND-DIG AREA. SEE SUPPLEMENTAL ARBORIST REPORT ON A-0.3.1

- KEYNOTES:**
- ROOF OVERHANG
 - PERMEABLE PAVERS
 - CONCRETE PAD
 - ELECTRIC PANEL AND TRASH ENCLOSURE WALLS WOOD FRAMED/STUCCO FINISH TO MATCH MAIN HOUSE
 - GENERATOR & POOL EQUIPMENT ENCLOSURE COVERED UNDER 6" HI AND INSULATED, TO MEET TOWN OF ATHERTON MUNICIPAL CODE SECTION 8.16.030 - SEE GENERATOR SPECS ON 6/A-1.5
 - PV SYSTEM, BATTERIES, DEFERRED SUBMITTAL
 - 8" H WALL FOR ELECTRICAL PANEL

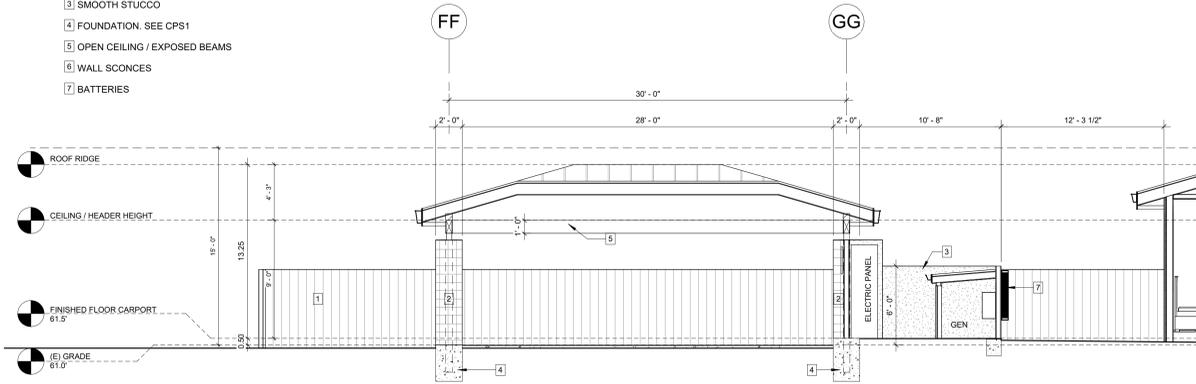
1 CARPORT SECTION 1 - Dependent 1
3/16" = 1'-0"

- 1 FENCE BEYOND
- 2 STONE VENEER FINISH
- 3 SMOOTH STUCCO
- 4 FOUNDATION. SEE CPS1
- 5 OPEN CEILING / EXPOSED BEAMS
- 6 WALL SCONCES
- 7 BATTERIES

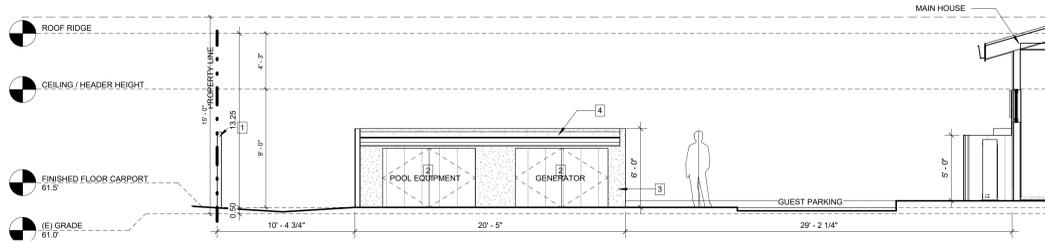
3 CARPORT SECTION 3 - Dependent 1
3/16" = 1'-0"

- 1 FENCE
- 2 SOLID CORE DOORS TREATED FOR EXTERIORS
- 3 WALLS: SMOOTH STUCCO
- 4 FOUNDATION. SEE CPS1
- 5 ROOF: TO MATCH CARPORT

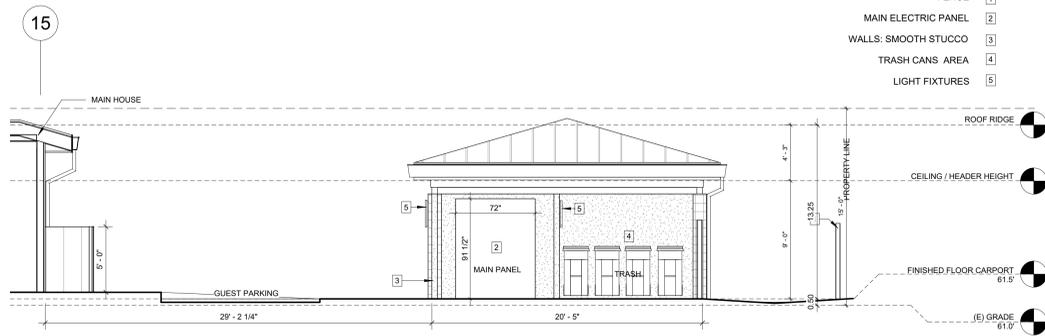
5 CARPORT SECTION 4
3/16" = 1'-0"

- FENCE 1
- MAIN ELECTRIC PANEL 2
- WALLS: SMOOTH STUCCO 3
- TRASH CANS AREA 4
- LIGHT FIXTURES 5

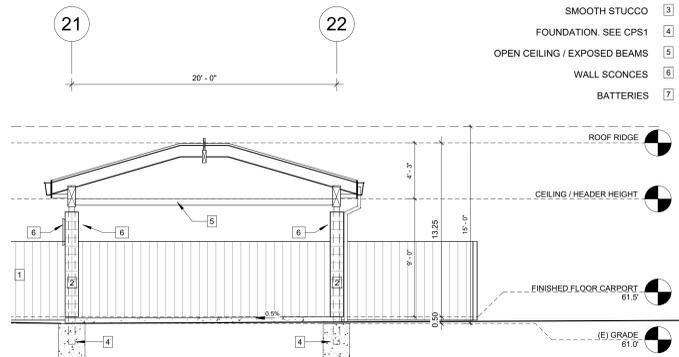
4 CARPORT SECTION 2 - Dependent 1
3/16" = 1'-0"

- FENCE BEYOND 1
- STONE VENEER FINISH 2
- SMOOTH STUCCO 3
- FOUNDATION. SEE CPS1 4
- OPEN CEILING / EXPOSED BEAMS 5
- WALL SCONCES 6
- BATTERIES 7

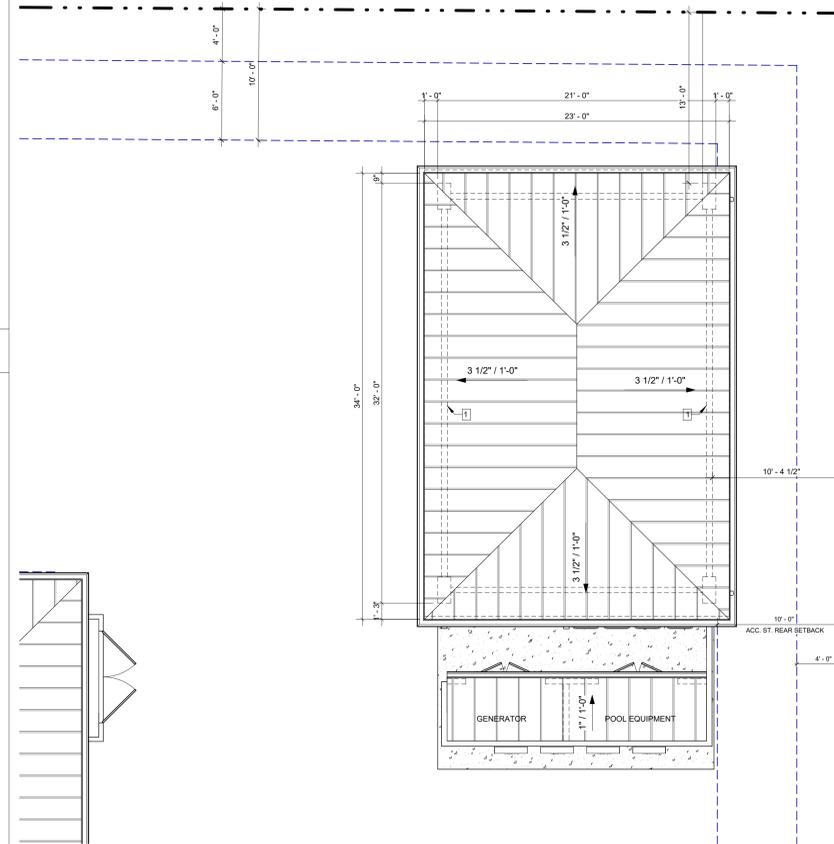
2 PROPOSED CARPORT ROOF PLAN - Dependent 1
3/16" = 1'-0"

- 1 CARPORT FOOTPRINT

ALL ROOFS ARE CLASS 'A' FIRE-RATED
